# Dog Fence Board

## Activity, Inspection & Condition Report

28 August 2023 – 11 December 2023

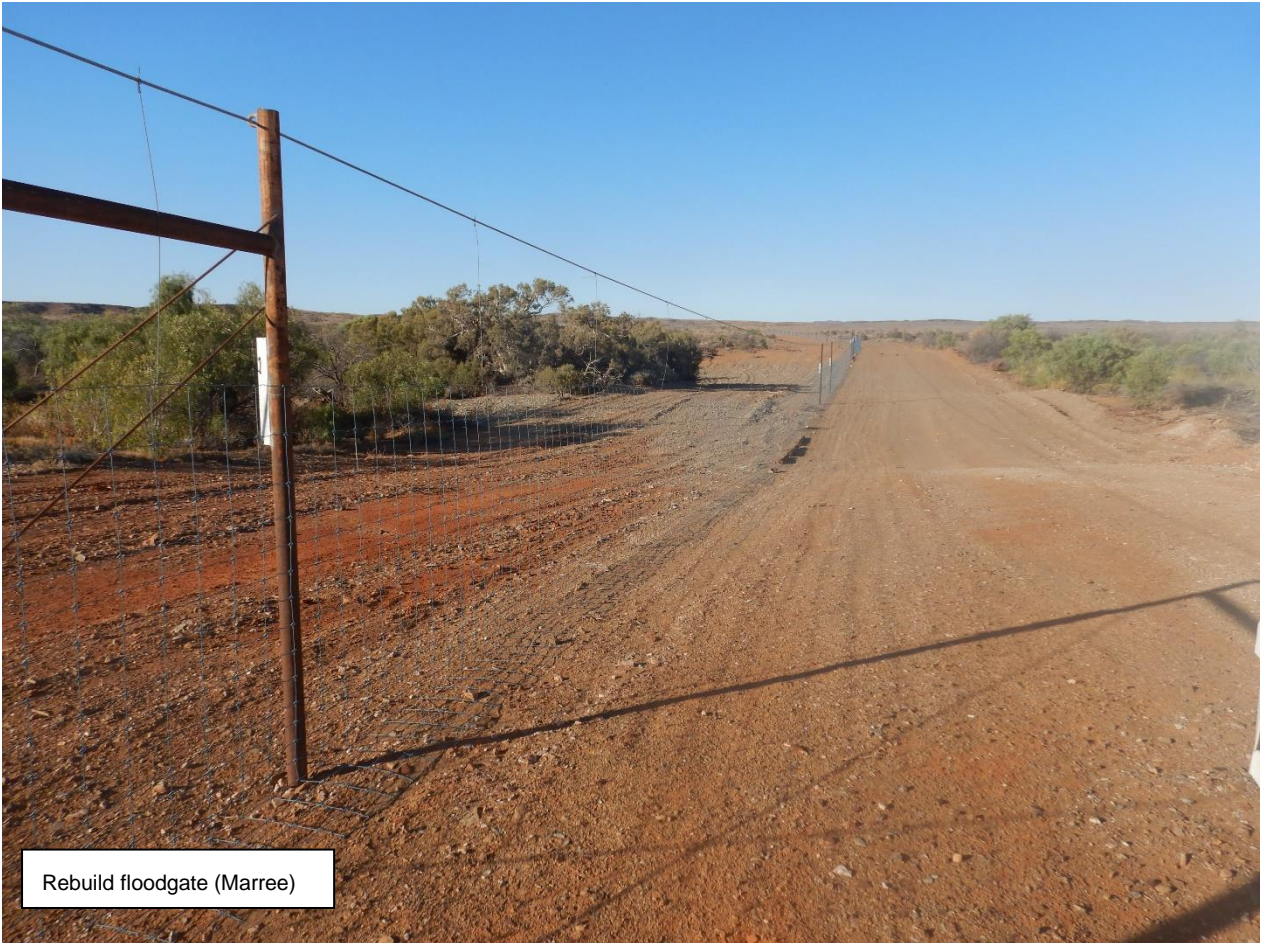
Rebuild floodgate (Marree)

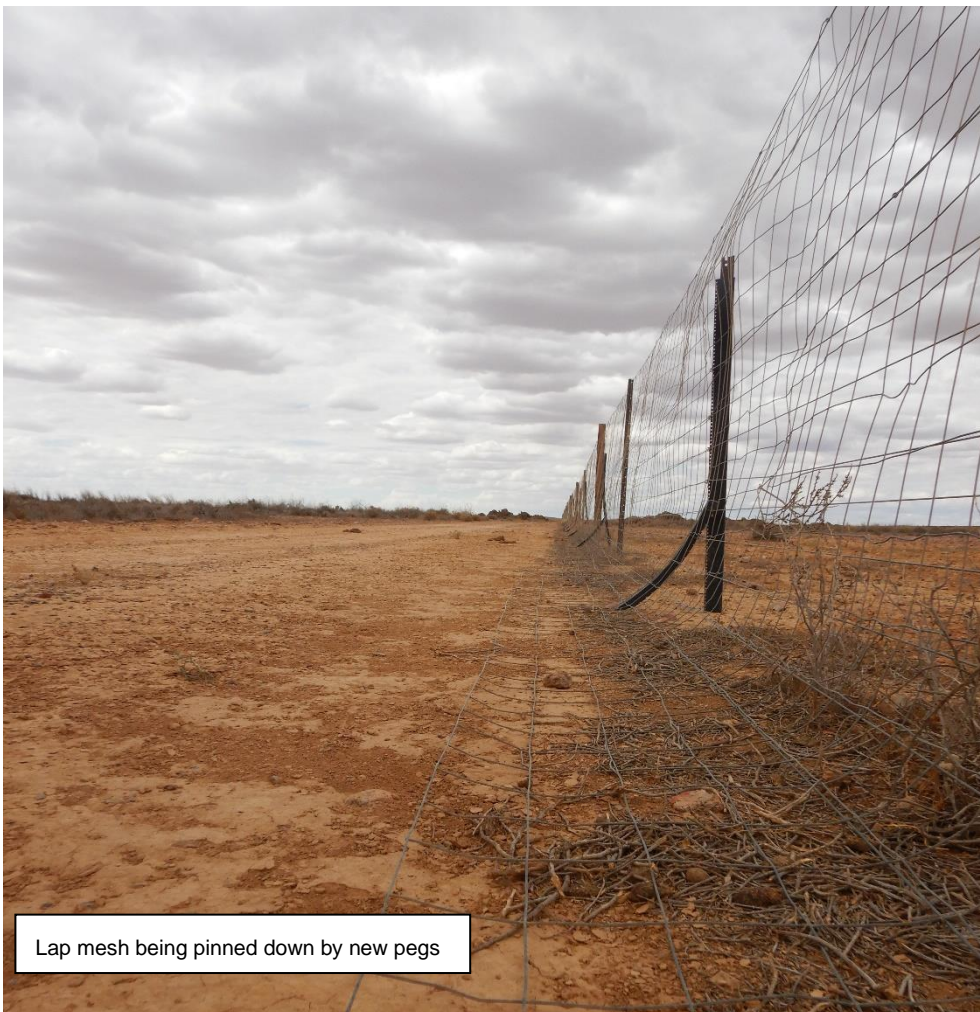
Lap mesh being pinned down by new pegs
