Dog Fence Board

Activity, Inspection & Condition Report

5 February 2024 – 13 May 2024

Eastern Fence Inspection 21/04/2024 – 29/04/2024

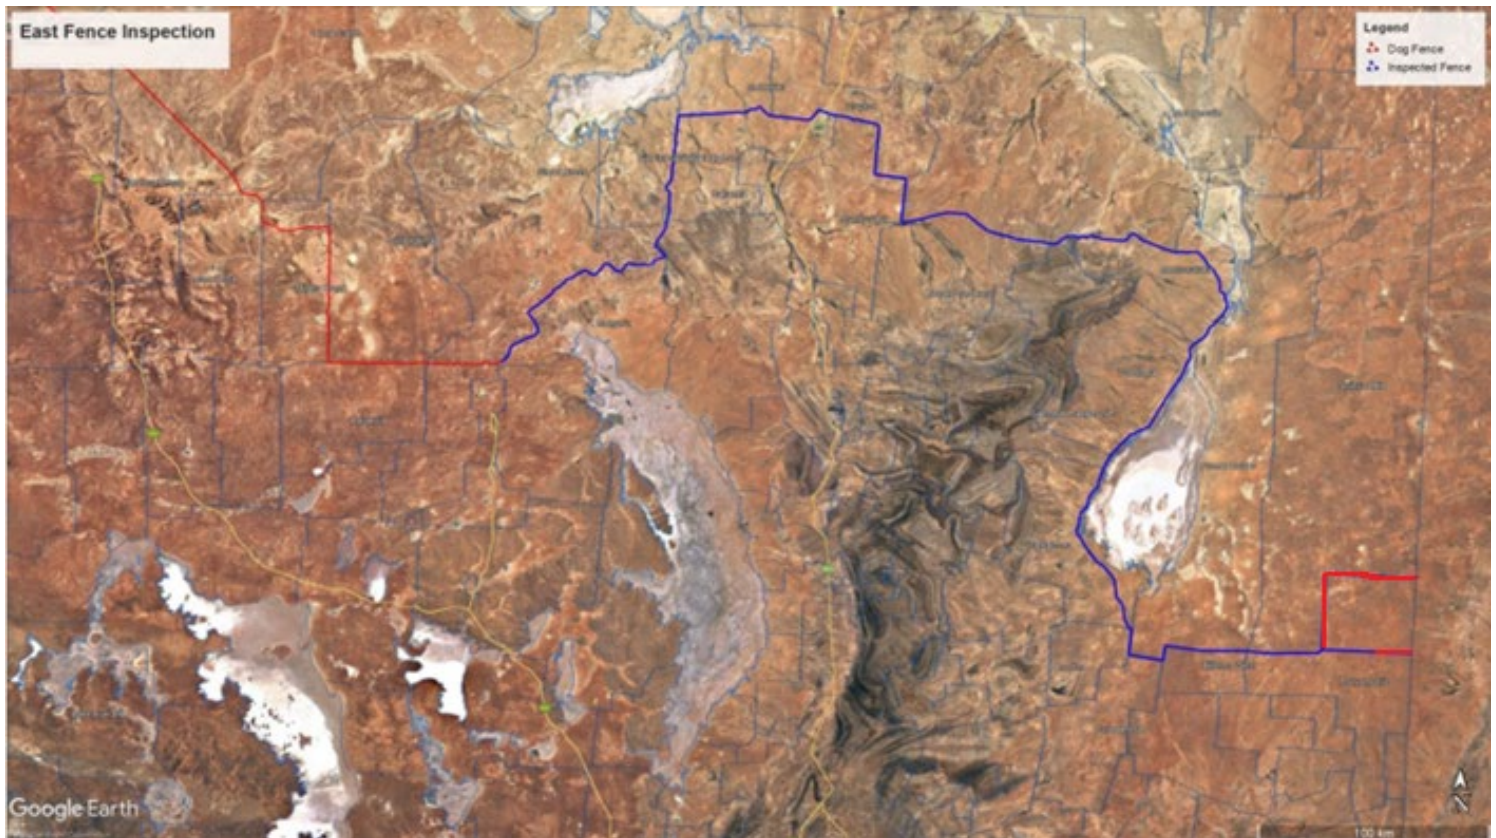
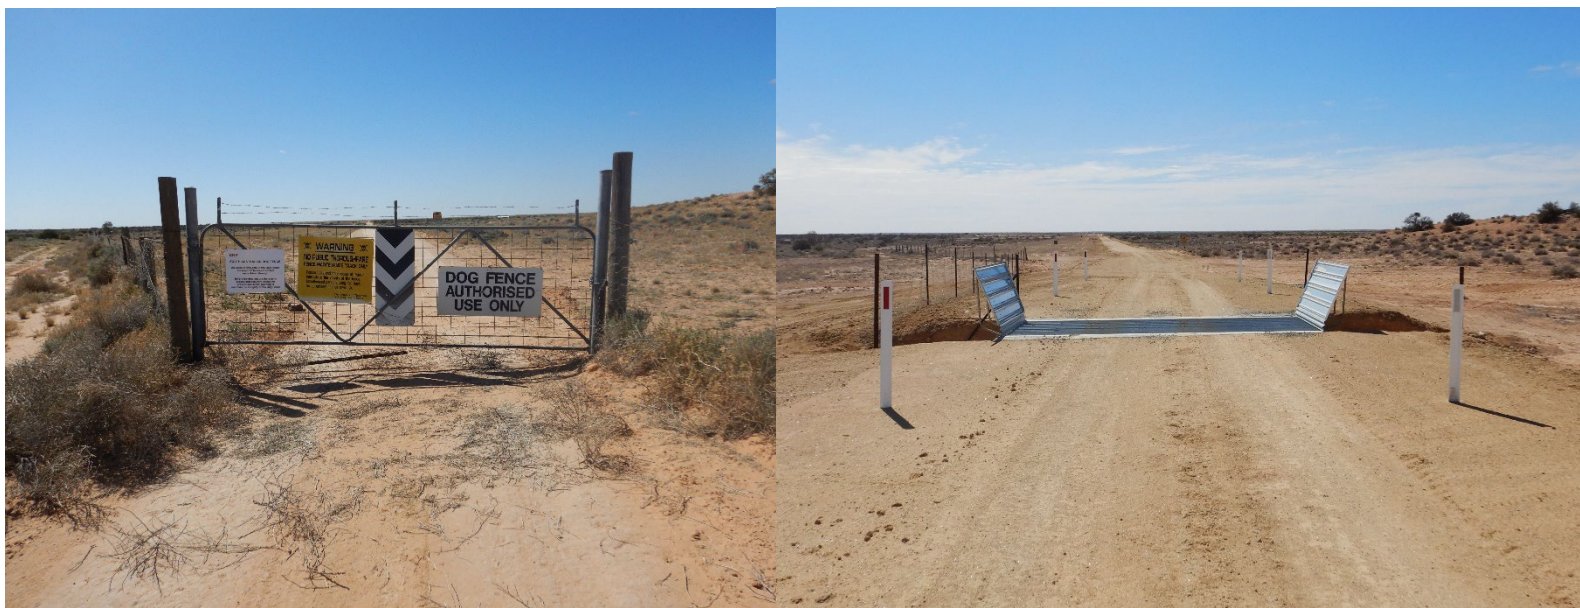
Muloorina Pipeline Road (south) gate replacement before & after

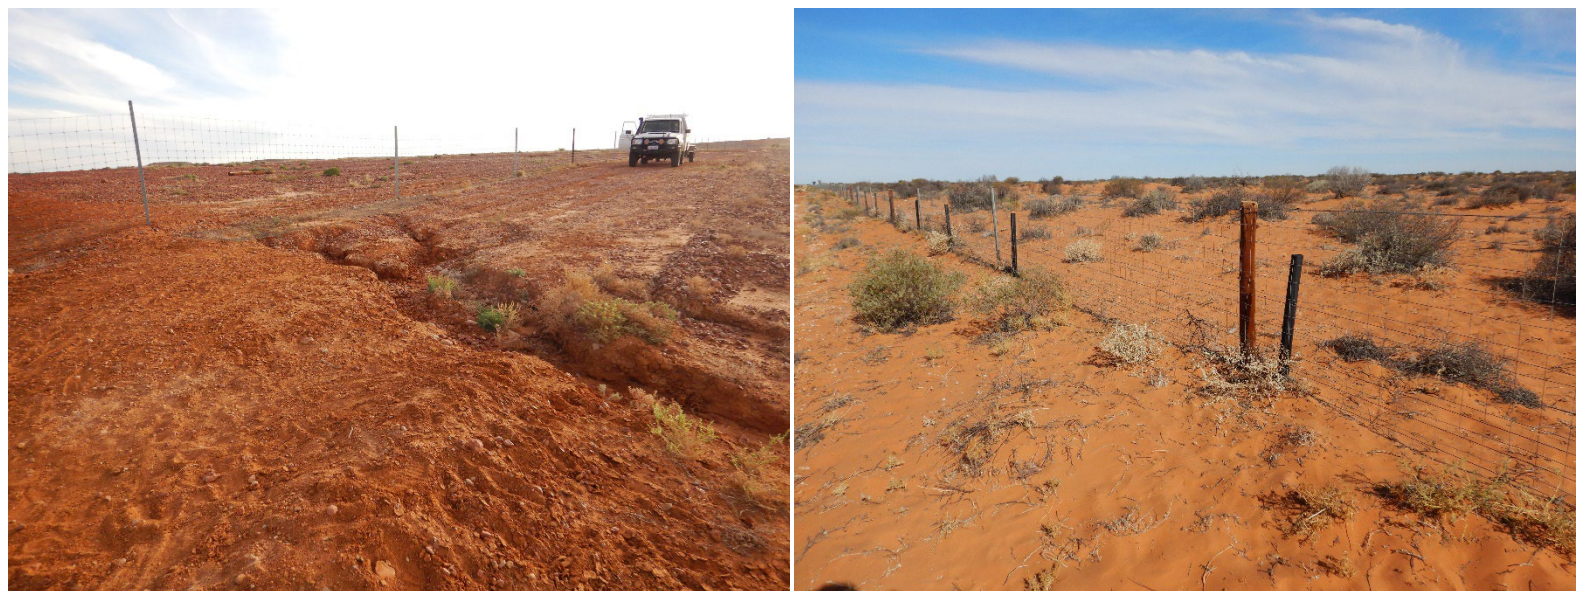
Water erosion and sand build up – Muloorina (Marree LDFB)

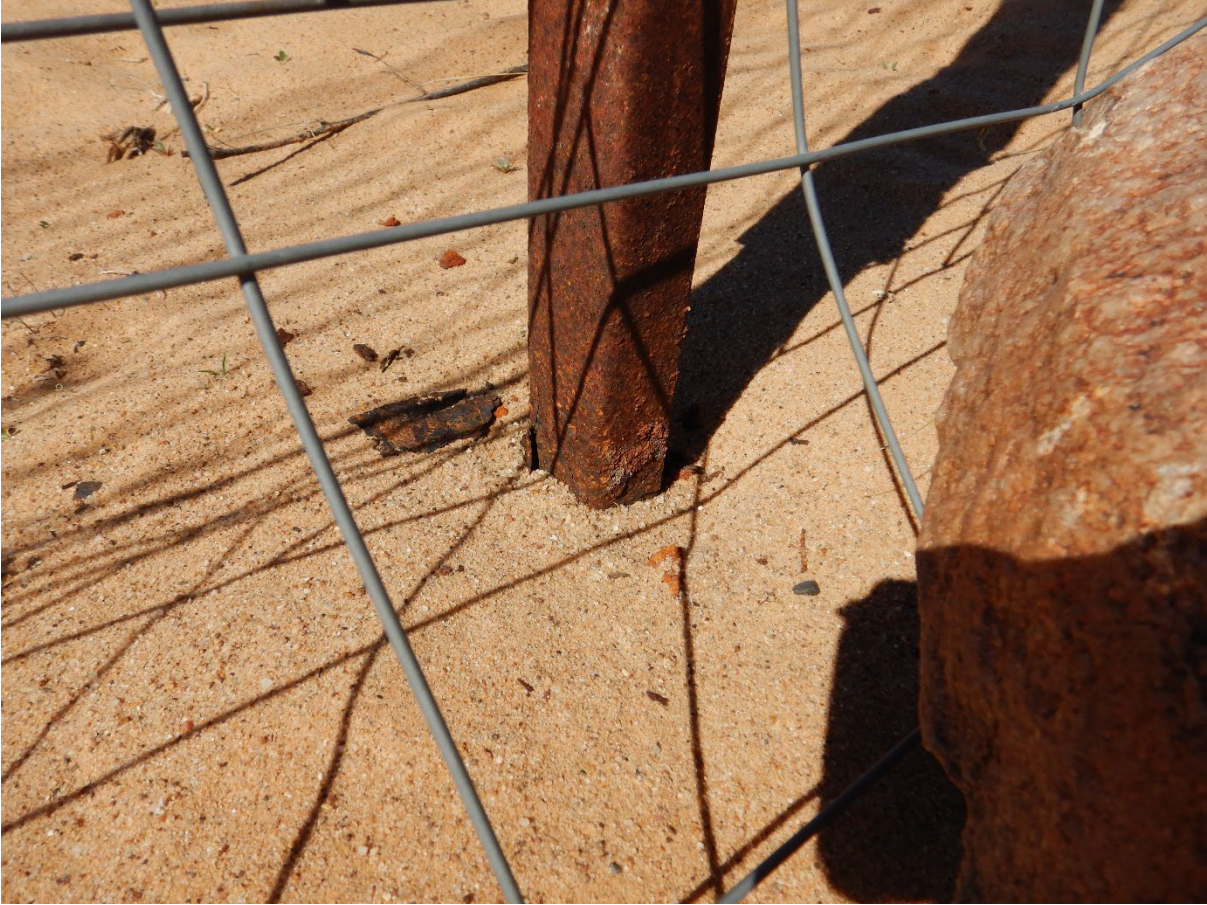
Rusted posts around Lake Eyre South (5km section)

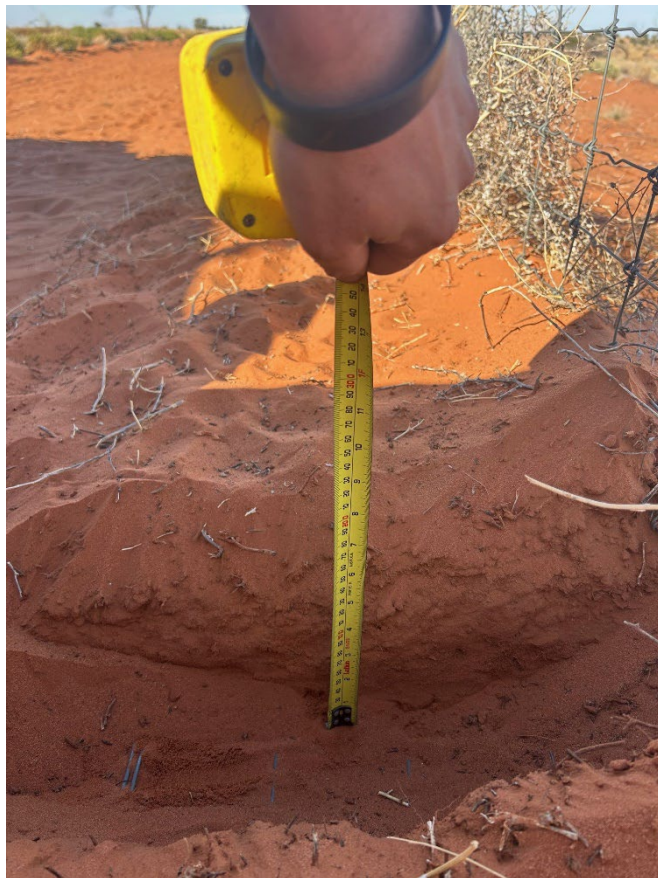
20 – 30cm sand build up – Billeroo (Frome LDFB)
