## Dog Fence Board Activity, Inspection & Condition Report

28 September to 20 December 2020

# Dog Fence Board - Activity, Inspection & Condition Report

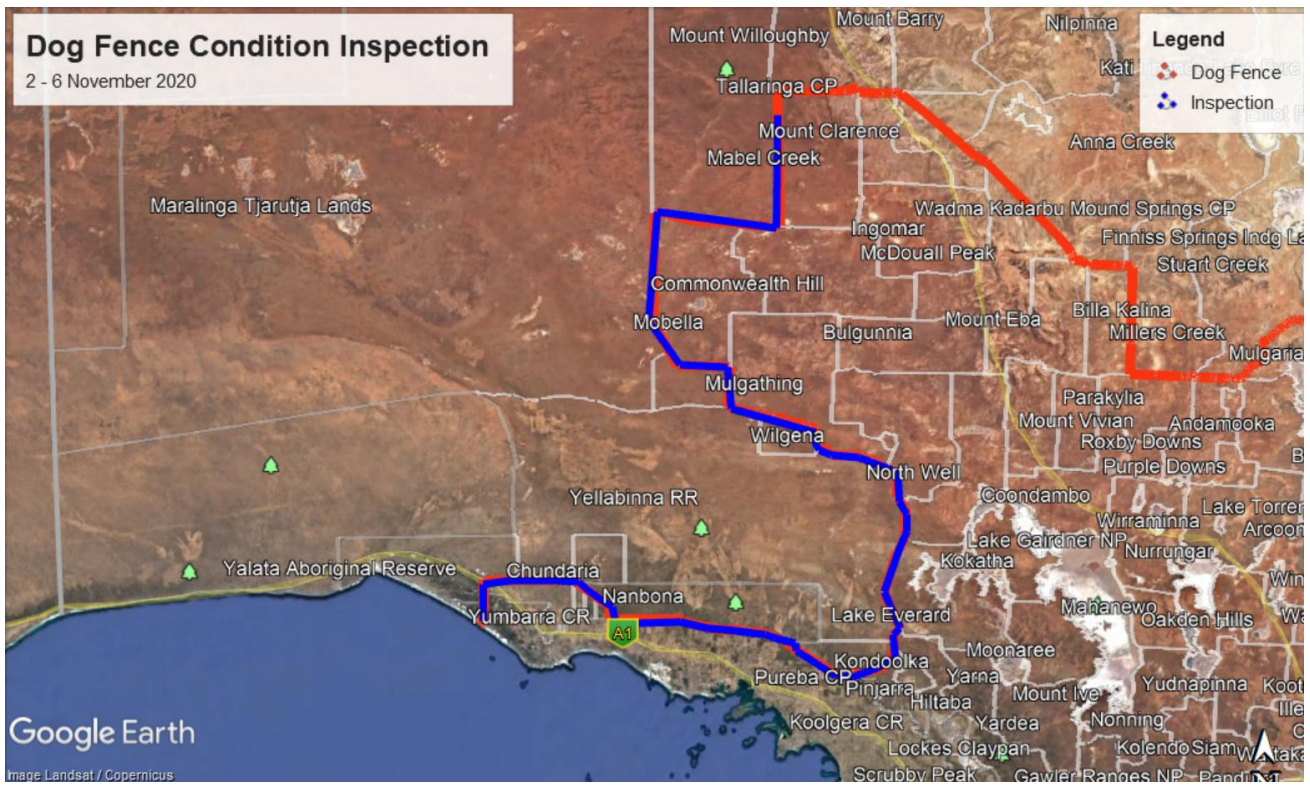
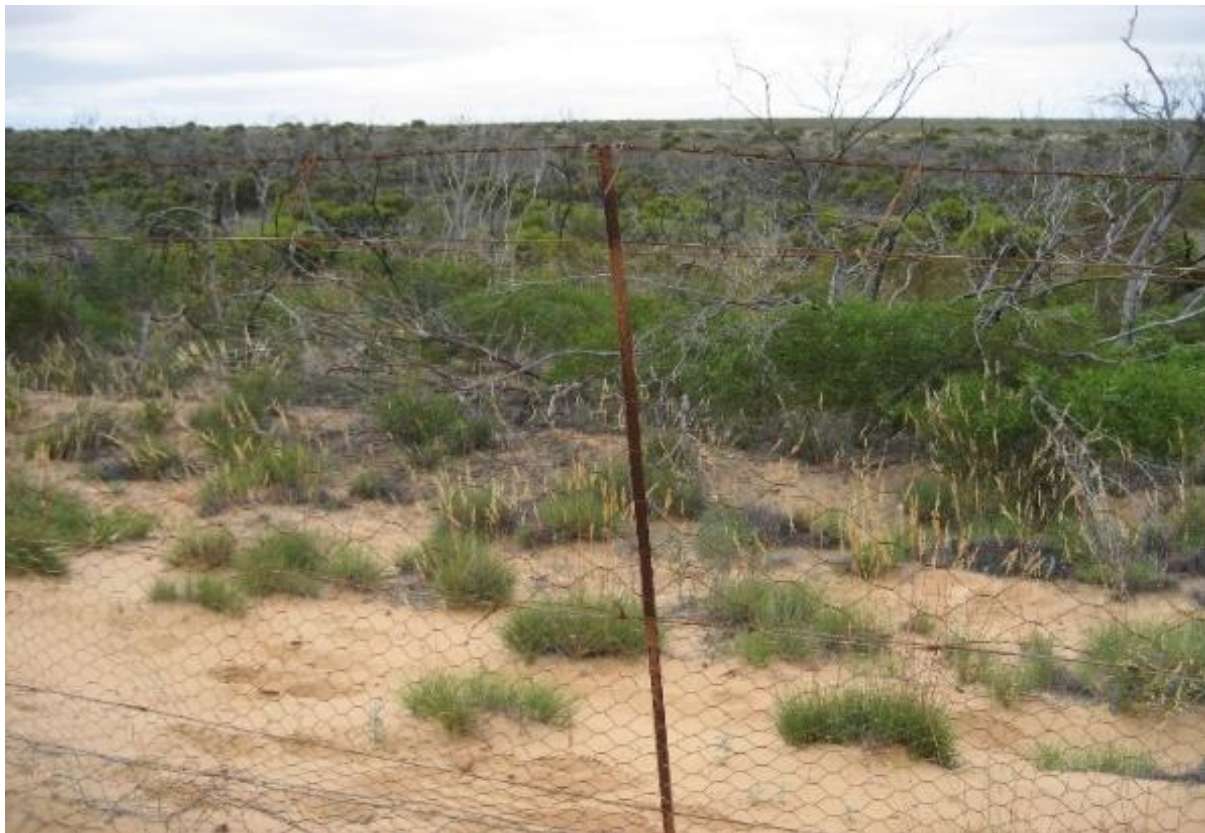
Burnt dropper and brittle wire in a high priority section of Pureba

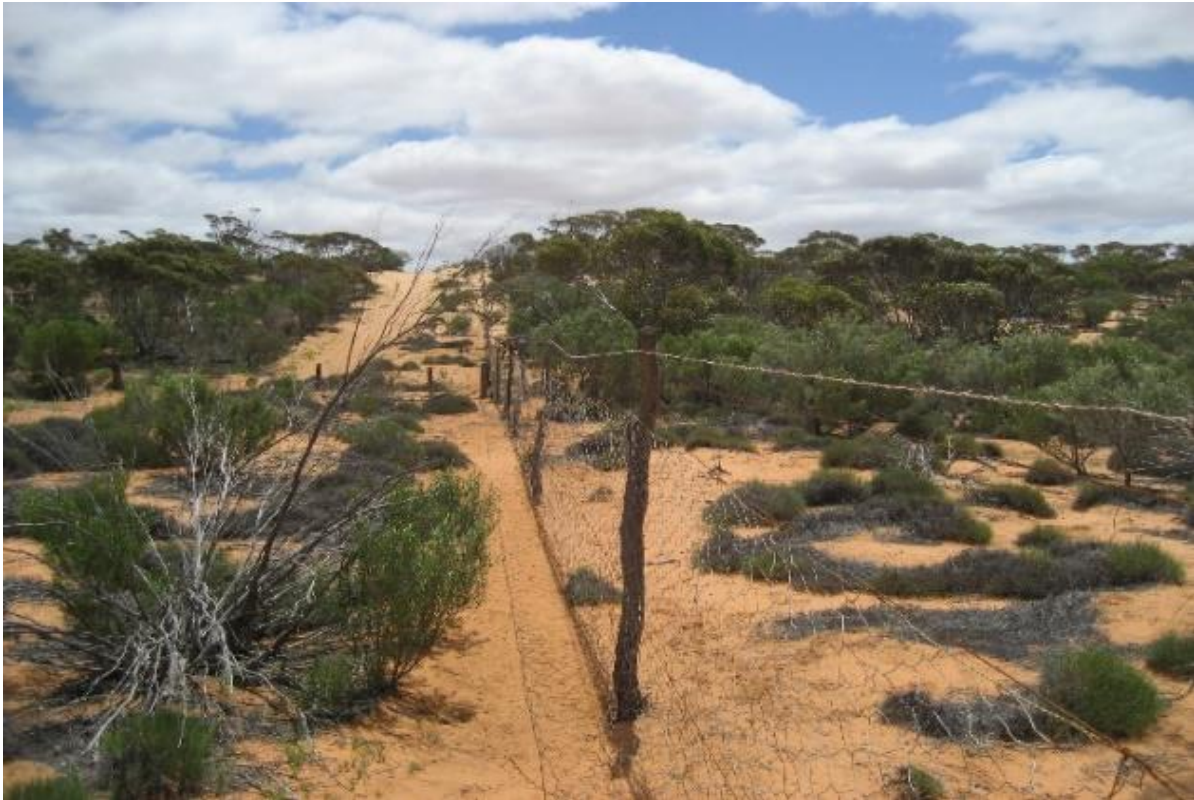
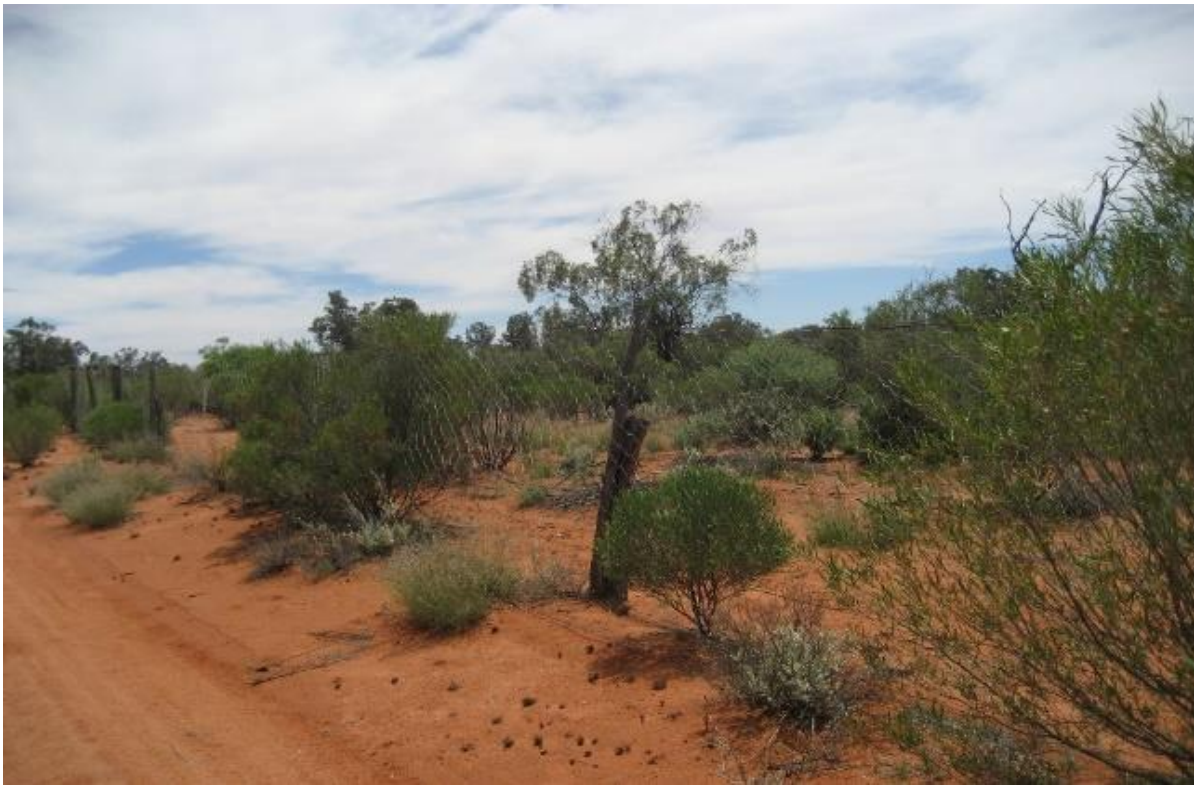
Vegetation in and along fence

Recommendations	<ul style="list-style-type: none"> <li>• Vegetation is an issue along various sections. All patrolman to continue with management.</li> <li>• Utilise rebuild/maintenance prioritisation template. Use this to help guide fence maintenance and rebuild process to a consistent standard. Section condition assessment report has been produced grading assessed Dog Fence from AS NEW to REPLACEMENT REQUIRED. Each section has been graded regarding fence height, and overall score of droppers, posts, netting, lap and pegging.</li> </ul>

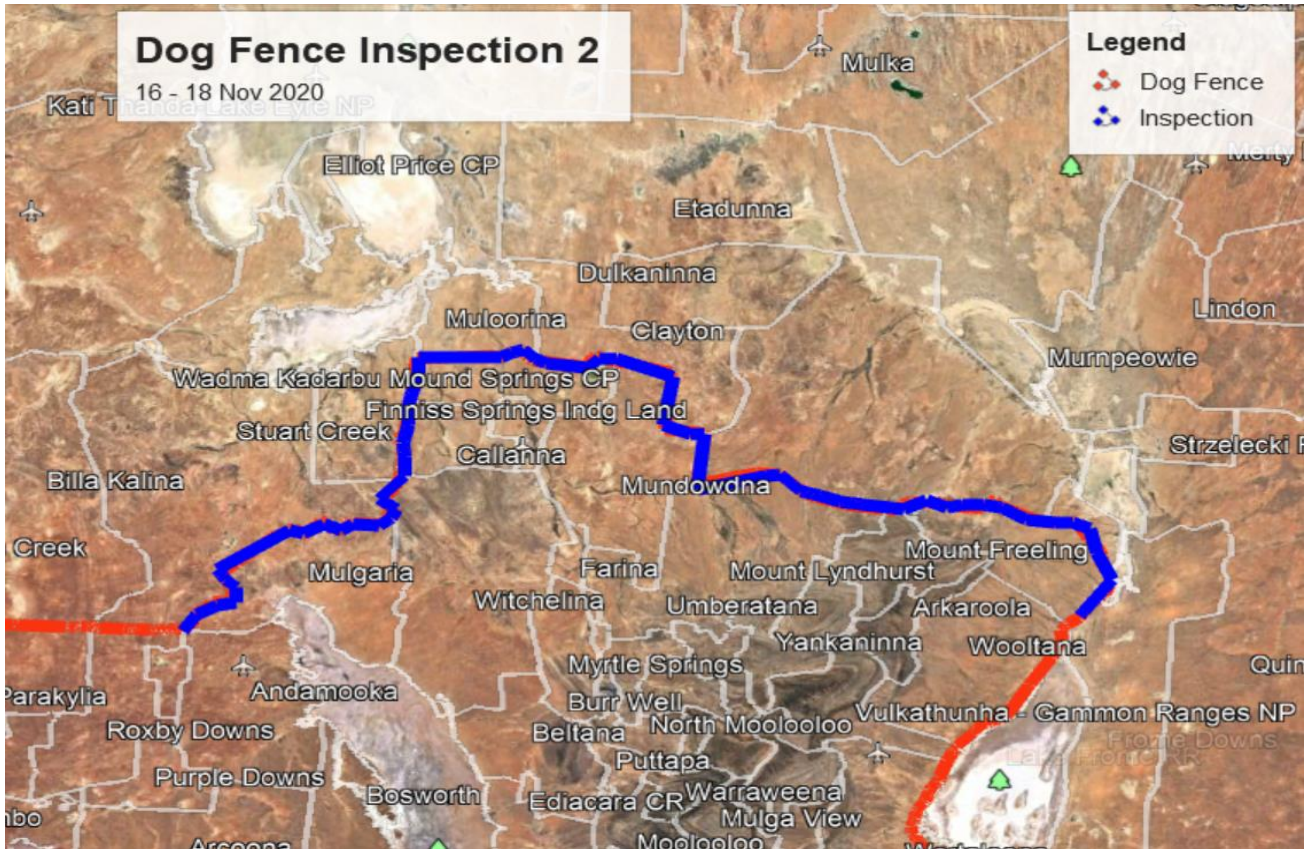
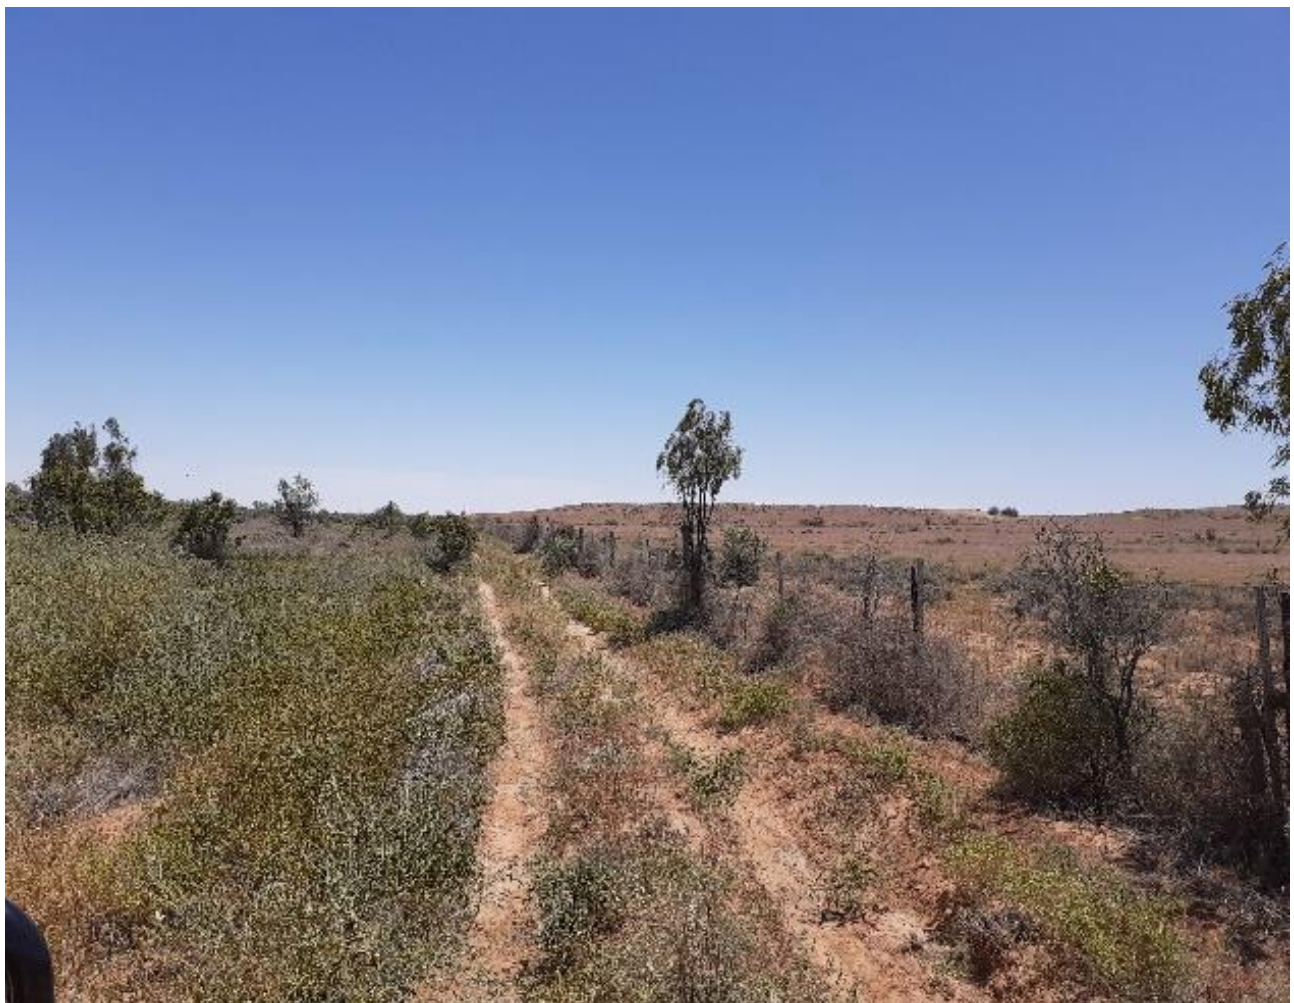
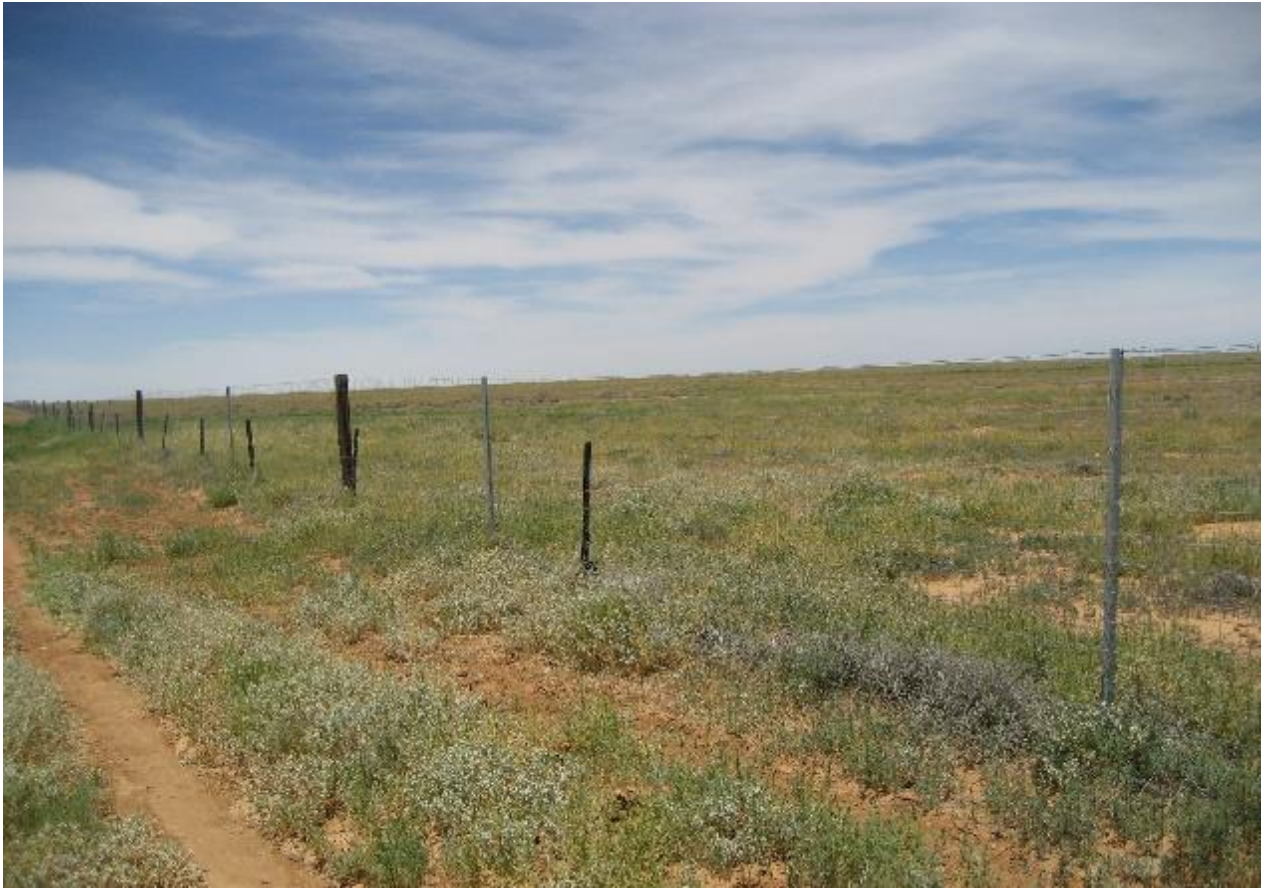
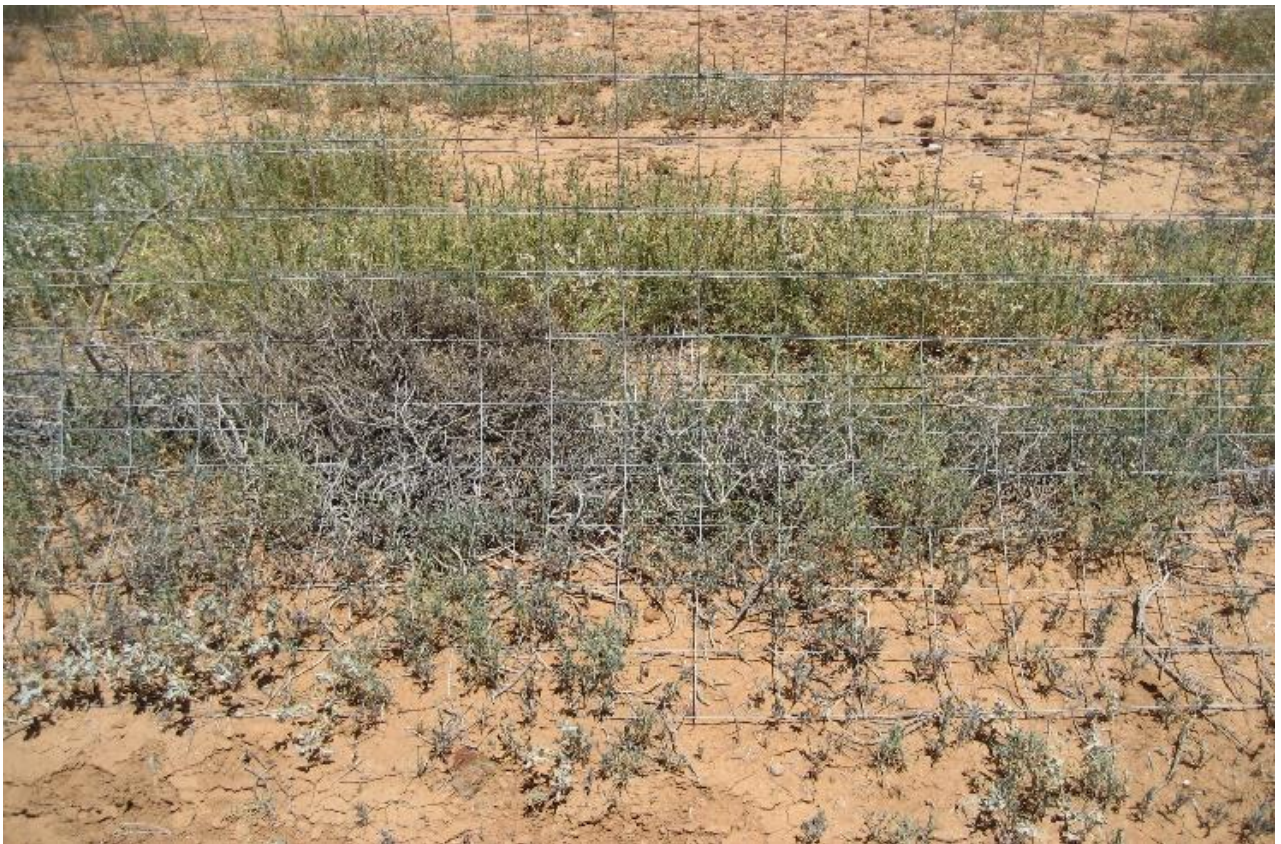
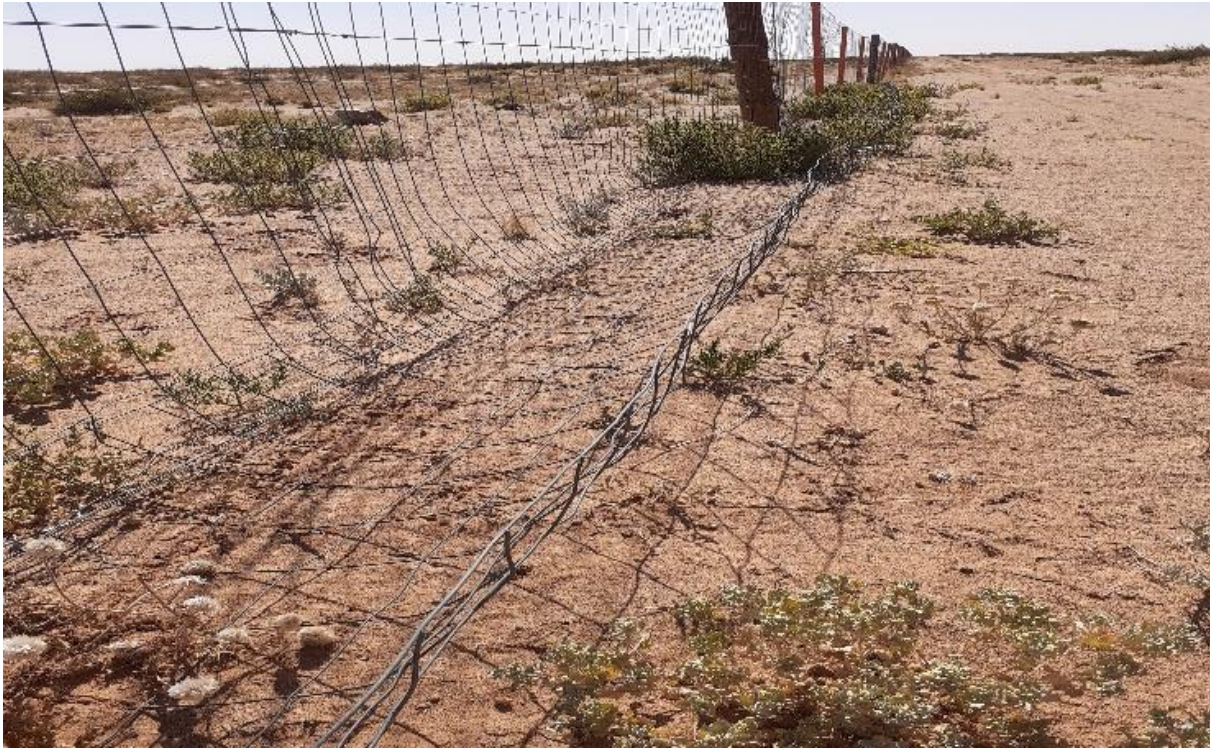
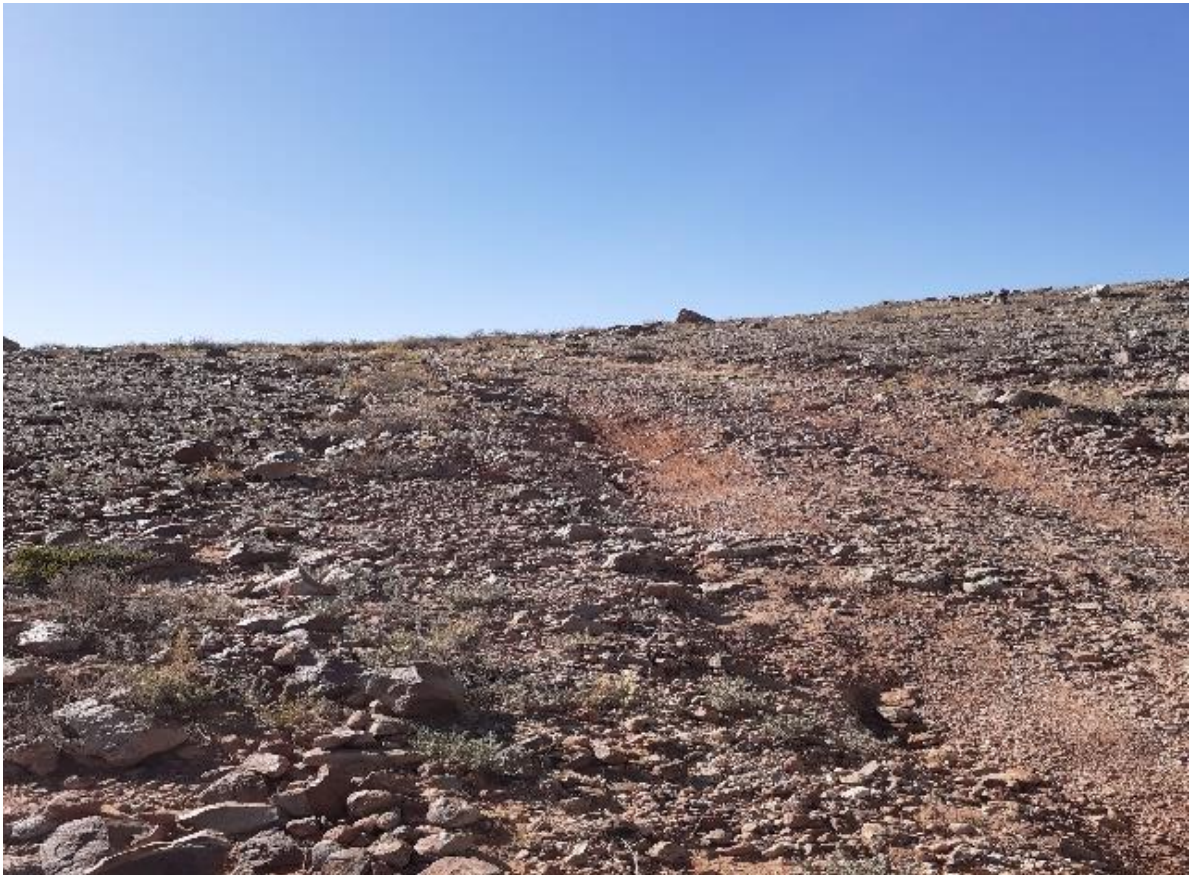
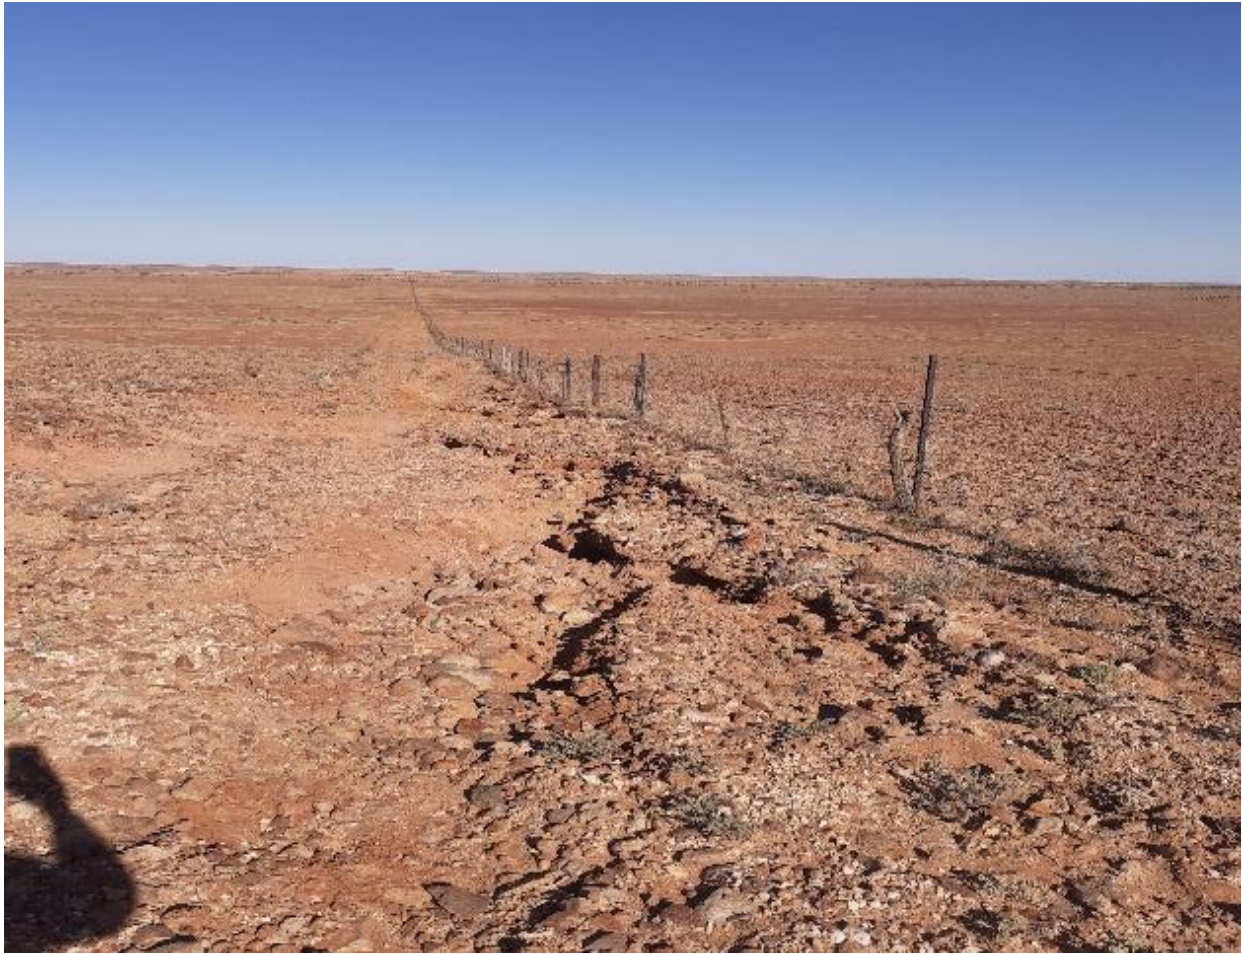
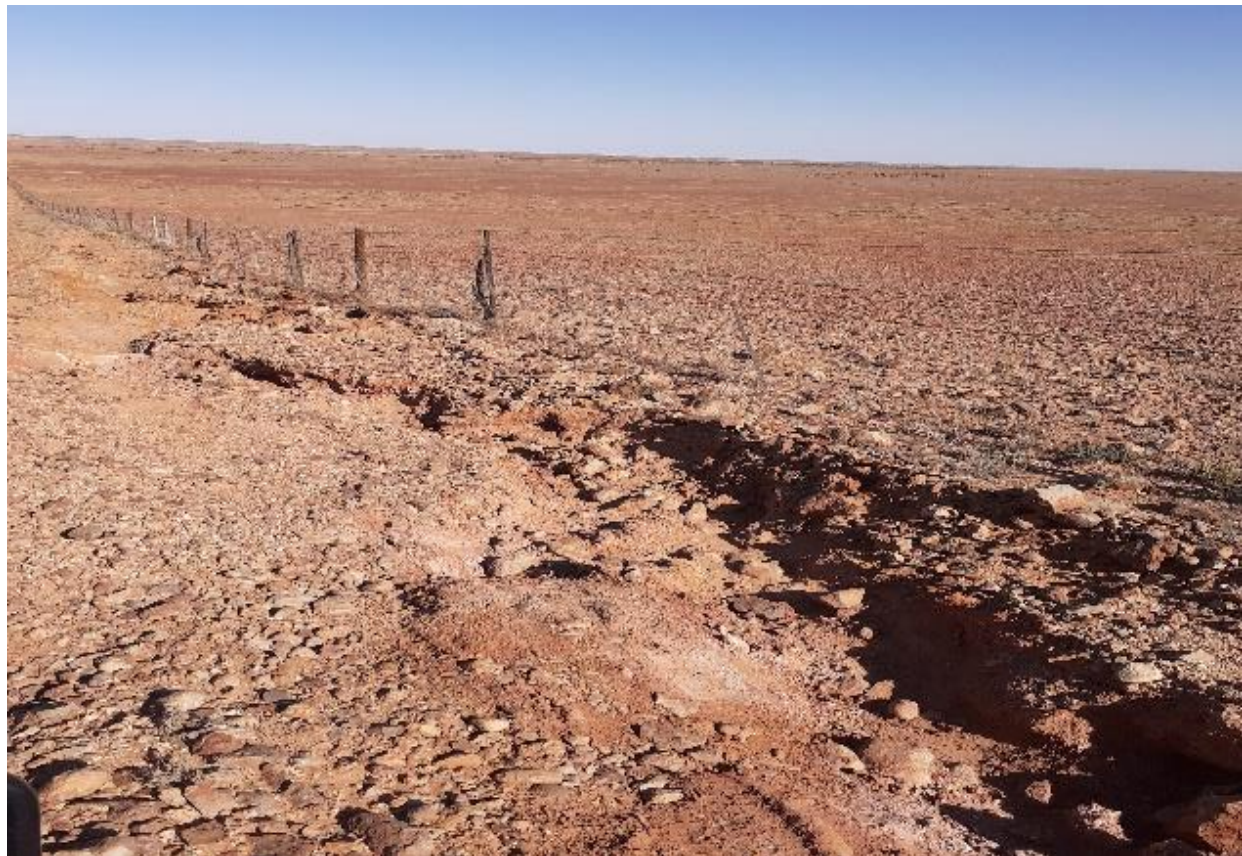
## Dog Fence Inspection 2

Date	16 – 18 Nov 2020
Section/s	Central, Marree ,Frome
Location description	Roxby Downs to Moolawatana – approx. 463km
Inspected by	Dog Fence Inspector
Comments	<ul style="list-style-type: none"> <li>• This trip was cut short due to state COVID-19 lockdown</li> <li>• Inspected eastern sections of Dog Fence.</li> <li>• Inspected fence maintenance works.</li> <li>• Fence in a dog-proof condition.</li> <li>• Mulgaria fence has sections with quite a lot of vegetation growing, and other areas where sand drift is occurring from lack of vegetation. Some curling noted at eastern end of fence. Track was generally ok.</li> <li>• Witchelina fence is quite poor in sections due to age. It is dog proof but will need rebuilding. The track will need attention soon at creek crossings and in the hills halfway along this fence section.</li> <li>• Callanna and Muloorina had areas of scattered vegetation. Some flood gates on Muloorina are around 1200mm. The track on the western side of Muloorina was recently graded.</li> <li>• Clayton track starts out good but at the change in fence turns very poor. Lots of curling in the lap after the Birdsville track. The fence is old and in poor condition. The track is very poor with erosion issues.</li> <li>• Mundowdna fence is in poor condition. The track also has significant erosion issues.</li> <li>• Wilpoorinna has a lot of vegetation in the fence. The track is ok.</li> <li>• Mt Lyndhurst has a lot of vegetation in the fence.</li> <li>• Mt Freeling and Moolawatana are dog proof. The creeks that have flowed up there recently have shifted large amounts of debris and sand. The patrolmen have done a great job in flood repair work.</li> </ul>

Recommendations	<ul style="list-style-type: none"> <li>• Sections of this run are marked for rebuild. Most of the track issues and fence will be fixed with the rebuild.</li> <li>• Monitor track issues on this run and put a track maintenance program in place before track reaches current condition</li> <li>• Vegetation control will need to be a priority as rebuild continues.</li> </ul>

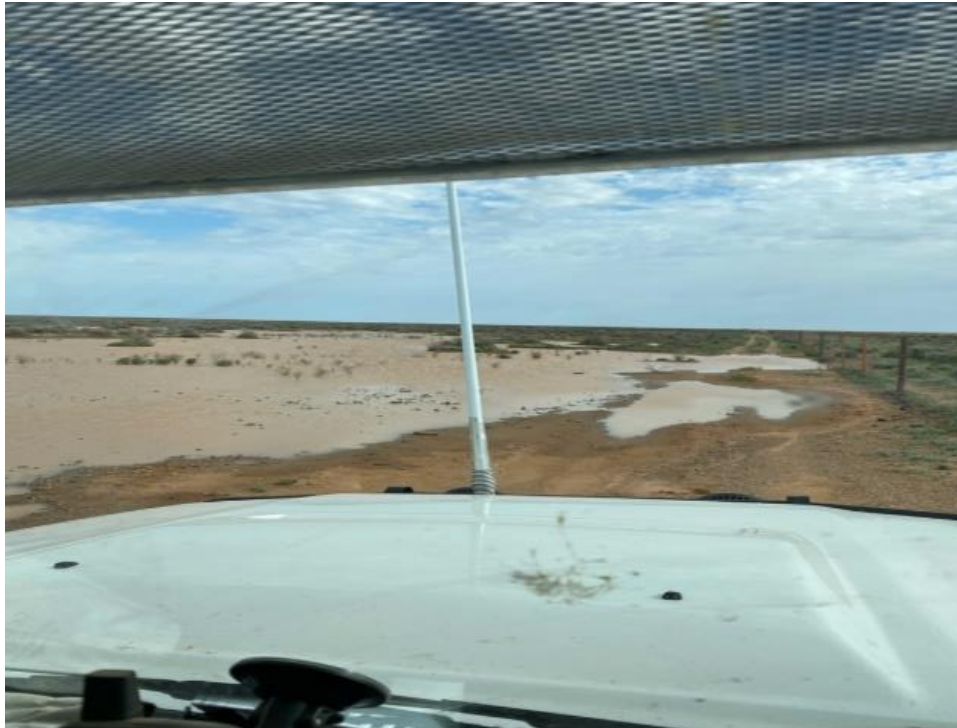
Flooding in the Marree LDFB section

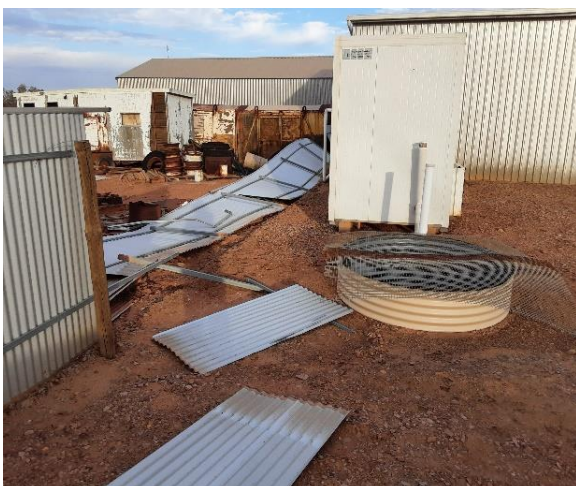
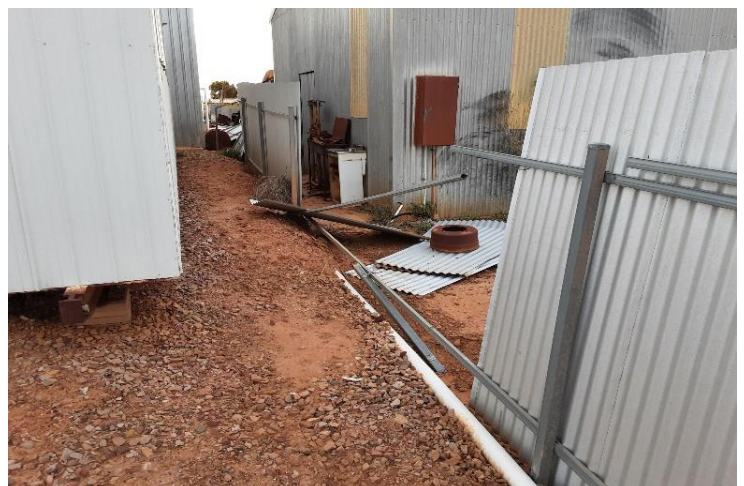
Significant damage occurred at the Lyndhurst Depot colour bond fence. High winds caused the north and south fences on the property to collapse. Temporary repairs were done by a community member, however the fence requires reposting. A local contractor has been sourced and repairs are aimed to be completed before Christmas. Approximately 80m of fence will be rebuilt, and an additional 40m of wire fence will be installed across the front of the property to increase depot security.
