Dog Fence Board

Activity, Inspection & Condition Report

10 February 2025 – 4 May 2025

Fence Condition and Inspection Report

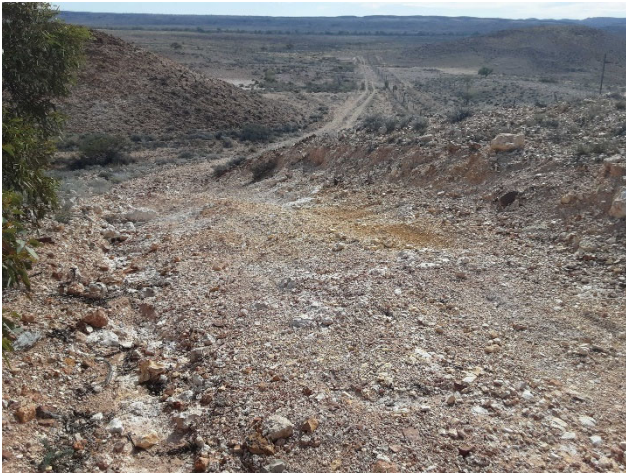
- Inspected Mulgaria section following reports of rough sections of track that was destroying tyres (Image 1) and requested track maintenance:
 - The sections identified were relatively short. Grading may not be a long-term solution; propose discussion with Marree LDFB to determine whether these sections could be clay-topped similar to the rough section east of the Strzelecki track.

Image 1 - Rough access track at Mulgaria

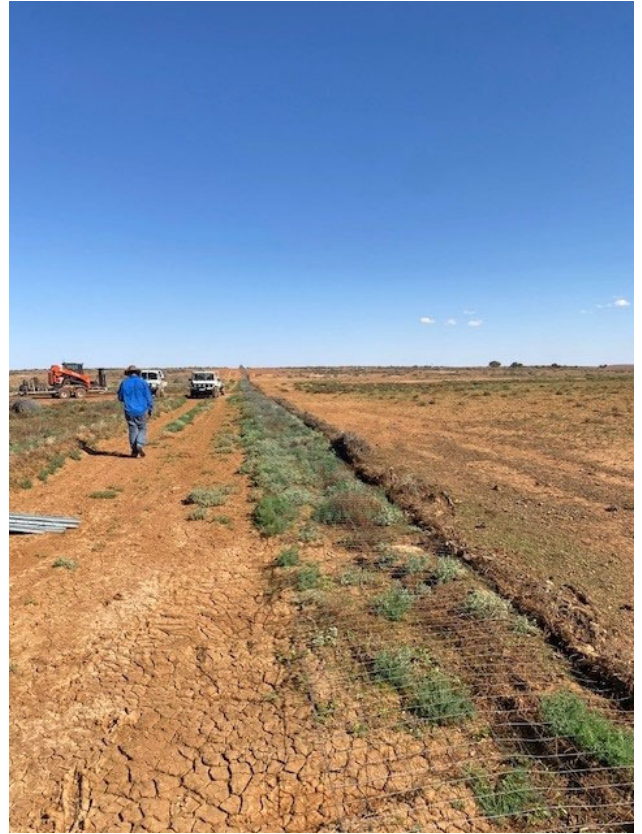
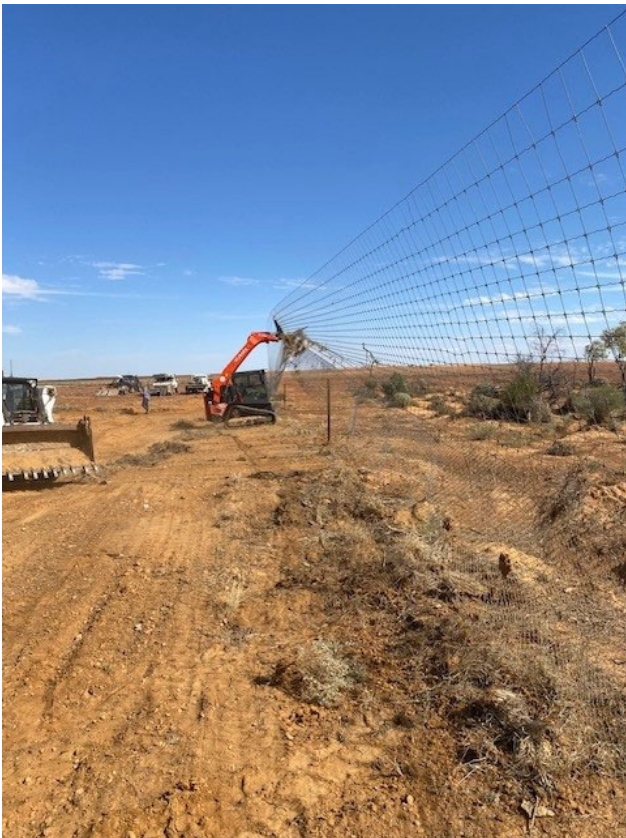
- Mundowdna flood repairs have been completed (Image 2 & 3):
 - Some extra chicken wire may need to be added.
 - High kangaroo numbers on the inside of the fence.

Image 2 - Flood repairs at Mundowdna

Image 3 - Flood repairs at Mundowdna

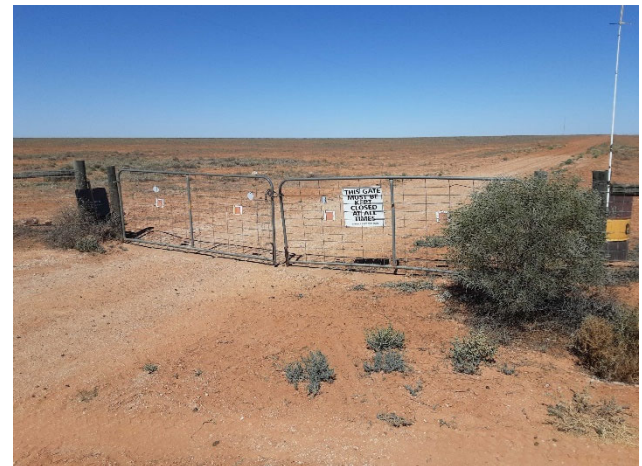
- Moolawatana
 - Current fence showing substantial lap curling - extra pegging will be required.
 - Pipeline road double gates below standard and too easy to be left with a gap between when closed (Image 4).

Image 4 - Double gates on the pipeline road

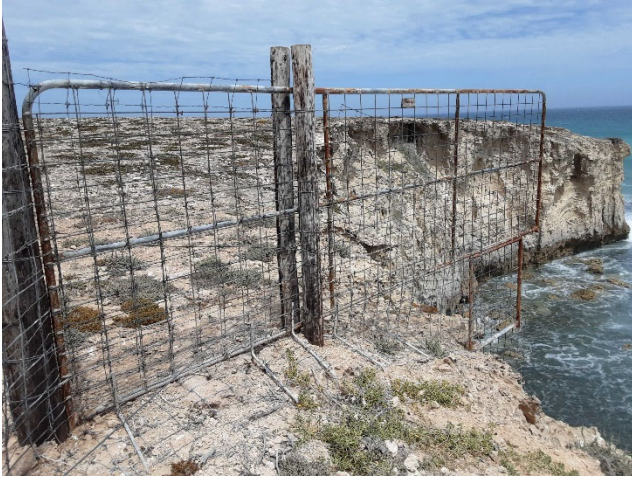
- Attended the Gallagher electric fence workshop in Penong.
- Gate hanging over the cliff is showing significant surface rust (Image 5).
- Potential for more erosion along the old maintenance track just south of the Eyre Highway.

Image 5 - Gate over the cliff at the western end of the fence

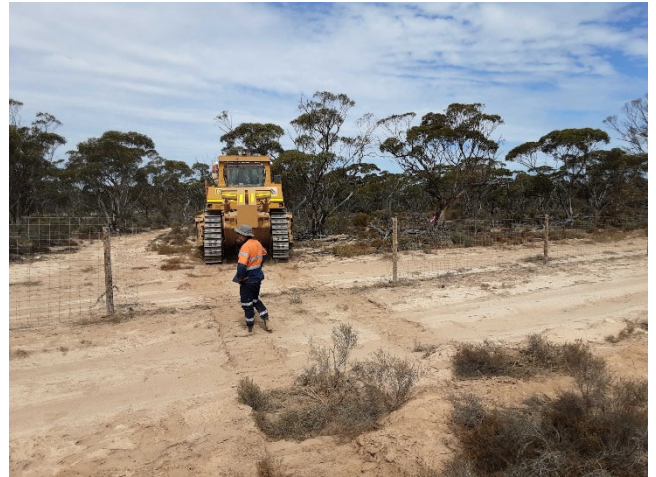
- Telstra contractors cut the fence at the Eyre highway. The fence was reinstated to an adequate standard while contractors are going back and forth with machinery. Penong LDFB patroller is monitoring the break in the fence to ensure it is kept dog-proof (Image 6).

Image 6 - Telstra working through the new fence

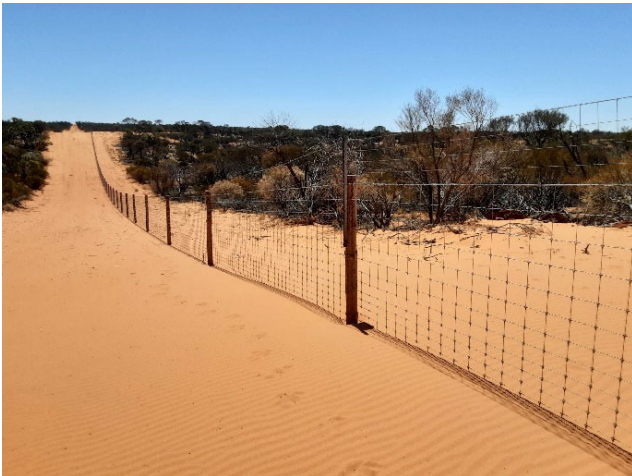
- Dog tracks observed inside Kondoolka gate; landholder notified and wild dog trapper deployed.
- Maintenance track along Lake Everard still sandy, unstable and challenging to drive through. Patroller has started topping the fence where required (Image 7).

Image 7 - Fence heightening at Lake Everard due to sand drift

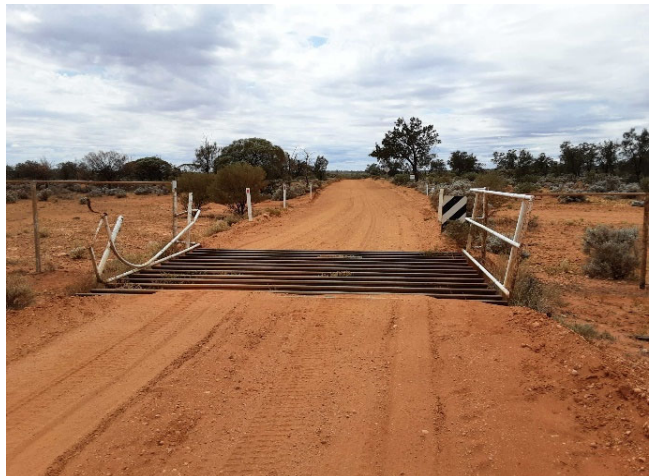
- Vegetation is starting to grow or is present – a second application of herbicide is required.
- Mulgathing grid is in poor condition and damaged. Recommend it be considered for replacement (Image 8).

Image 8 - Grid at Mulgathing
