## Dog Fence Board Activity, Inspection & Condition Report

14 February to 13 May 2021

# Dog Fence Board - Activity, Inspection & Condition Report

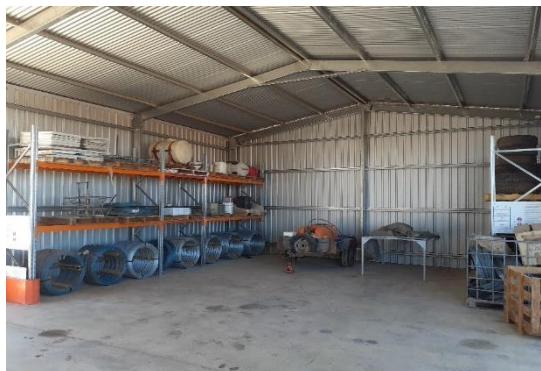
Lyndhurst Depot with new racking installed

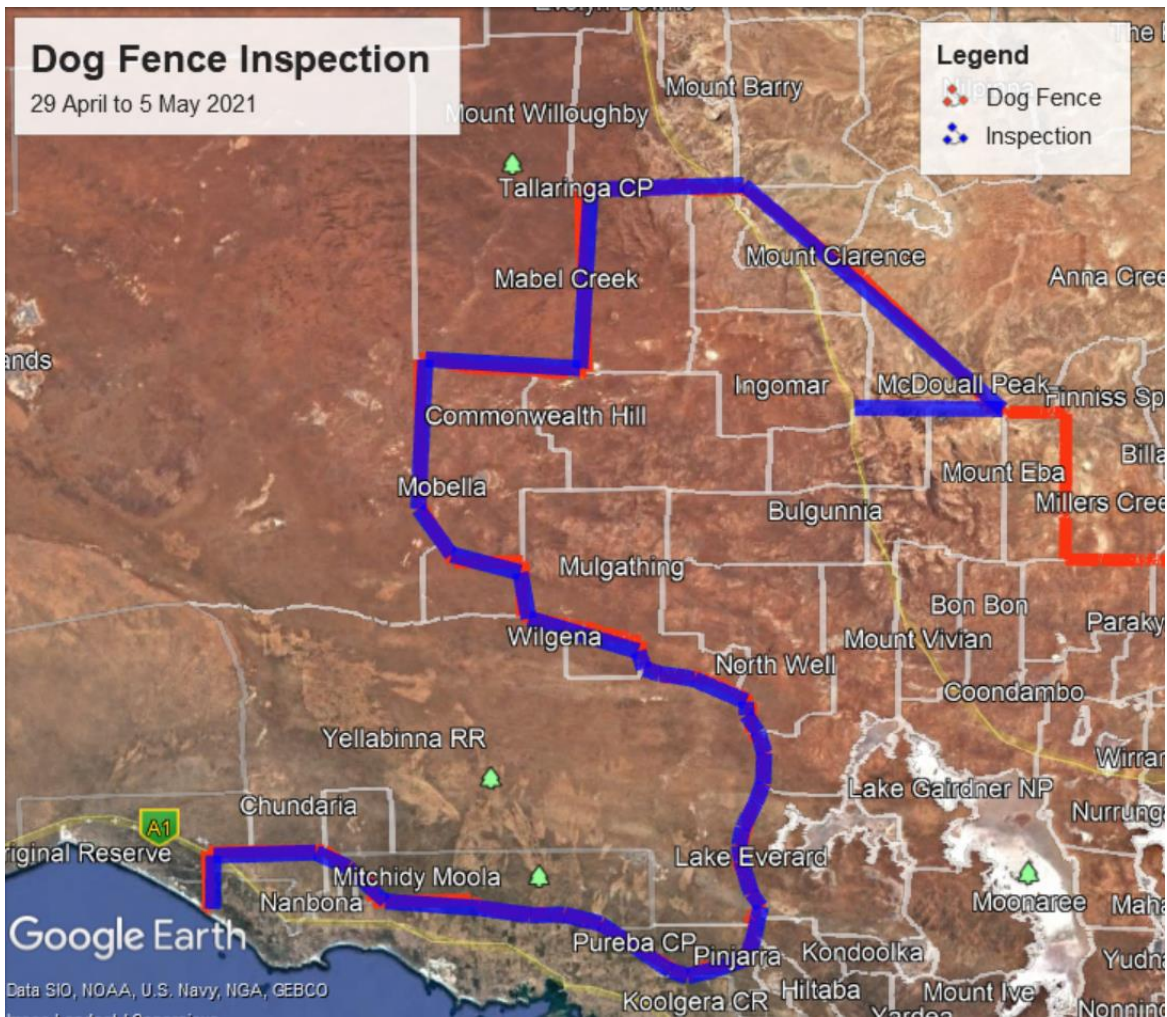
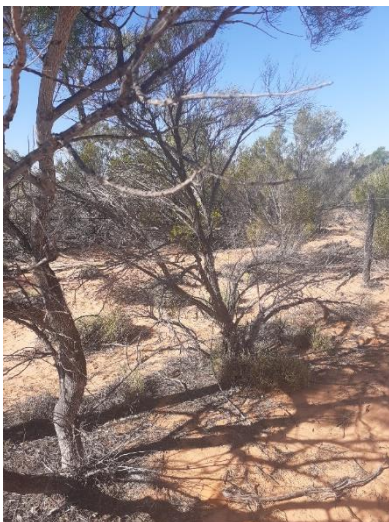
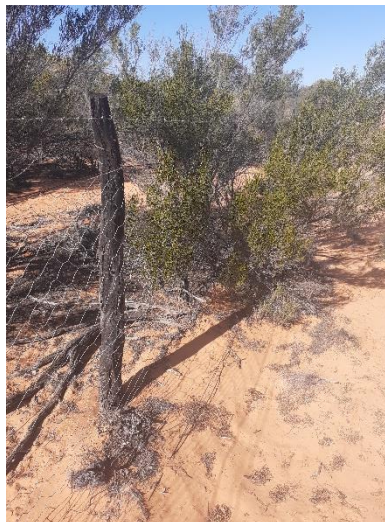
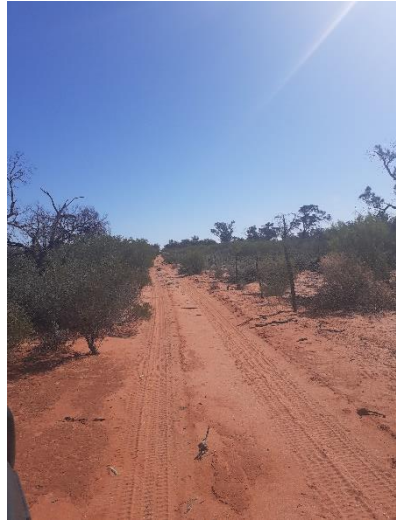
Condition inspection
29 April – 5 May 2021
Penong, North East Private, Central
Fowlers Bay to Mt Eba – 1153km approx.
Inspector, Dog Fence
<ul style="list-style-type: none"><li>• Inspected western half of Dog Fence.</li><li>• Inspected fence maintenance works.</li><li>• Fowlers Bay, Penong, Pureba Fence is in a dog-proof condition. Lap wire along coastal strip has been flagged needing replacement. Burnt section in Pureba is also a priority. Curling of lap was noted in other areas. Wild dog and fox activity regularly observed. New style beeper was working effectively</li><li>• Lake Everard and Wilgena Fence is in a dog-proof condition. Vegetation is an issue in this fence. Patrolman is dragging the track to maintain condition. The track requires monitoring to maintain its condition. Very soft sand in places.</li><li>• North West Private Fence is in a dog-proof condition. The fence is in better condition as you head North. Vegetation is an issue in the southern sections. The track has received some grading and is still very soft in places. The vegetation is crowding the track in places. This fence is under constant camel pressure, with camel activity noted along this fence section. Some dog activity was noted along this fence section.</li><li>• Mabel Creek is in dog proof condition. Has had some recent rain in the area. A lot of camel activity noted on Mabel Creek.</li><li>• Mount Clarence is in a dog-proof condition. New style beeper was working effectively</li><li>• Balta Baltana Fence is in a dog-proof condition. Very dry through here. Some large mobs of kangaroos noted on the fence.</li><li>• Mt Eba to Borefield Road not inspected due to WPA closure.</li></ul>

Vegetation in Fence and vegetation starting to encroach on the maintenance track
