Dog Fence Board

Activity, Inspection & Condition Report

17 May 2023 – 28 August 2023

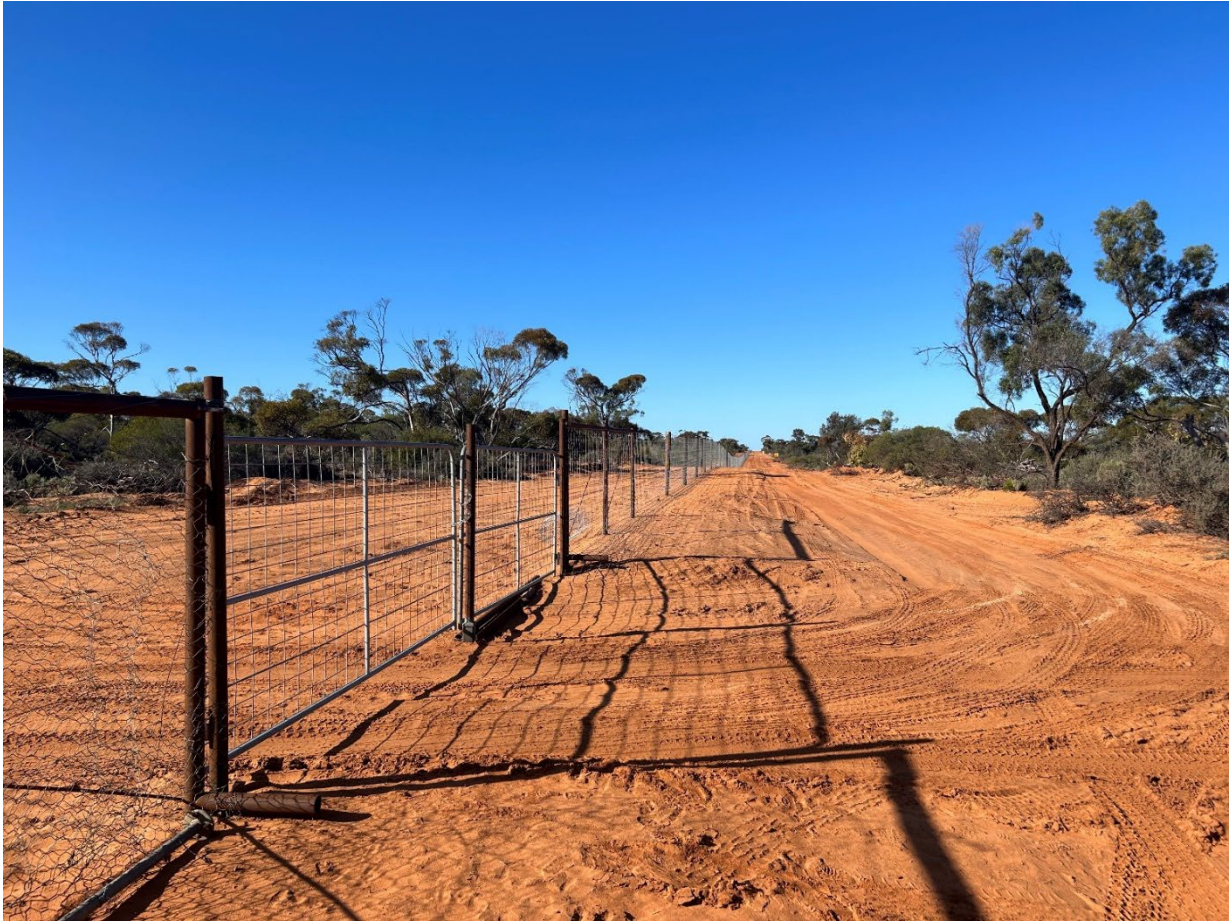
Dog Fence Rebuild Stage 10 – Lake Everard

Stage 10 (adjacent to Lake Everard; 63 kilometres) is progressing well, as is the Dog Fence and associated wombat fencing of Stage 8 (154 kilometres).

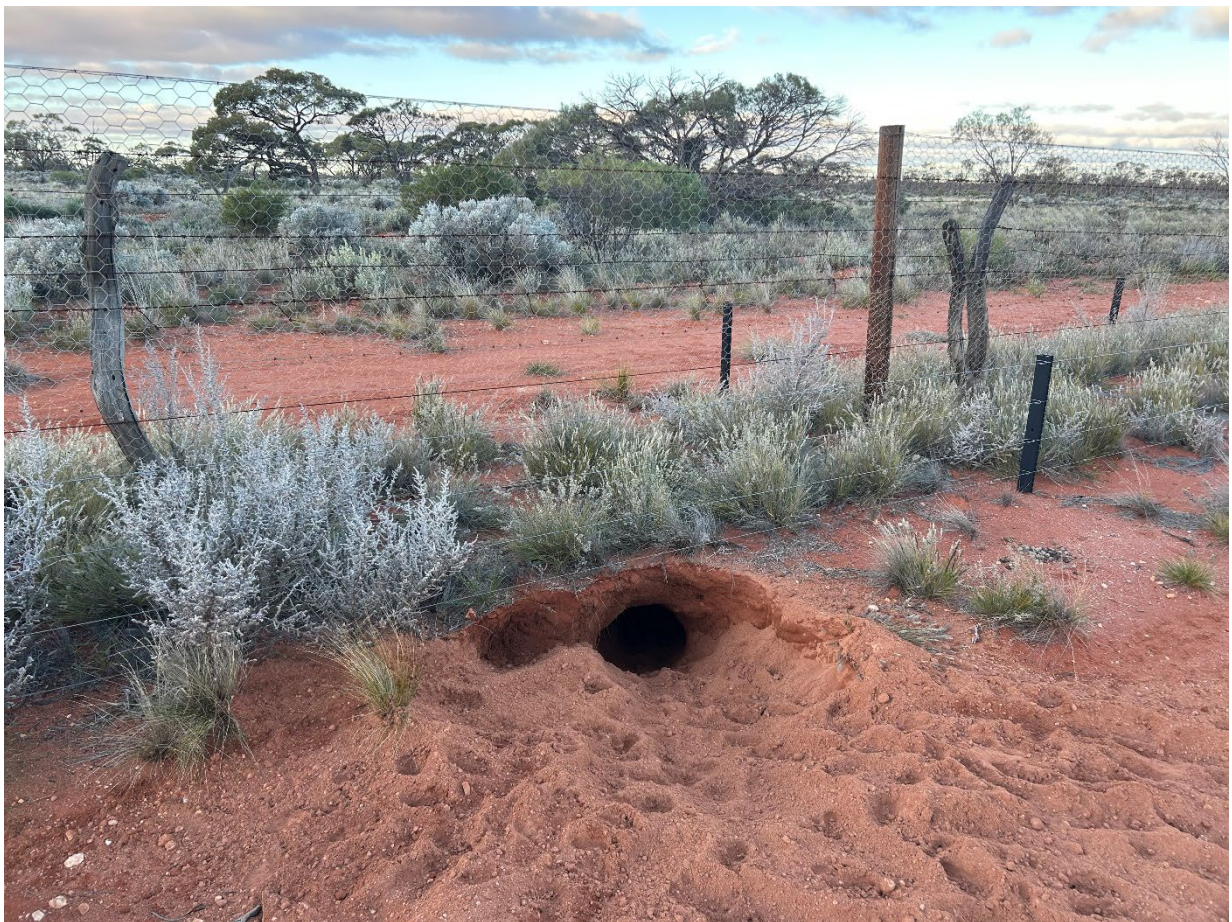
- Delivered materials and met with Northwest Private Patrolmen.
- Increased wombat activity and damage noted in Northwest Private and Penong sections of fence and track.

Active wombat hole under Dog Fence – Northwell

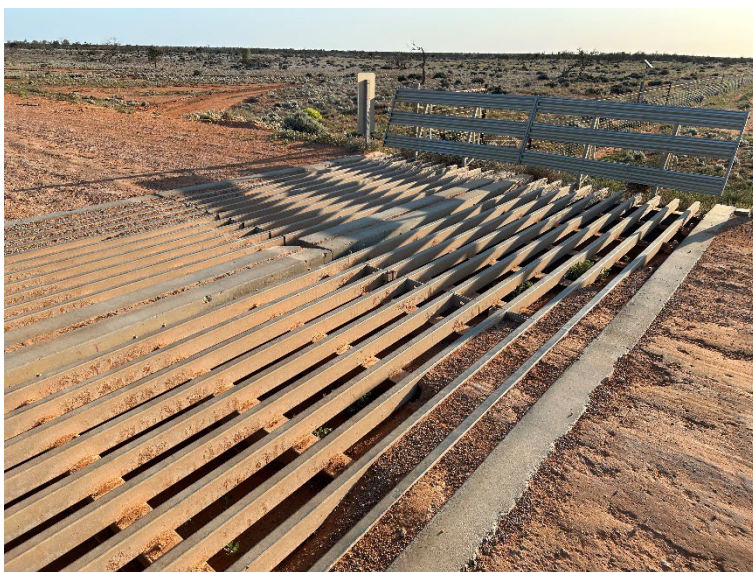
- Commenced testing of DFB's prototype herbicide applicator.
- Treated 156 km of fence.
- Tried different granulated herbicides split into 3 linear plots.
- Results and findings to influence future weed control.
- Grid on southern Tea Tree Road requires clearing – DIT notified.
- Dog and multiple camel tracks seen on Quinyambie and Frome Downs sections of fence.
- Inspected sections of fence are dog proof unless stated otherwise; grid alarms operational.

Tea Tree Road Grid – North side

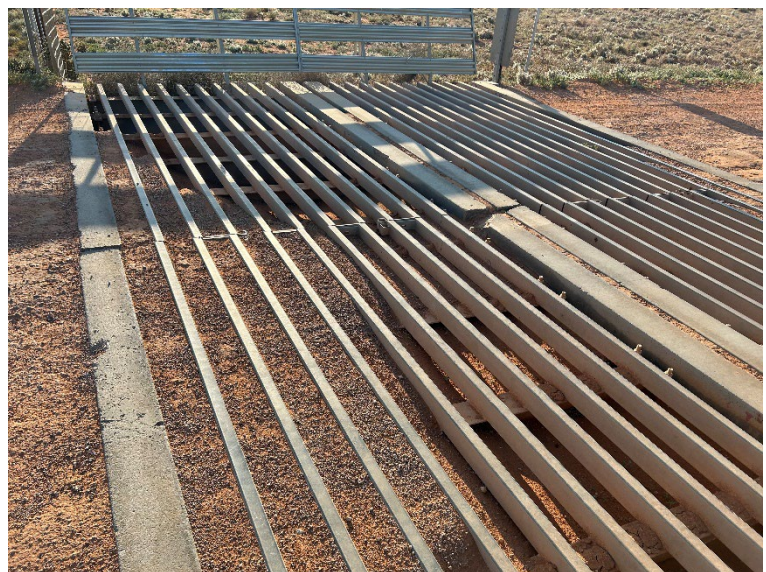
Tea Tree Road Grid – South side
