## Dog Fence Board Activity, Inspection & Condition Report

20 December 2020 to 14 February 2021

# Dog Fence Board - Activity, Inspection & Condition Report

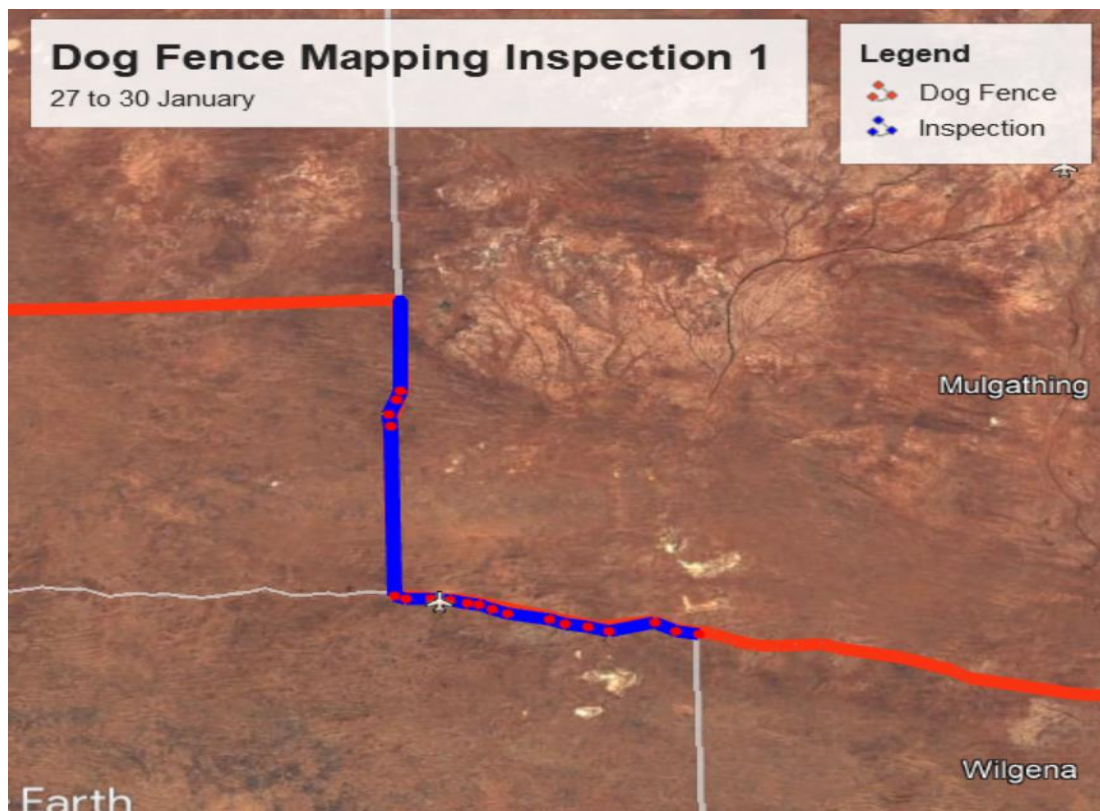
Dog Fence Mapping Inspection 1	
Date	27 - 30 January 2021
Section/s	North West Private
Location description	Wilgena/Malbooma corner to Mt Christie Corner – approx. 50km
Inspected by	Dog Fence Rebuild Inspector and Biosecurity Operations Coordinator
Comments	This section was mapped for the Dog Fence rebuild. All gates, box frames and deviations in fence were recorded. Ready to start the rebuild process for these sections
Recommendations	<ul style="list-style-type: none"><li>•</li></ul>

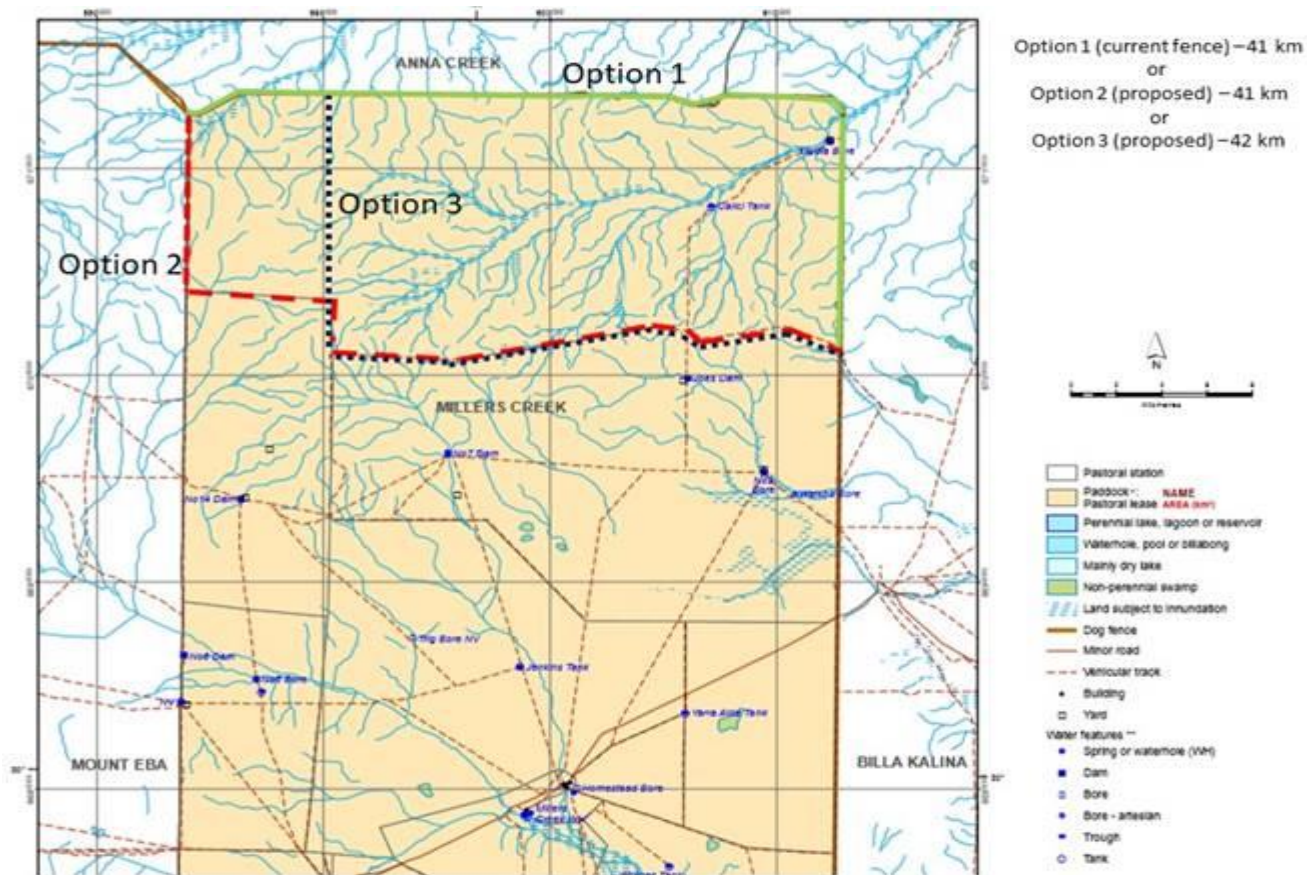
Proposed realignment options

Date	2 – 4 February 2021
Section/s	Central
Location description	Mt Eba, Millers Creek
Inspected by	Dog Fence Rebuild Inspector and Dog Fence Rebuild Manager
Comments	<ul style="list-style-type: none"> <li>Inspection was made of a proposed Dog Fence realignment to the south of the current fence line.</li> </ul>
Recommendations	<ul style="list-style-type: none"> <li>This makes a lot of sense and will make maintenance much easier in future.</li> </ul>

Dog Fence Rebuild Inspector and Dog Fence Rebuild Manager Also made a trip to Mt. Eba and Millers Creek to look at a proposed realignment. This makes a lot of sense and will make maintenance much easier in future.

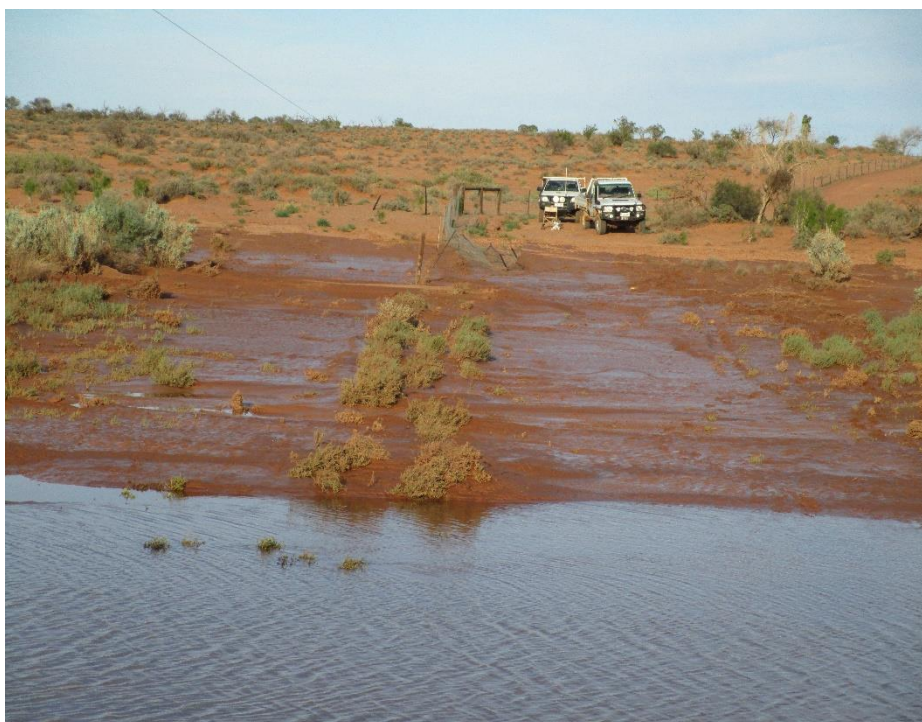
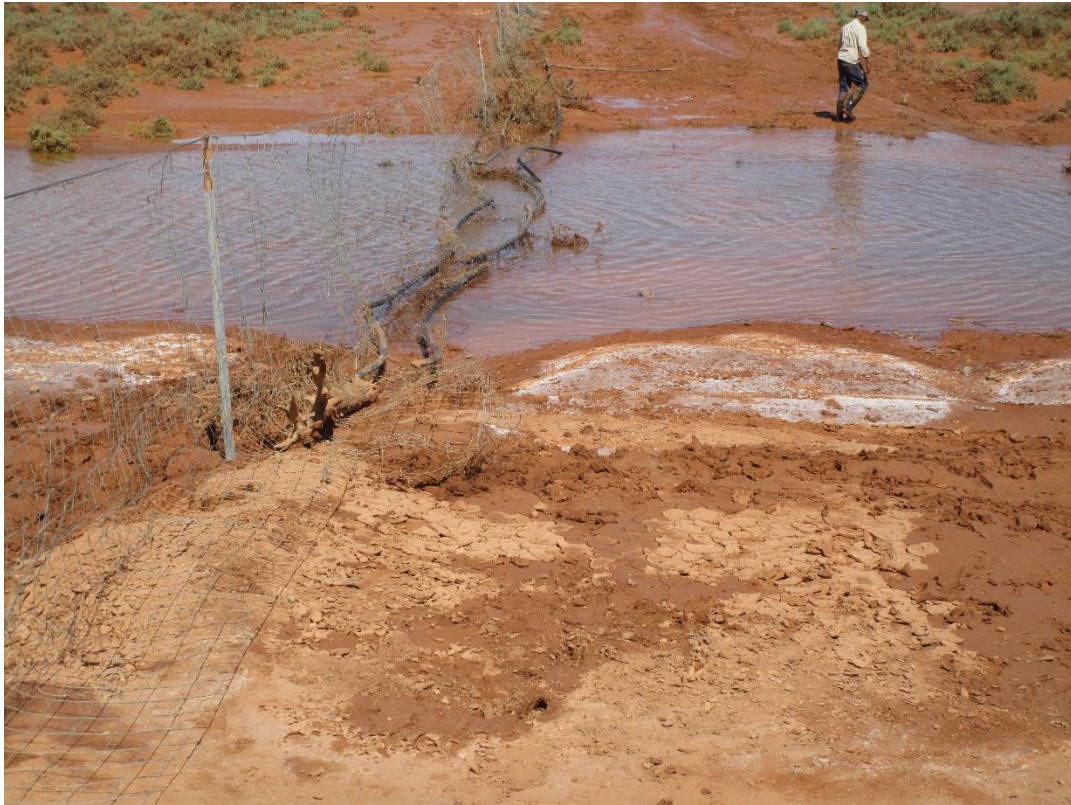
- The entire length of the fence was inspected at a minimum of every 14 days by the Patrolmen.
- All Patrolmen baited at a rate of 1 bait per 500m.
- Patrolmen reported wild dog activity occasionally on both sides of the fence. Penong LDFB reported dogs on most inspection runs.
- LDFB's are being set up to have 12 months supply of meat baits on hand.
- Penong LDFB are being trained to manage their own baiting requirements
- Significant rainfall created some sections of flood damage. Frome LDFB section received the most damage. Frome LDFB had floodgates down or sections of fence washed away or inaccessible. This required additional support to manage the repairs, and for additional safety. The patrolmen responded quickly and efficiently to achieve dog proof repairs.

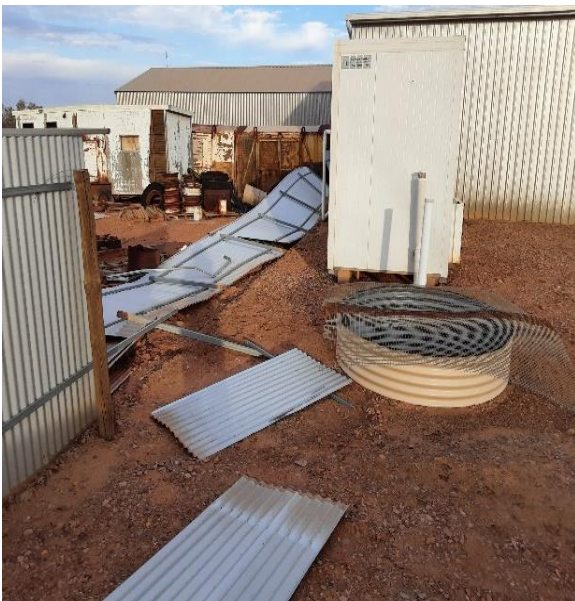
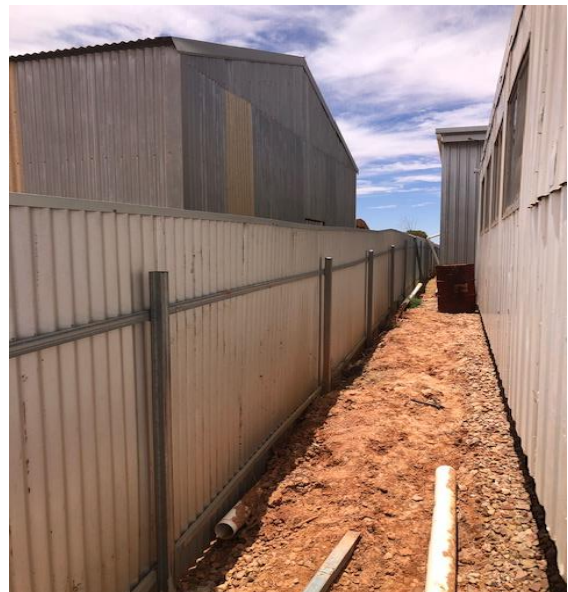
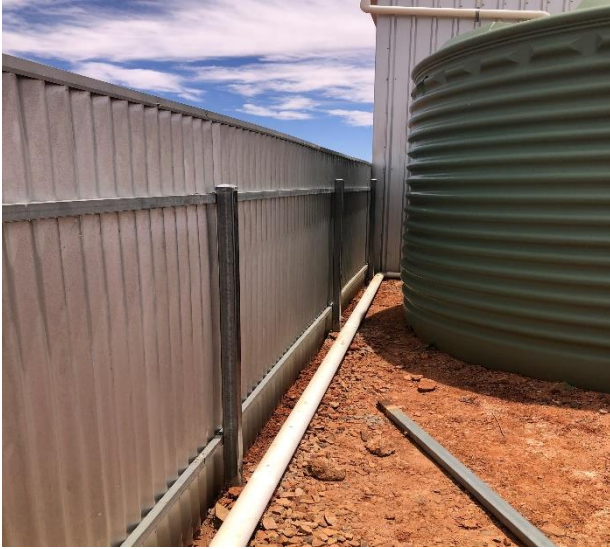
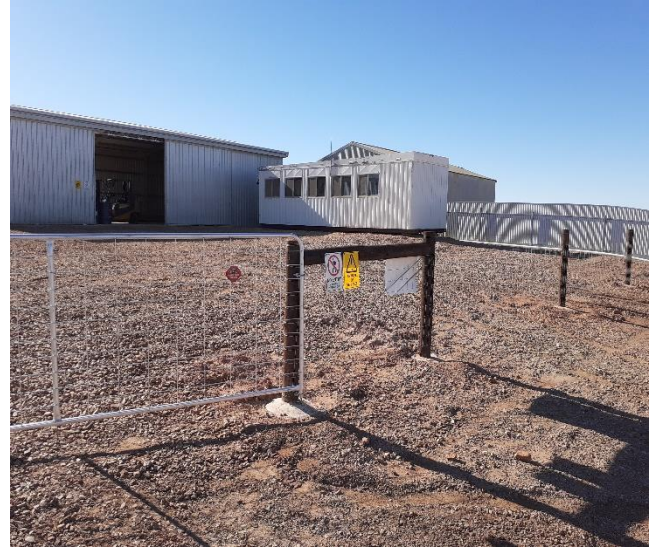
- Lyndhurst depot fencing was badly damaged by high winds. A contractor was sourced, and the fence was repaired, and a new front fence was installed to improve site security.

Significant damage occurred at the Lyndhurst Depot colour bond fence. High winds caused the north and south fences on the property to collapse. A local contractor has completed the repairs and required reposting. Approximately 80m of fence was be rebuilt, and an additional 40m of wire fence has been installed across the front of the property to increase depot security.
