Dog Fence Board

Activity, Inspection & Condition Report

1 June to 28 September 2020

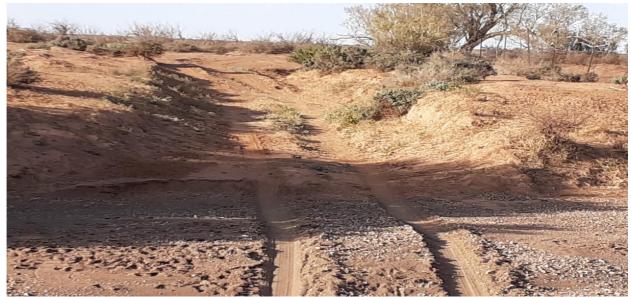
Typical creek crossing – erosion channel developing on entry.

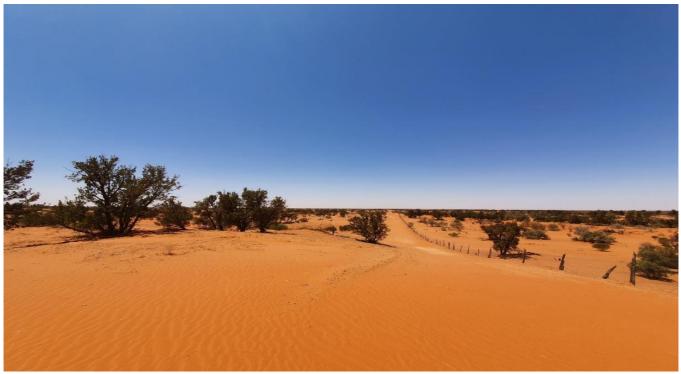
Volume of sand drift that has been common in the Frome LDFB area

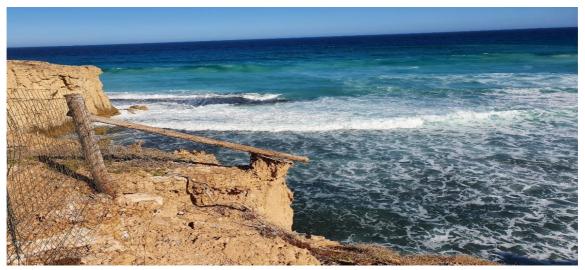
The End of the Dog Fence at Fowlers Bay

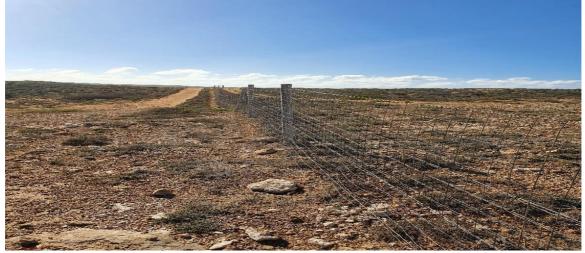
Fowlers Bay Dog Fence near coast

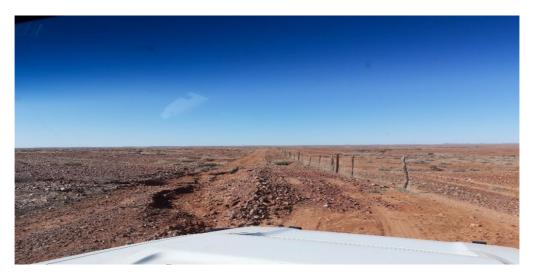
Track erosion requiring work on Millers Creek

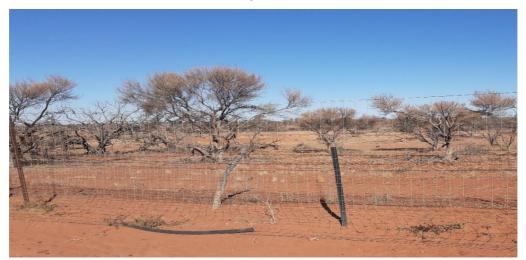
The Parakylia Fence

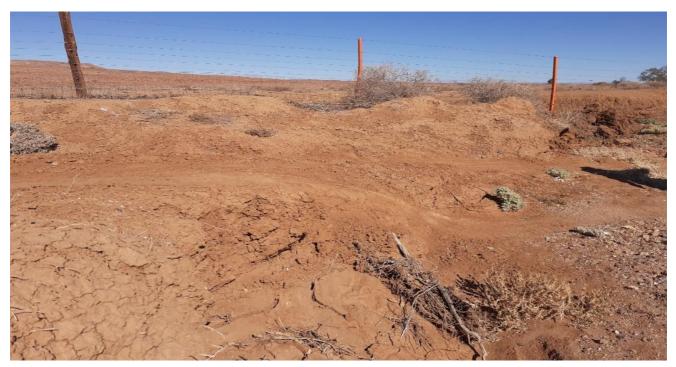
Minor Track repair - Before

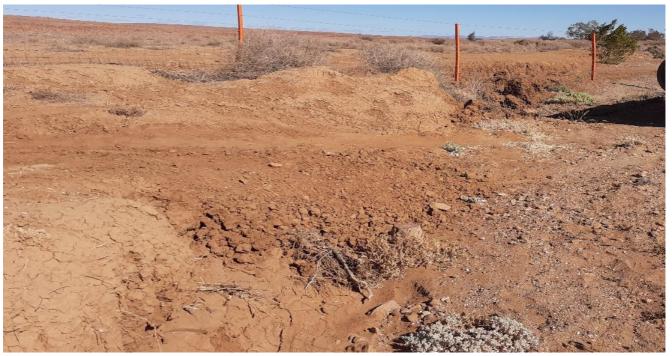
Minor Track repair - After

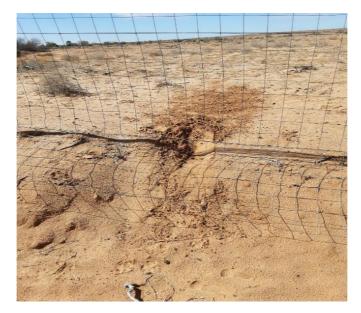
Evidence of Dogs attempting to dig under fence
