# Dog Fence Board

## Activity, Inspection & Condition Report

3 February 2023 – 17 May 2023

Information current as of 17 May 2023

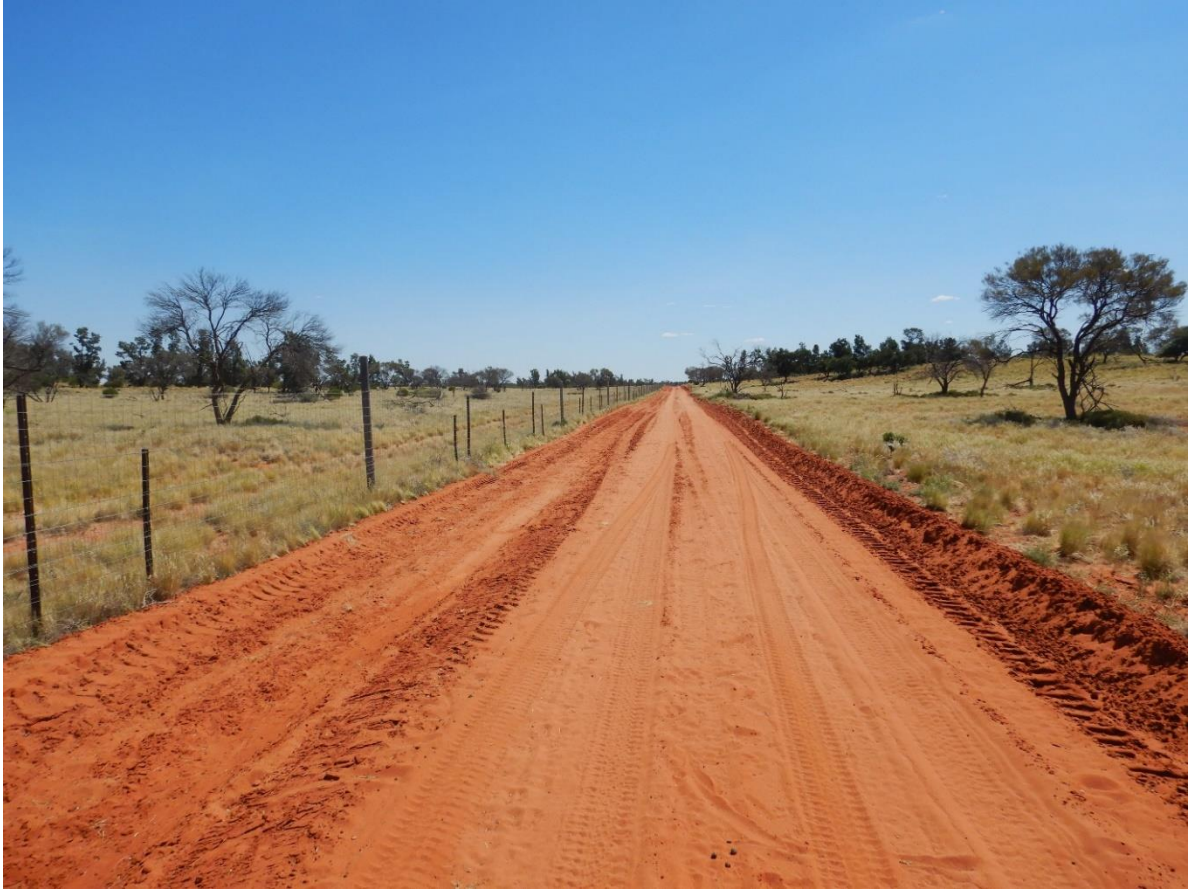
Completed earthworks - Parakyliia fence (Central LDFB)

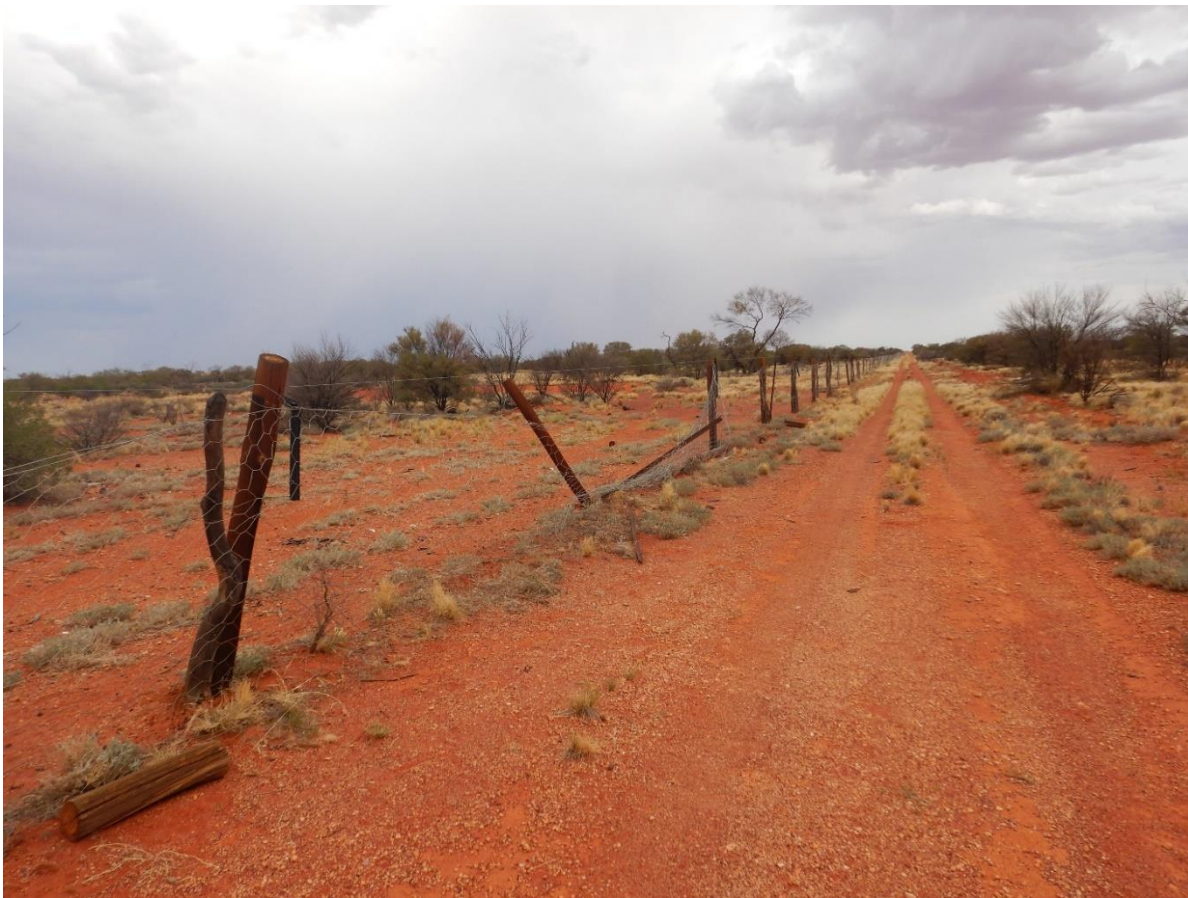
Camel damage sustained to fence – Mabel Creek (Central LDFB)

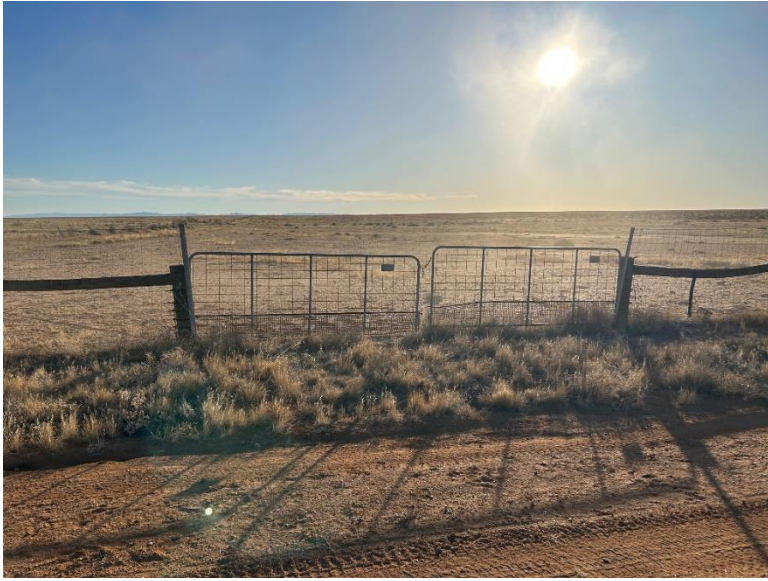
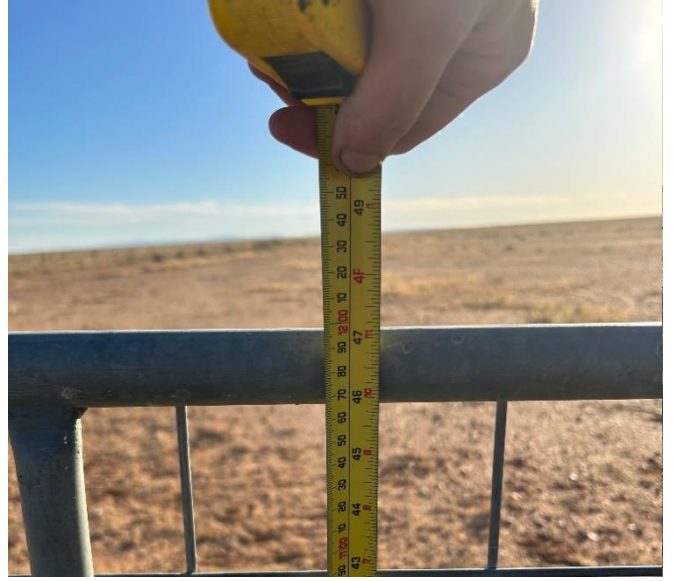
Moolawatana gate at 1200mm – Gate to be topped with netting or replaced

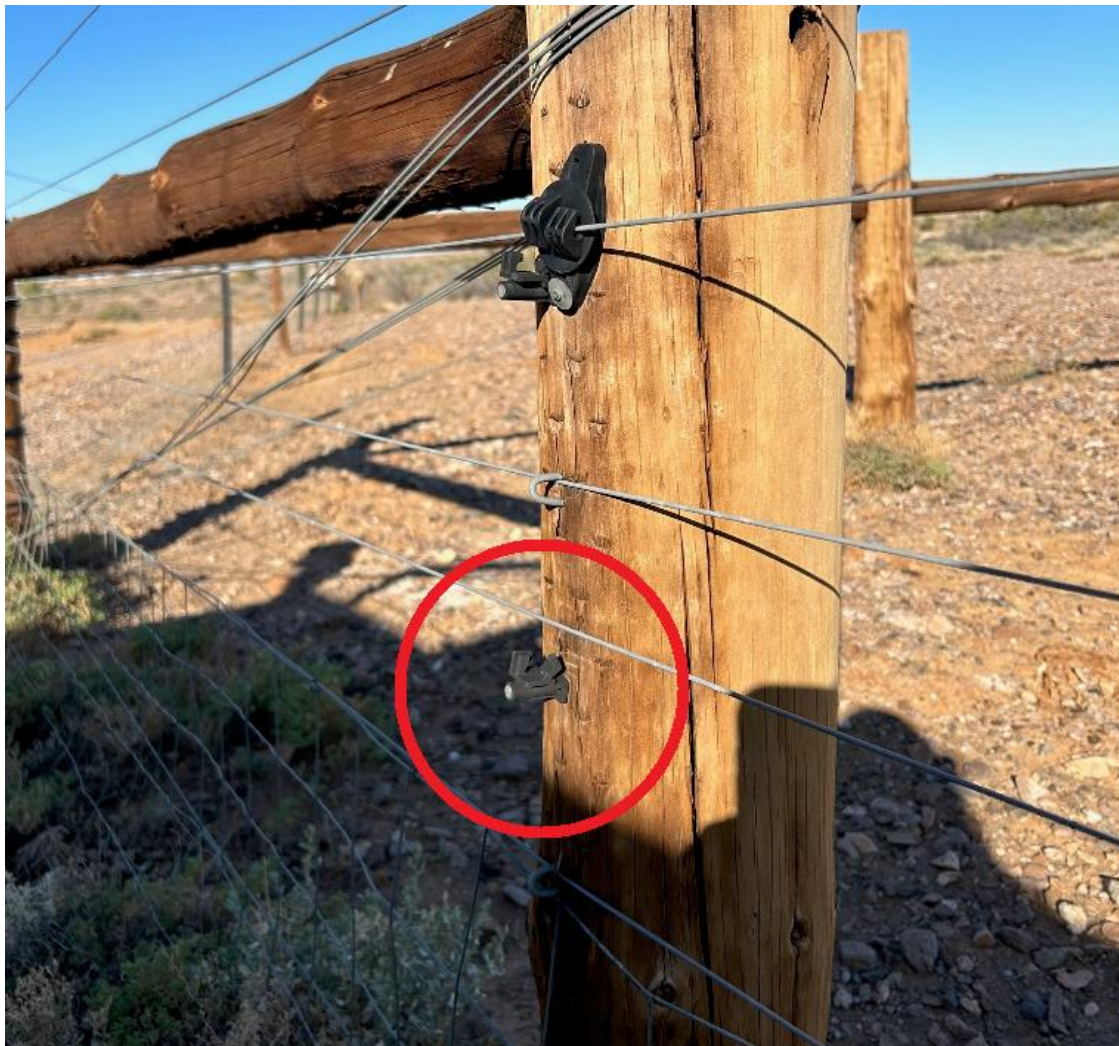
Perished plastic insulator causing faults – Mount Freeling
