PIRSA

Dog Fence Board Activity, Inspection & Condition Report

2 September 2021 to 27 January 2022

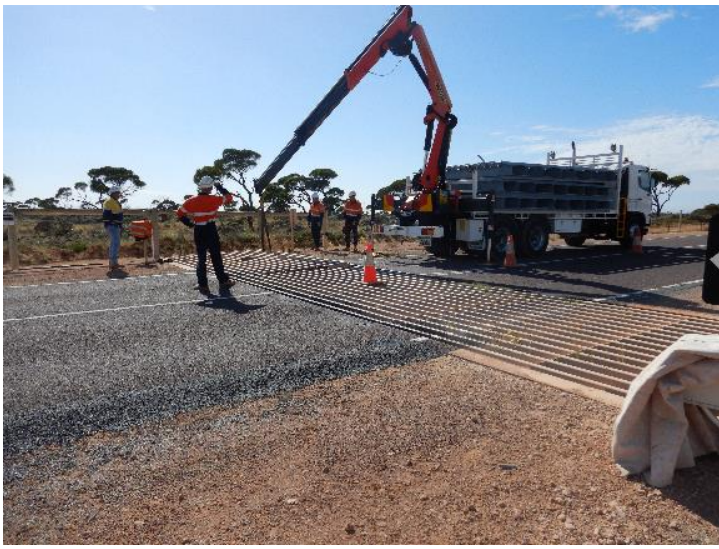
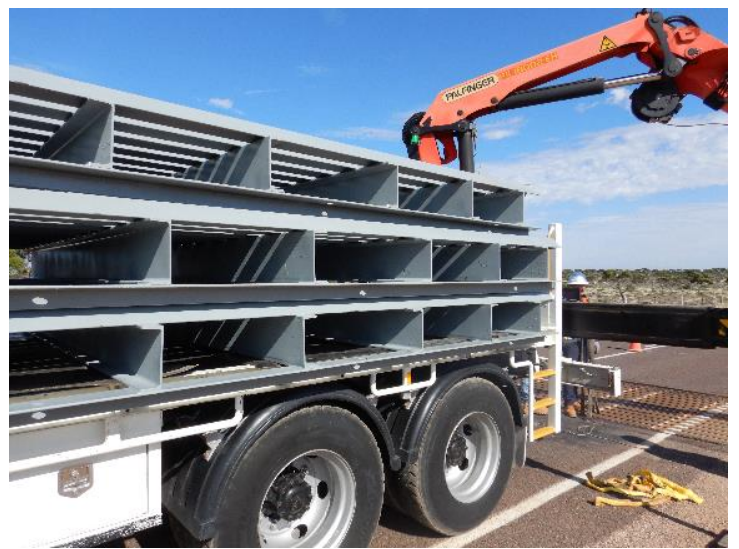
Grid Replacement – Oodlea Road

- Inspected Western half of Dog Fence.
- Observed replacement works of the Oodlea Road grid being carried out by Iluka Jacinth-Ambrosia mine. Iluka are replacing the grid to bring it in line with the Dog Fence Board's grid standard. Works were eventually put on hold due to damage being found on the already installed concrete abutments.

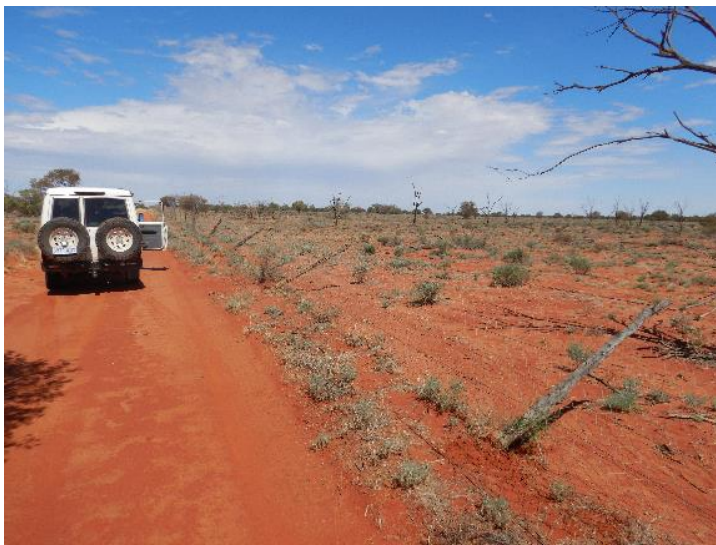
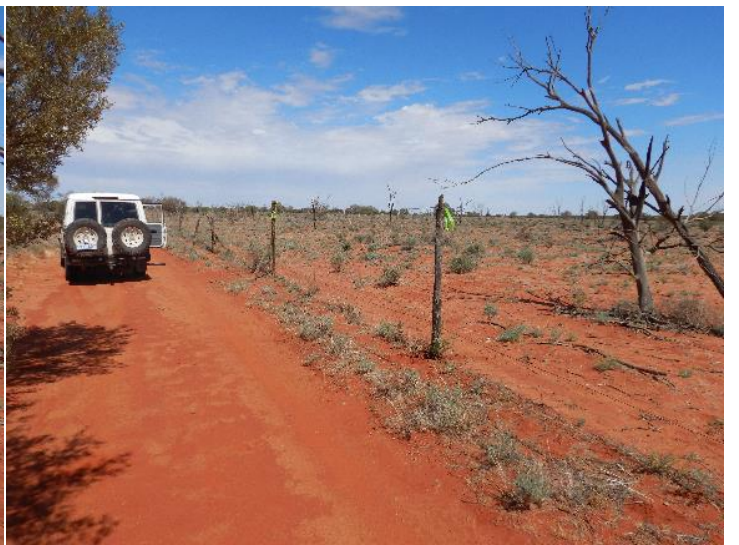
Camel damage – North West Private

- North West Private Fence is in a dog-proof condition. Noted a grid in this section has wing damage and build up dirt and weeds. The NWP fence is under constant camel pressure, with camel activity noted along this fence section.

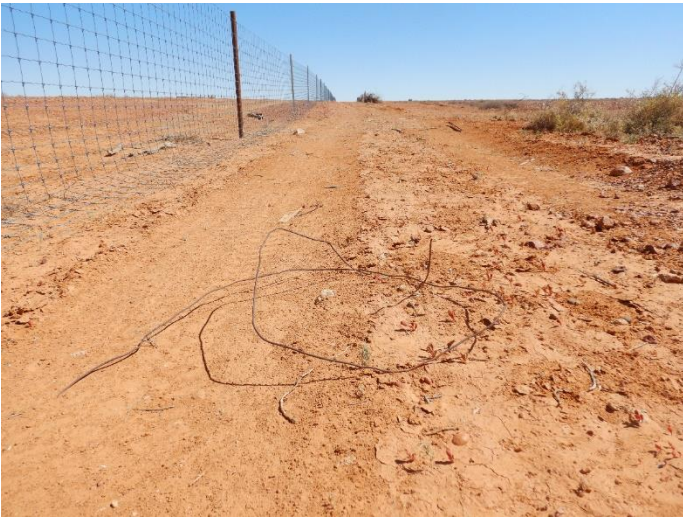
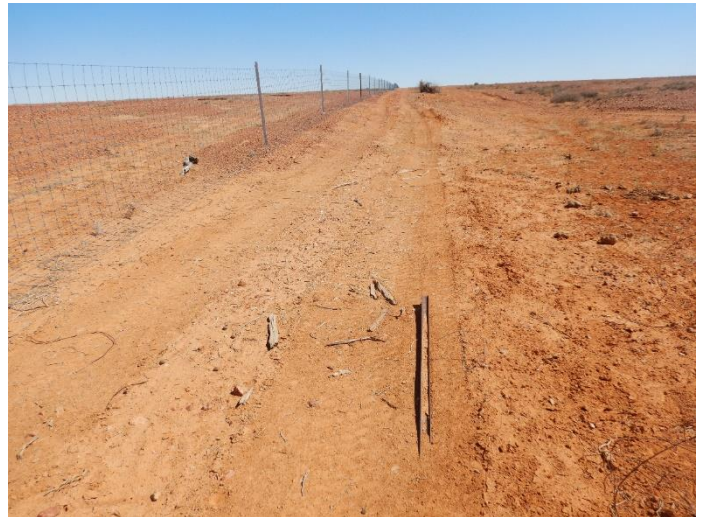
Old material on track

- Noted a lot of old material and empty pallets along fence. Bent droppers and wires were left on the track in places, Fence inspector to remove on future fence trips.
