Dog Fence Board

Activity, Inspection & Condition Report

11 December 2023 – 5 February 2024

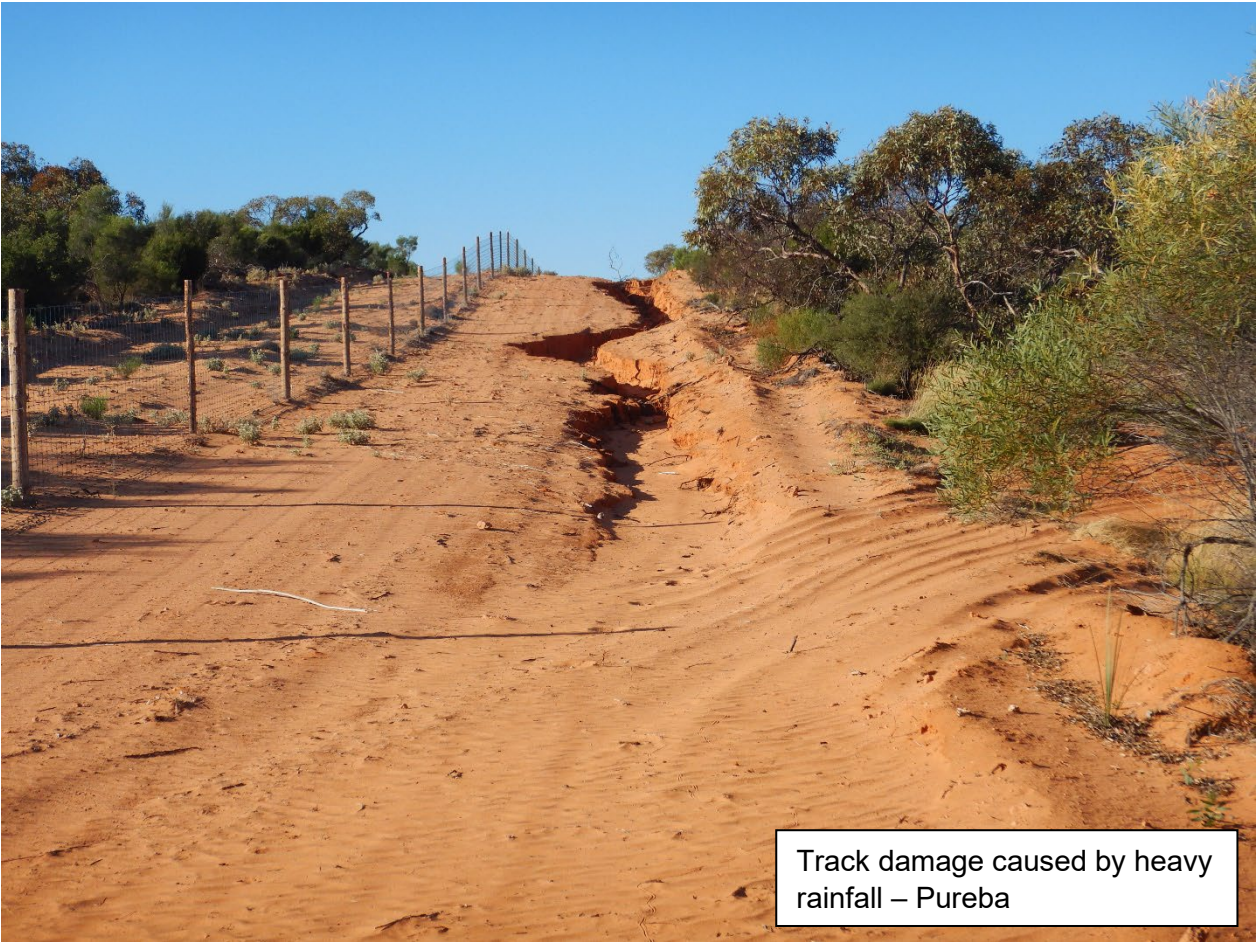
- Plotted and recorded track damages caused by heavy rainfall late 2023, a loader, grader and labourer have been organised works to commence mid – late February

Track damage caused by heavy rainfall – Pureba

In the past month there has been rain, fire and feral animals threaten the fence, with the Penong LDFB area being hit the hardest. An isolated rain cell dumped an extraordinary amount of rain on the fence (in Stage 10) in mid-December, creating a chasm beside the fence (image above). Fortunately, this did not compromise the fence itself.

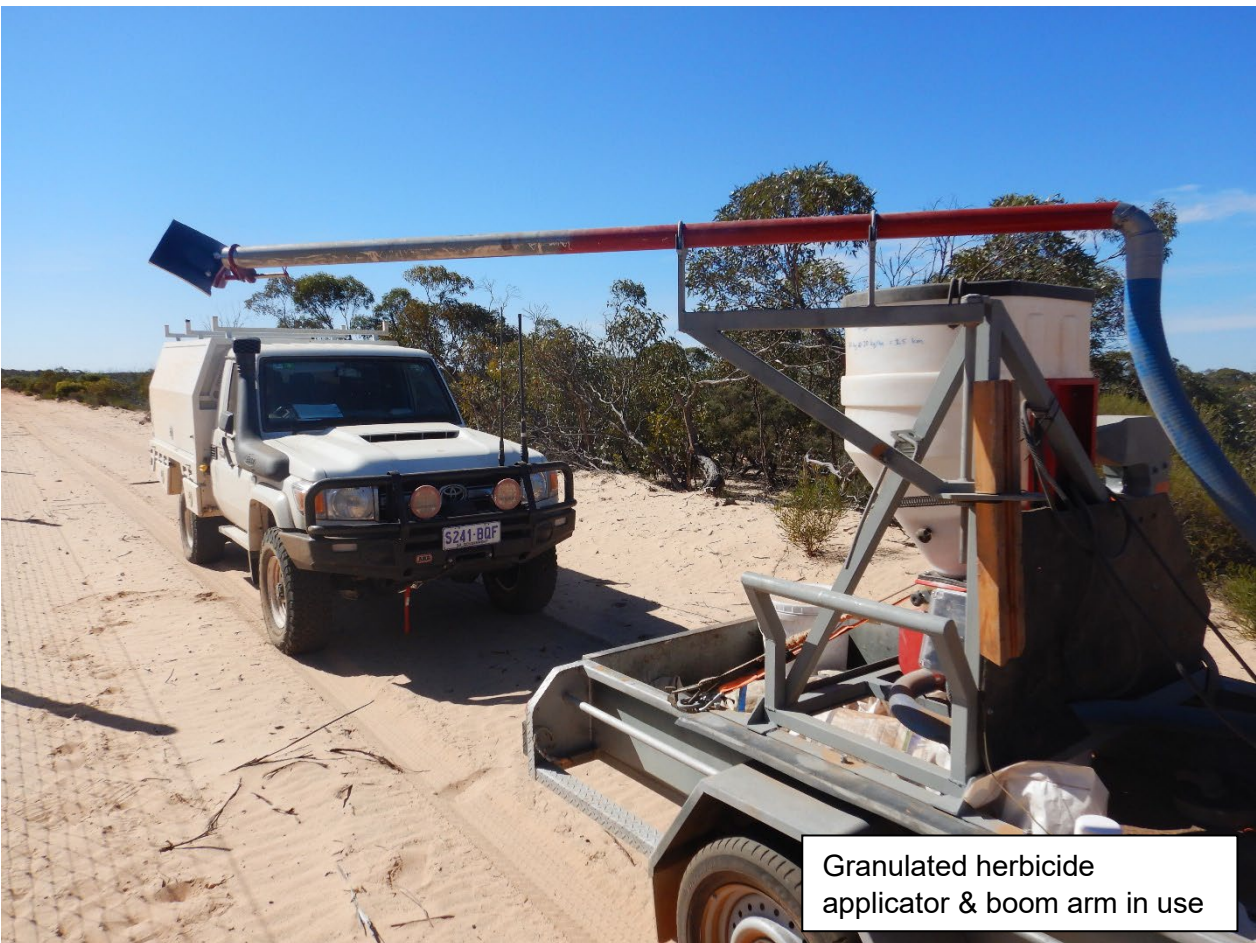
Granulated herbicide applicator & boom arm in use

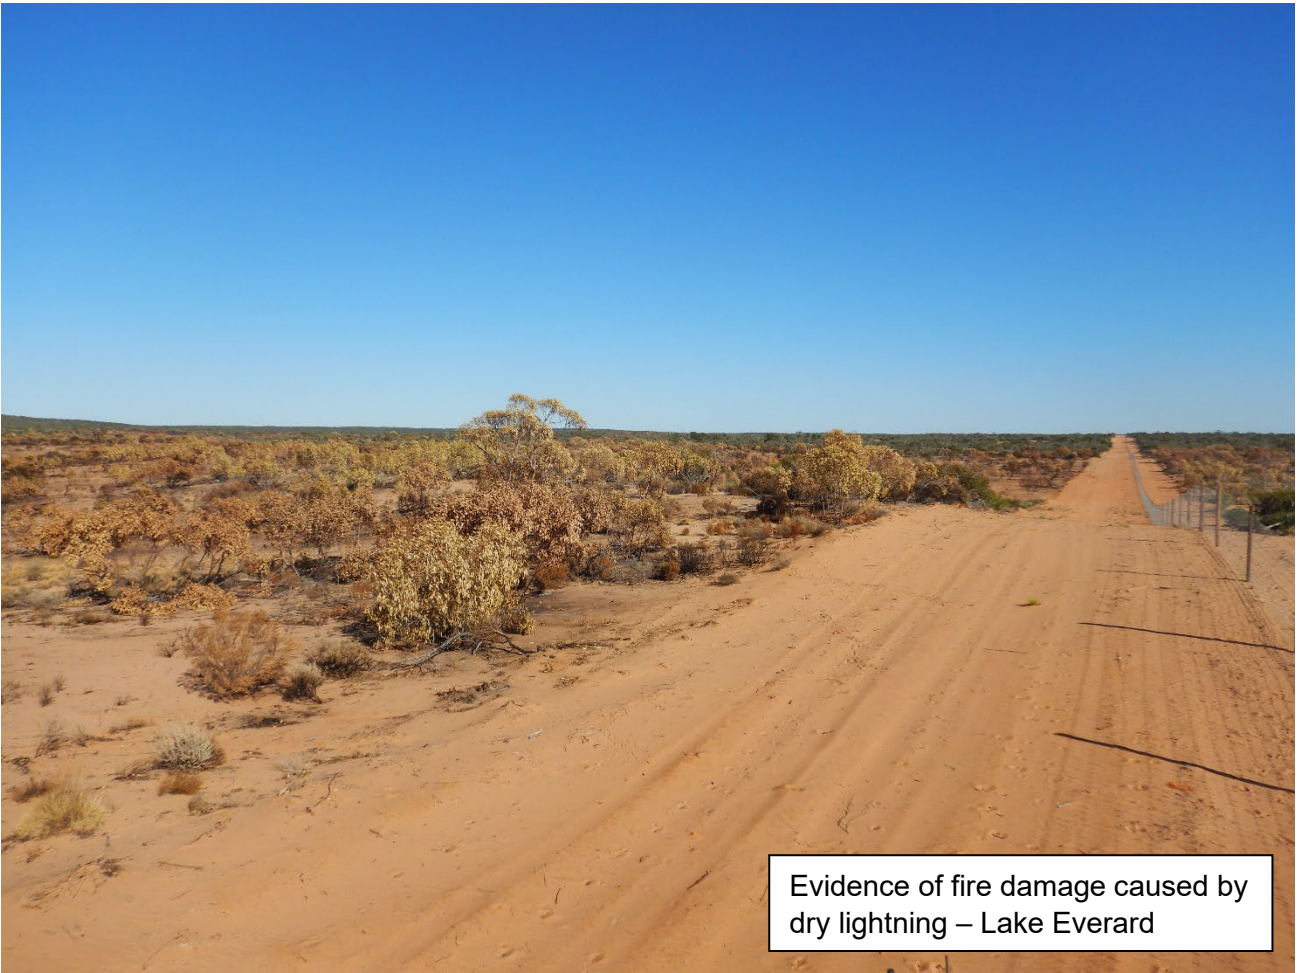
- Updated GPS plots and scoring to reflect current condition of fence following fence rebuild works
- Observed burned scrubland adjacent to Dog Fence, no damage caused to fence line.

Evidence of fire damage caused by dry lightning – Lake Everard

A few weeks later, multiple fires broke out in the region, with one fire crossing over about 900 metres of fence in Stage 7.

The fence was not impacted, largely because of the cleared track on either side that acts as a fire break, and importantly because there was no vegetation in or up against the fence to burn.

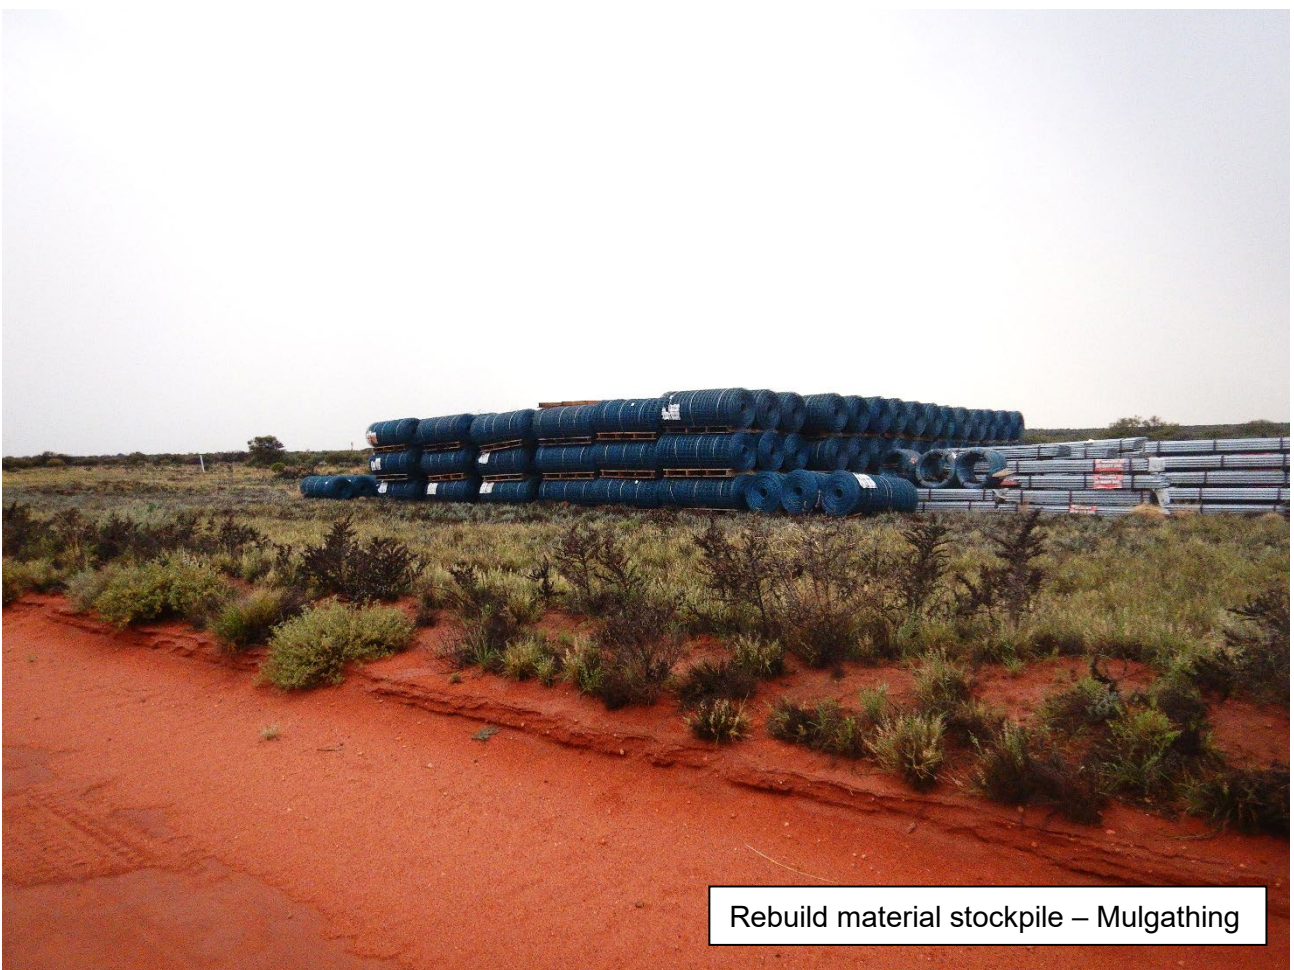
Rebuild material stockpile – Mulgathing
