Field trial investigating use of drip irrigation to improve condition of black box (*Eucalyptus largiflorens*) woodlands Phase 1: Infrastructure Test Report

SARDI Publication No. F2013/000438-1
SARDI Research Report Series No. 706

August 2013

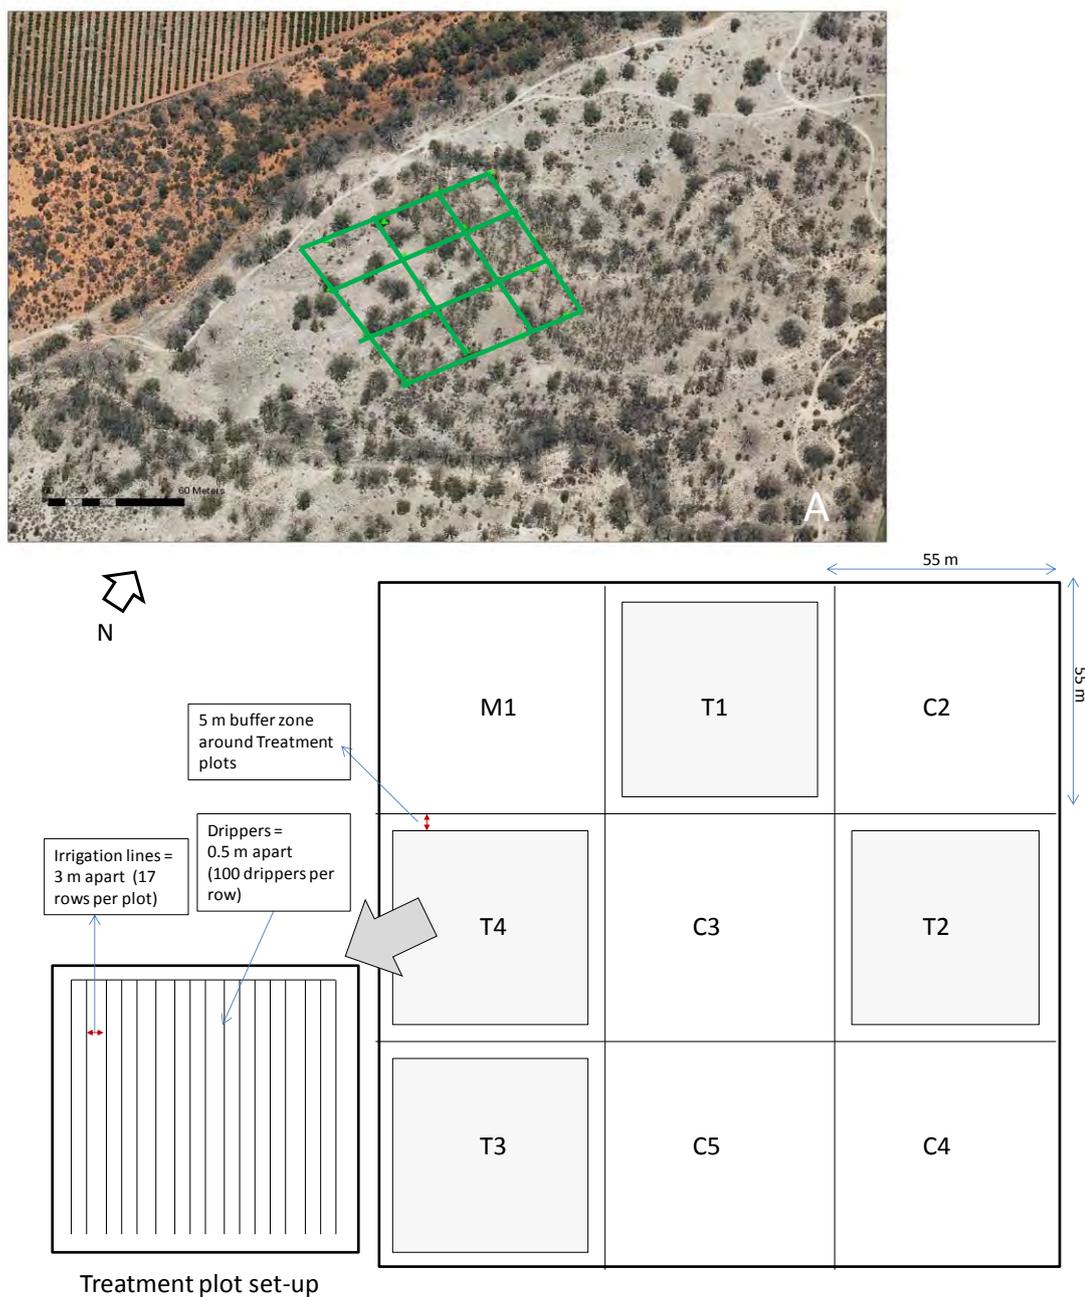
Figure 3: Experimental set up and design. M1 = monitoring plot, C2, C3, C4, C5 = control plots, T1, T2, T3, T4 = treatment plots (shaded). All experimental plots are 55 × 55 m². Within treatment plots the dripper system is within 50 × 50 m area (i.e. 17 rows, 3 m apart, dripper spaced every 0.5 m), creating a 5 m buffer zone around the irrigated area within each treatment plot. Insert (A) shows aerial view image of experimental set up on the Markaranka floodplain.

The experimental plot is located on the Markaranka Floodplain (Figure 2). A total of nine (55×55 m; 0.3025 Ha) plots were marked out within the Markaranka Floodplain black box woodland. One of the plots (M1) is a monitoring plot and of the eight remaining plots, 4 controls (C2 to C5) and 4 treatment (T1 to T4) plots were randomly assigned (Figure 3). Measurements pre- and post-treatment (drip irrigation) included tree health, tree water stress and soil and woodland condition (understorey vegetation surveys, photopoints, comparison of vegetation under canopy versus open areas). A watering point was located on the southern edge of the adjacent Treasury Wine Estates' property (Figure 2) and a manually operated hydraulic valve (80 mm diameter) was installed to isolate the experimental system from the vineyard operations. A length of PVC ($4 \text{ m} \times 100 \text{ mm}$) was connected to the valve and buried under the track to allow vehicle access. To reach the floodplain field site, a length of SunnyRed Layflat™ hose ($100 \text{ mm} \times 2 \text{ km}$) was installed along the edge of the access track (Figure 4A). At the experimental site a series of four (50 mm) manually operated ball valves were installed to deliver water to each treatment plot. The ball valve system was designed to operate all treatment plots at once and/or independently (Figure 4B). Lengths of poly submain (50 mm diameter) were connected to each ball valve to deliver water to each treatment plot (Figure 4C). Rows of dripper lines ($50 \text{ m} \times 20 \text{ mm}$) were connected to the submain poly lines, spaced at 3 m intervals (i.e. total 17 rows per plot) (Figure 4D). Drippers (capacity = 2.2 L hr^{-1}) were installed every 50 cm along the dripper lines to provide a flow rate of 1.1 L s^{-1} to each experimental treatment plot (0.25 Ha).

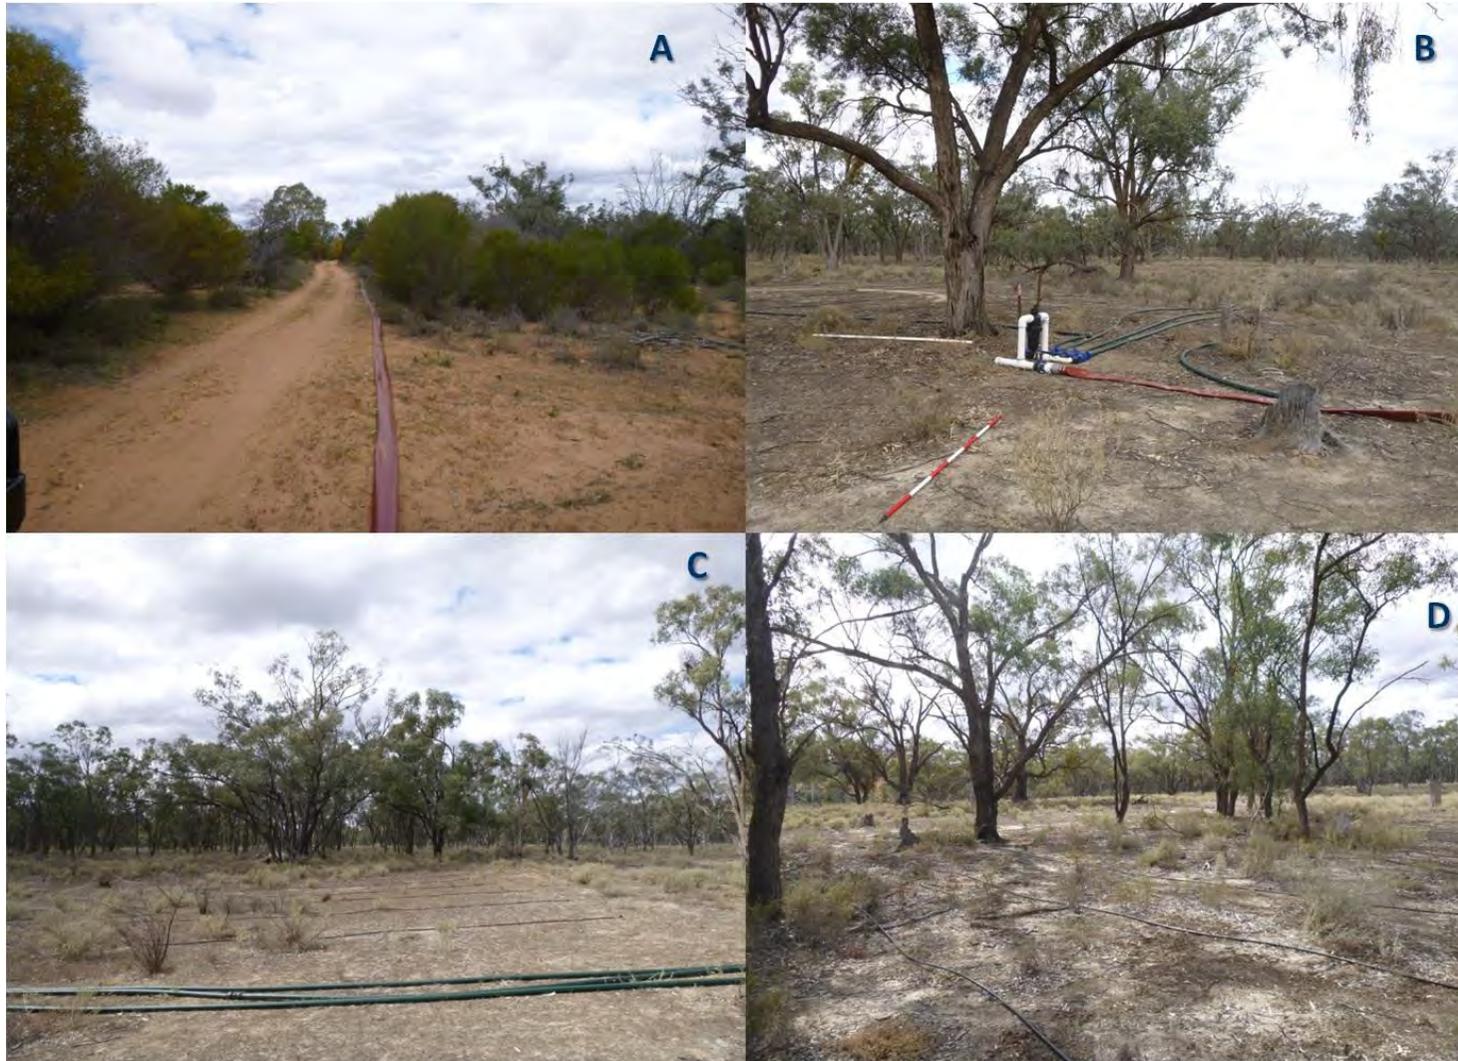
Figure 4: Experimental set up of drip irrigation system for Markaranka Floodplain trial. **(A)** 2 km hose connected to pump valve on adjacent Treasury Wine Estates vineyard to reach floodplain experimental site; **(B)** 4 multi-valve system set-up to pump water to each treatment plot; **(C)** green/black poly submain pipe in foreground and **(D)** dripper lines spaced 3 m apart, 50 m length in each treatment plot.

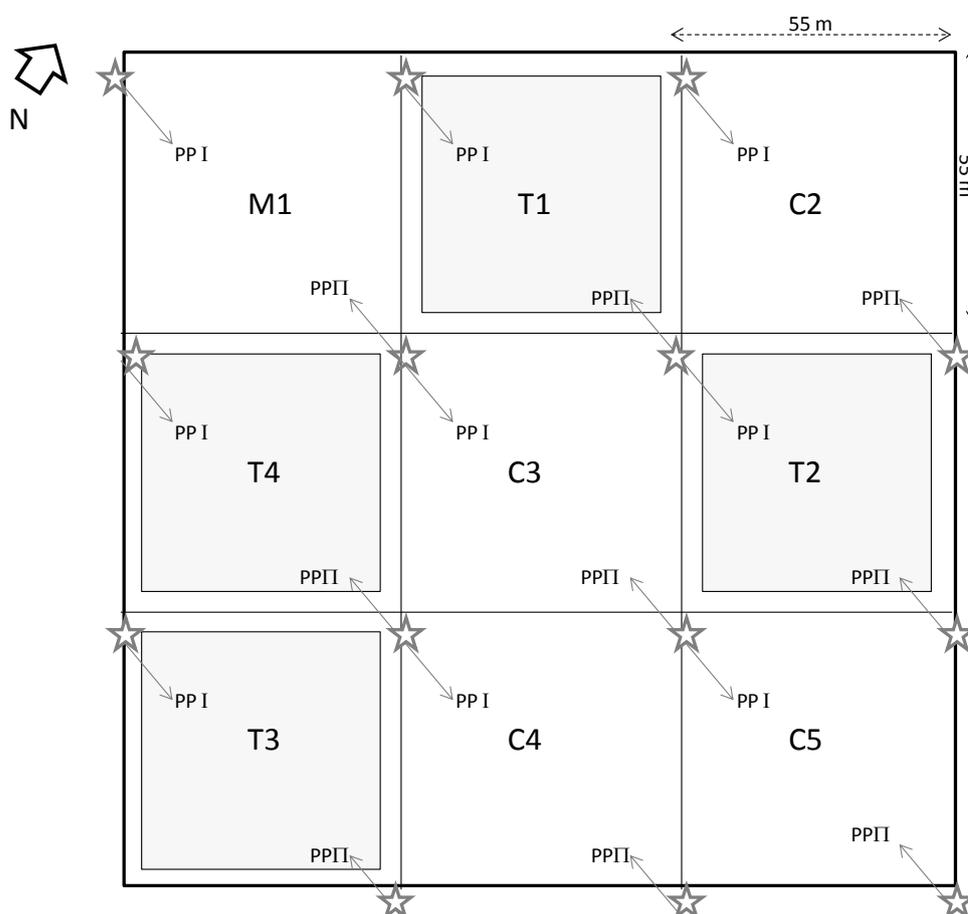
Figure 5: Photopoint sampling protocol for experimental field site: plan view showing placement of photopoint fixed point position (stars), direction of transect view (arrows; PP I = photopoint 1, PP II = photopoint 2) for each plot. Photopoints were taken in collaboration with staff from the South Australian Natural Resources Management Murray Darling Basin Board (SA NRM MDB Board).

In each plot, diagonal transects were established from the NW to SE corners of each plot (Figure 5). The corners were the “fixed point” or photopoint (Figure 5) and photos were sighted along both directions of the transect line.

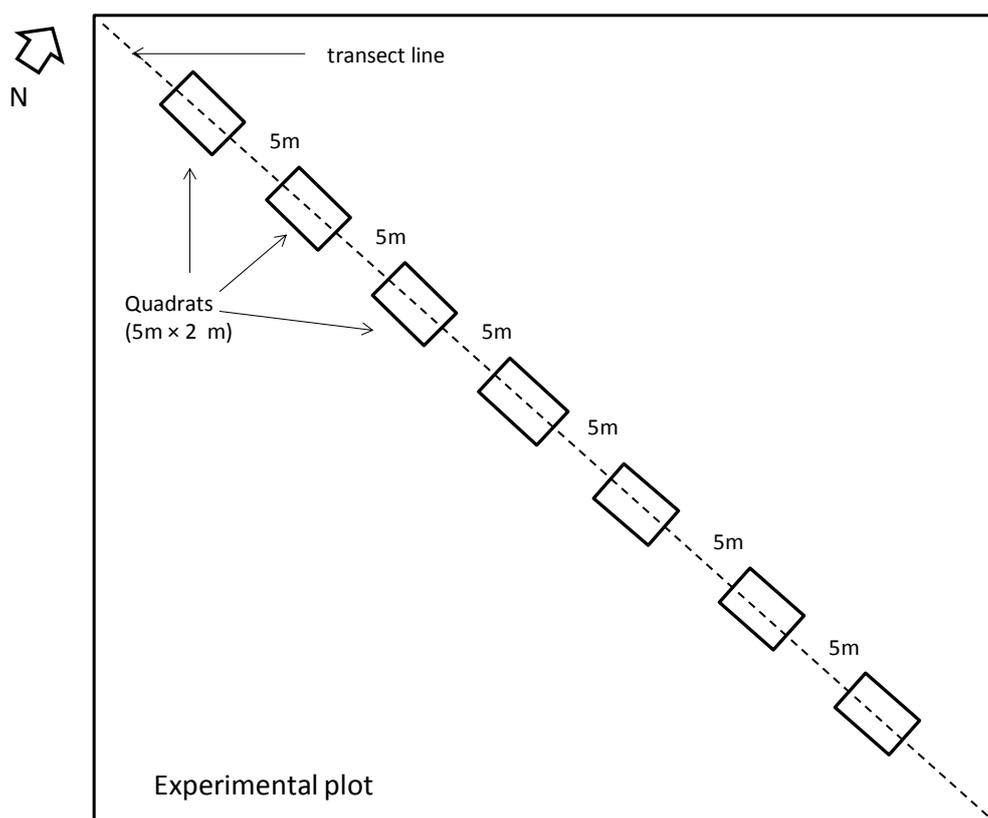
Figure 6: Plan view of the understorey vegetation sampling protocol within each experimental control and treatment plots. A diagonal transect with seven, 2×5 m quadrats (separated by 5 m) was established

In each experimental plot (4 treatment; 4 control) a diagonal transect with seven, 2×5 m quadrats (separated by 5 m) were established (Figure 6). The cover and abundance of each understorey taxa present (including leaf litter, bare soil and soil lichen crust) per quadrat were estimated using the method outlined in Heard and Channon (1997), except that scores of N and T were replaced by 0.1 and 0.5 to enable statistical analyses (Figure 6).

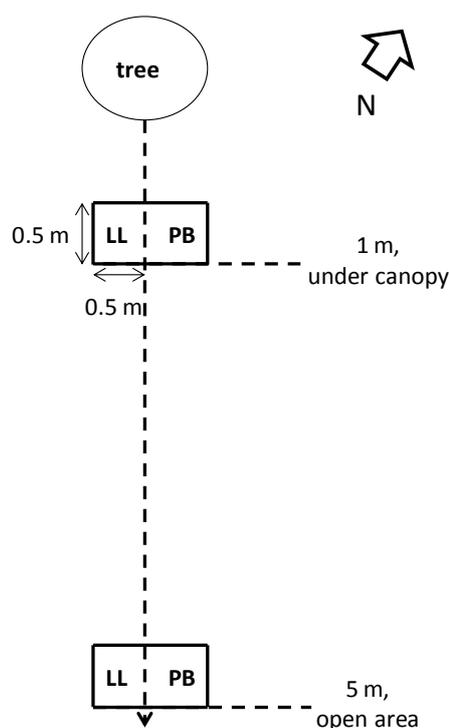
Figure 7: Sampling protocol for leaf litter (LL) and understorey plant biomass (PB) under black box canopy (1 m) and in open (5 m) within experimental control and treatment plots.

Prior to each sampling trip (pre- and post-irrigation), a subsample of 4 trees ($n = 32$ trees) were randomly selected within each treatment and control plot (using a random number generator within the range of trees per plot). On the South-southeast (SSE) side of each tree a perpendicular transect was established and two, 1×0.5 m quadrats were set up under the tree canopy (1 m) and in the open (5 m) (Figure 7). In one, 0.5×0.5 m quadrat cell, all above ground understorey biomass was removed and bagged. Similarly, in the adjacent 0.5×0.5 m quadrat cell, all leaf litter was removed and bagged (Figure 7). Bagged samples were then transported back to SARDI to be oven-dried at $\sim 60^\circ\text{C}$ for three days. Dried plant samples were then weighed and recorded to provide biomass (g) estimates per m^2 . A soil sample (~ 100 g) was also collected within the 1×0.5 m quadrat from the soil surface (0 – 10 cm depth) using a 50 mL Dormer soil auger. Soil samples were placed into airtight containers and transported to SARDI, where the following analyses were conducted: total soil moisture (gravimetric water content; g g^{-1}) (Klute 1986; Rayment and Higginson 1992), electrical conductivity and pH (1:5 soil water extract) (Rayment and Higginson 1992).

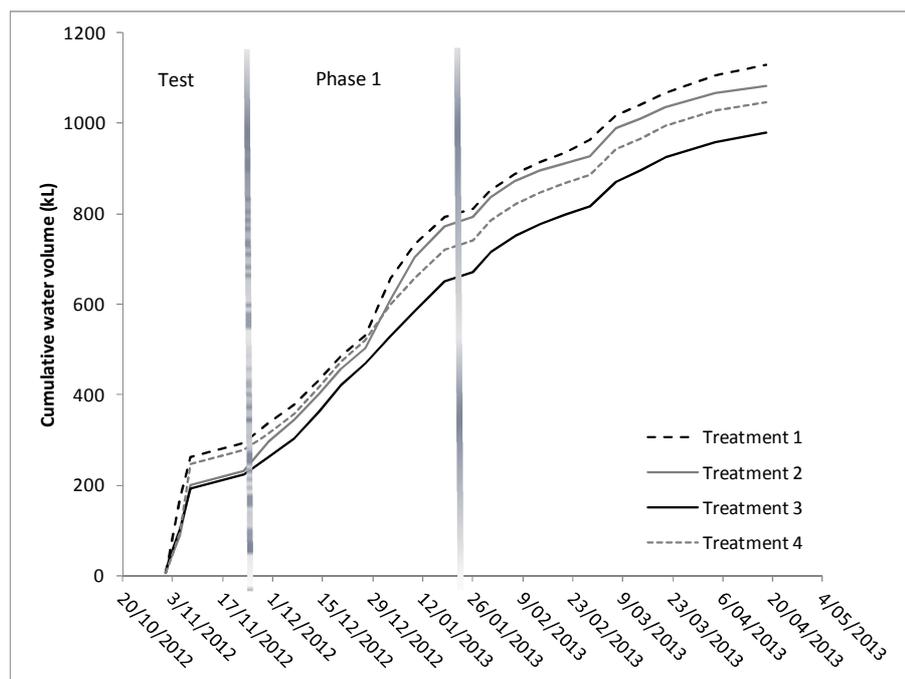
Figure 8: Cumulative water volumes applied to treatment plots across the total six month experimental watering trial (November 2012 to April 2013) at Markaranka Floodplain. Phase I irrigation began 23 November and finished 18 January 2013.

During the first weeks of November 2012 there was a “test” phase for the irrigation system and different durations were trialled (i.e. 12, 16, 18 and 24 hour duration) (Figure 8), hence varying water volumes were delivered. It was deemed that a weekly watering regime of 16 hr was a workable operational sequence for Treasury Wine Estates Limited staff (every Thursday, start time = 15:30; finish time = 7:30) and was estimated to deliver approximately 50 kL of water per treatment plot (0.25 Ha); equivalent to precipitation rate of approximately 20 – 25 mm week⁻¹ (per treatment plot). Regular weekly, 16 hour watering applications began 23 November 2012. The Phase 1 irrigation period finished on 18 January 2013 (10 wk) and encompassed the initial experimental watering period designed to investigate whether black box trees would use the water provided via the installed drip irrigation infrastructure. There were episodic incidents within this period where dripper lines were pierced or the caps or the end of lines blew out (due to pressure), accounting for the variation in total water volume and watering duration applied per treatment plot (Figure 8). In general, however, application rates remained consistent across the period, with each treatment plot receiving between 0.46 – 0.57 ML across the watering period, which equated to an average precipitation rate of 22.59 ± 7.65 mm week⁻¹ per treatment plot (Table 6). Please note, regular weekly, 16 hour duration watering continued until 18 April 2013 (= total of 22 week watering period) so that the total volume of water delivered to the experimental area to the date of this report was 4.235 ML (Table 6).

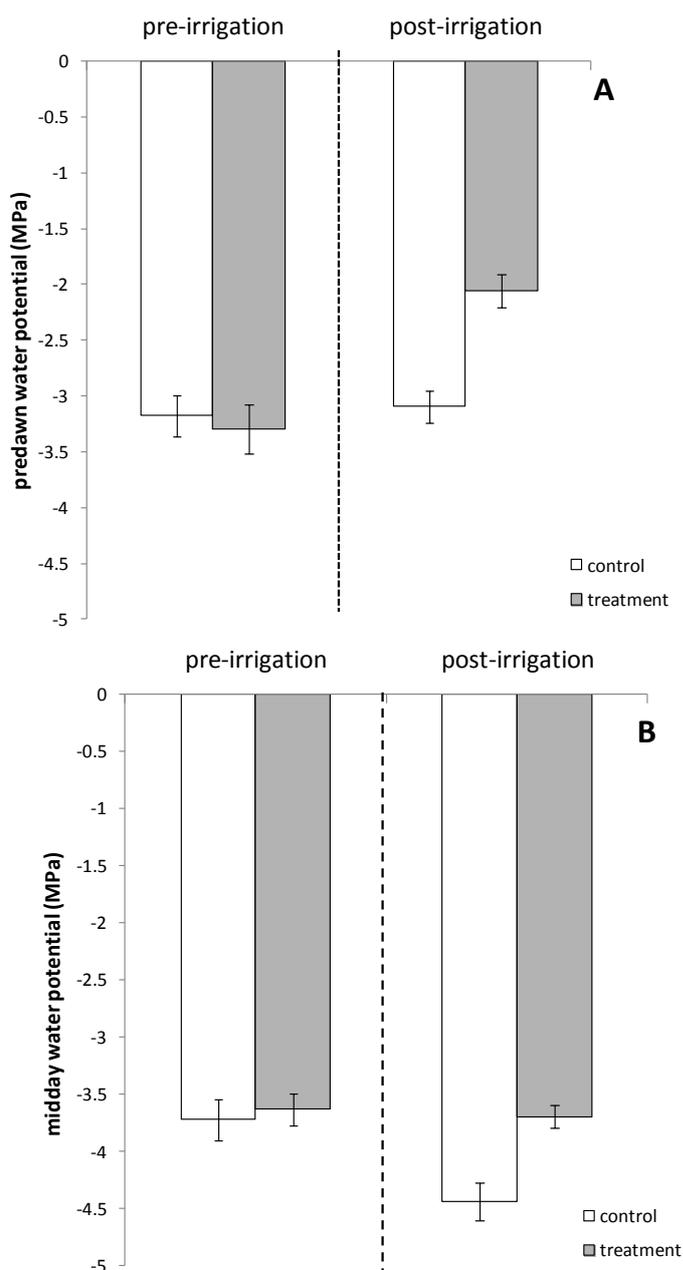
Figure 9: Predawn (A; Ψ_{predawn}) and midday (B; Ψ_{midday}) shoot water potentials for black box within the pre-irrigated (November 2012) and post-irrigated (January 2013) control and treatment plots; Markaranka field irrigation trial.

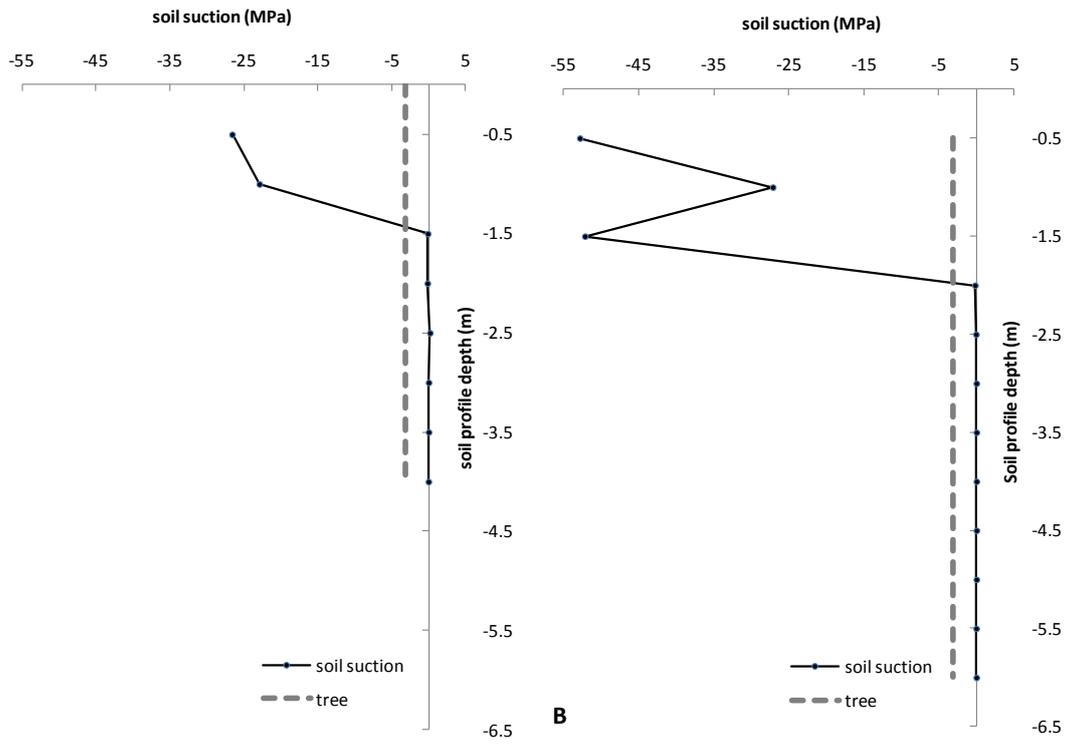
Figure 10: Soil suction (MPa) of the soil profile (0 to -6.5 m) and predawn shoot water potential (MPa) of black box within the pre-irrigated (A) and post-irrigated (B) control plots.

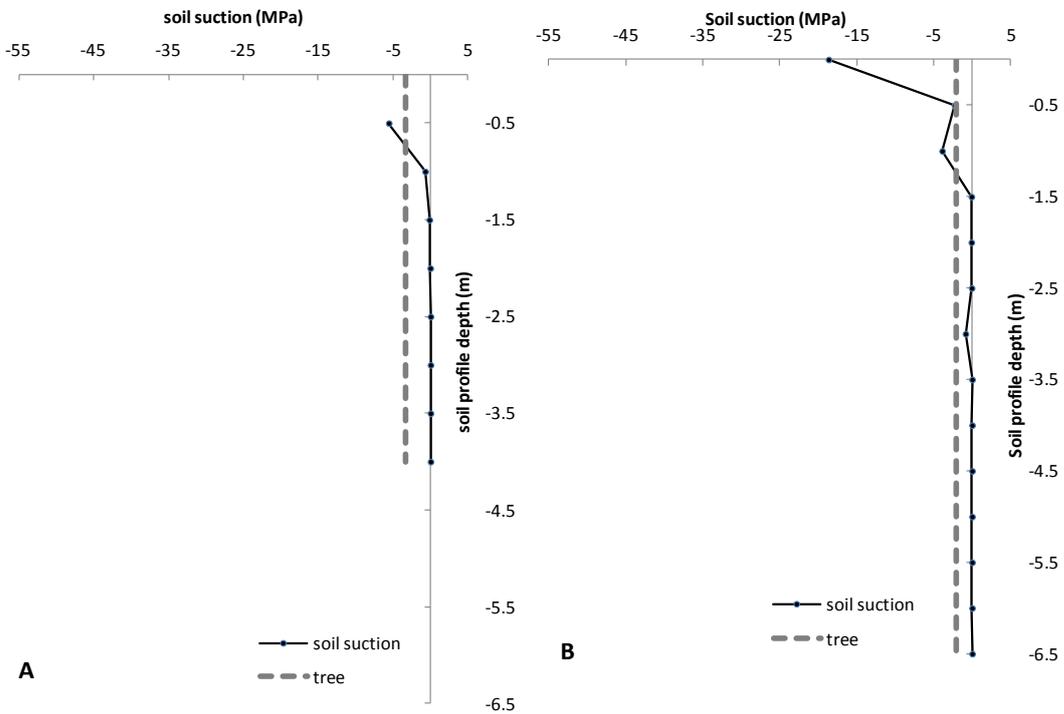
Figure 11: Soil suction (MPa) of the soil profile (0 to -6.5 m) and predawn shoot water potential (MPa) of black box within the pre-irrigated (A) and post-irrigated (B) plots.

Following irrigation, black box in the treatment plots had $\delta^{18}\text{O}$ stem tissue values that ranged from -0.41 to 0.22 ‰ $\delta^{18}\text{O}$ (mean value = -0.31‰ $\delta^{18}\text{O}$). The isotopic composition of the soil samples ranged from 5.45 ‰ $\delta^{18}\text{O}$ at the surface (0 – 25 cm) to -3.16 ‰ $\delta^{18}\text{O}$ at the saturated watertable level (6.5 m). The isotopic composition of the tree stem tissues correspond to soil-water $\delta^{18}\text{O}$ values measured at \sim 0.5 m depth (Figure 12). Similarly, the enriched $\delta^{18}\text{O}$ soil-water values measured at this depth correspond to the increase in soil suction (-2.3 MPa) recorded at this particular depth following irrigation (Figure 11b).

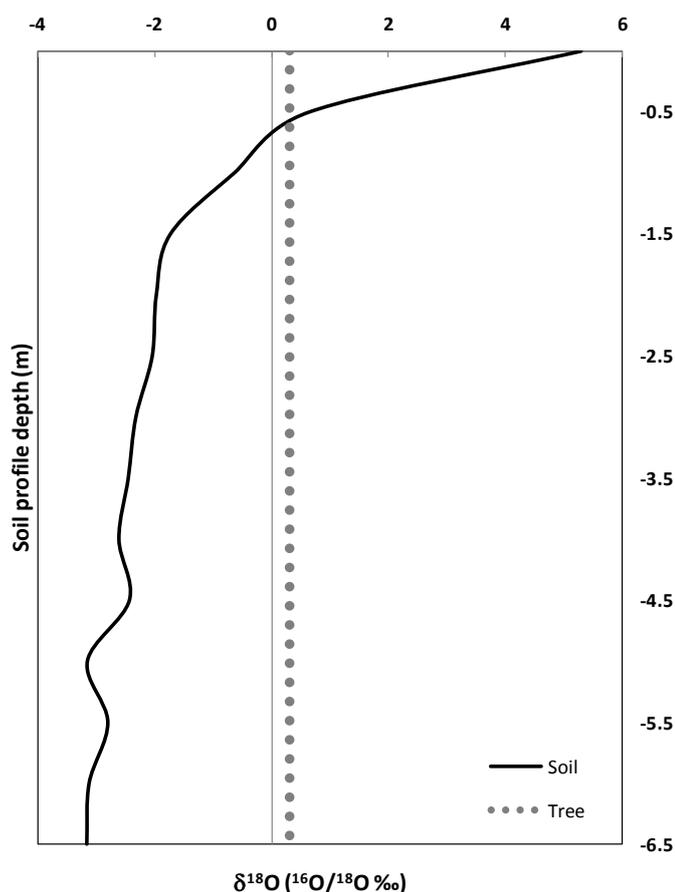
Figure 12: $\delta^{18}\text{O}$ values for black box stem tissue and soil-water samples (0 to -6.5 m) within the irrigated soil profile treatment plot (1) of Markaranka field irrigation trial (January 2013).

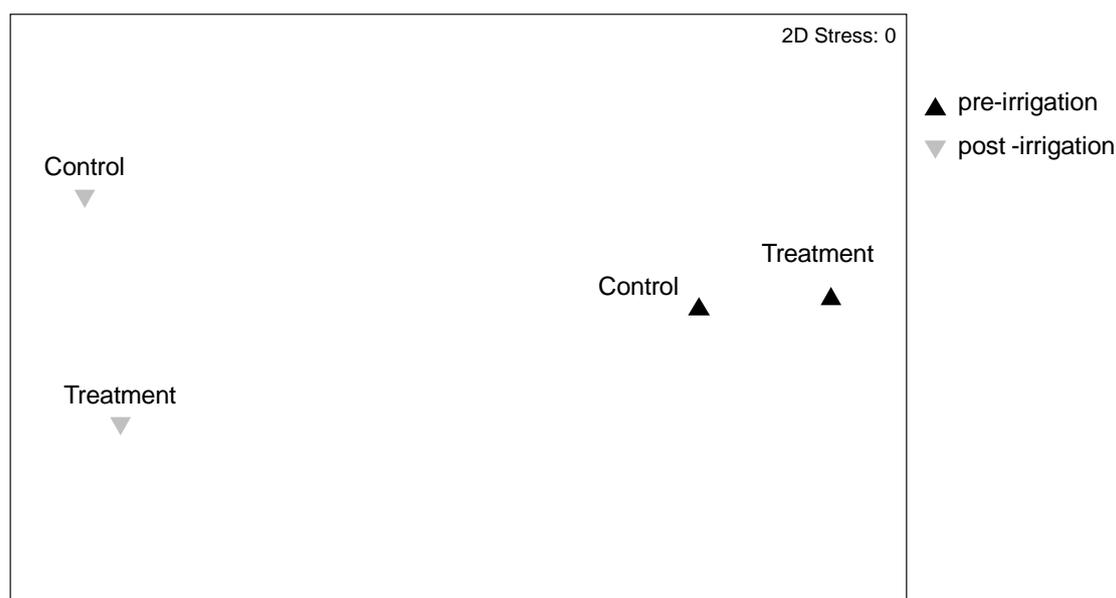
Figure 13: NMS ordination comparing per cent ground cover of understorey species, bare soil, leaf litter and lichen crust) of control and treatment plots during pre- and post-irrigation (stress = 0%).

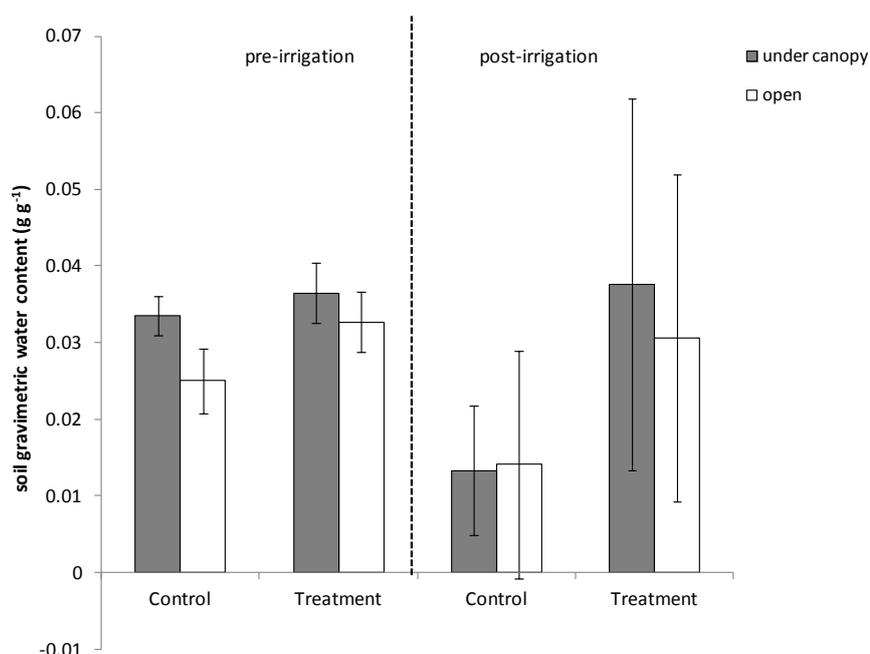
Figure 14: Comparison of soil gravimetric water content (g g^{-1}) under black box canopy (1 m) and in the open (5 m) for control and treatment plots during pre-irrigation (October 2012) and post-irrigation (January 2013); Markaranka field trial. Measurements are mean \pm S.E \times 1.96.

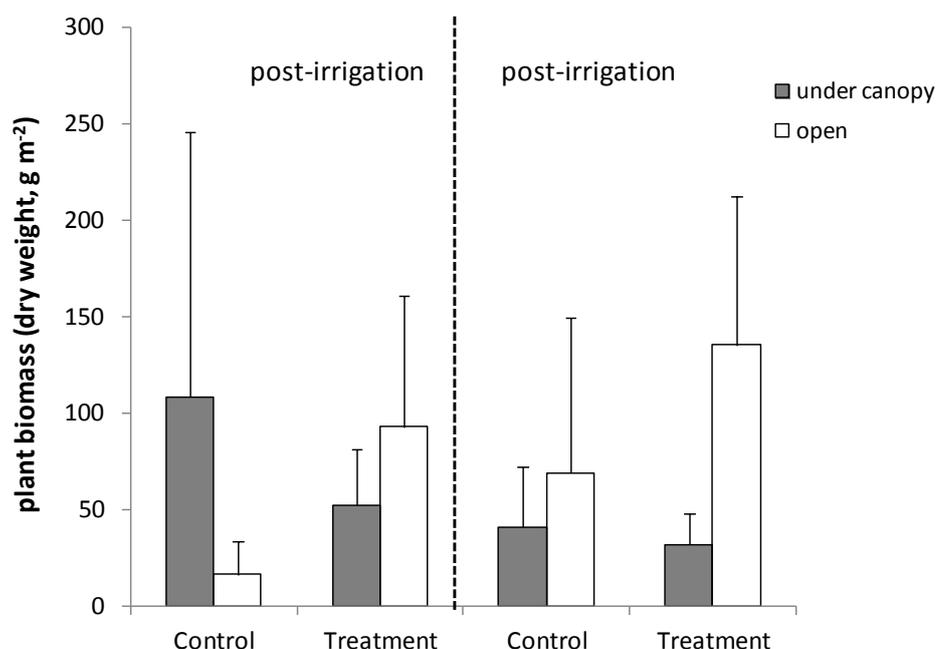
Figure 15: Comparison of understorey plant biomass (dry weight, g m⁻²) under black box canopy (1 m) and in the open (5 m) for control and treatment plots during pre-irrigation (November 2012) and post-irrigation (January 2013) surveys; Markaranka field trial. Measurements are mean \pm S.E \times 1.96.

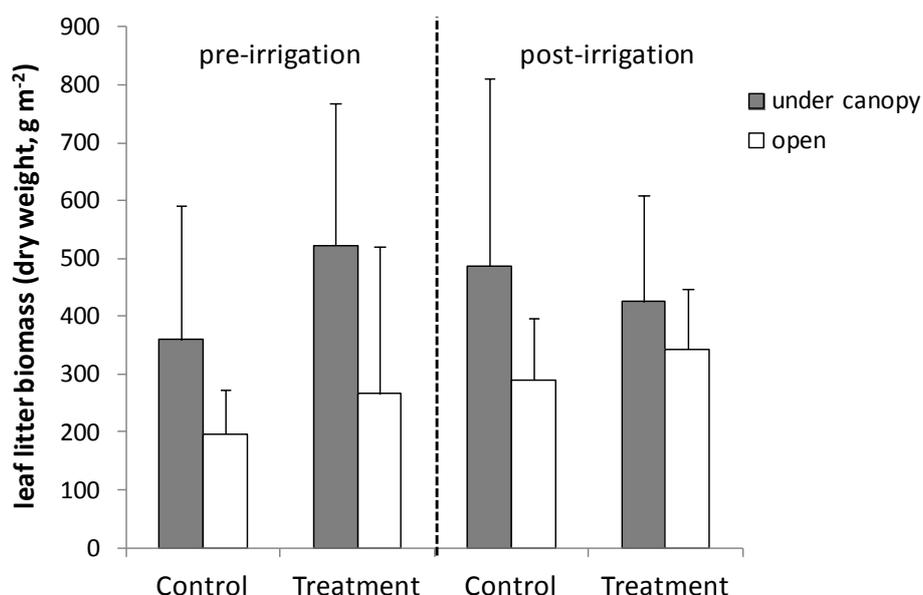
Figure 16: Comparison of leaf litter biomass (dry weight, g m⁻²) under black box canopy (1 m) and in the open (5 m) for control and treatment plots during pre-irrigation (October 2012) and post-irrigation (January 2013); Markaranka field trial. Measurements are mean \pm S.E \times 1.96.

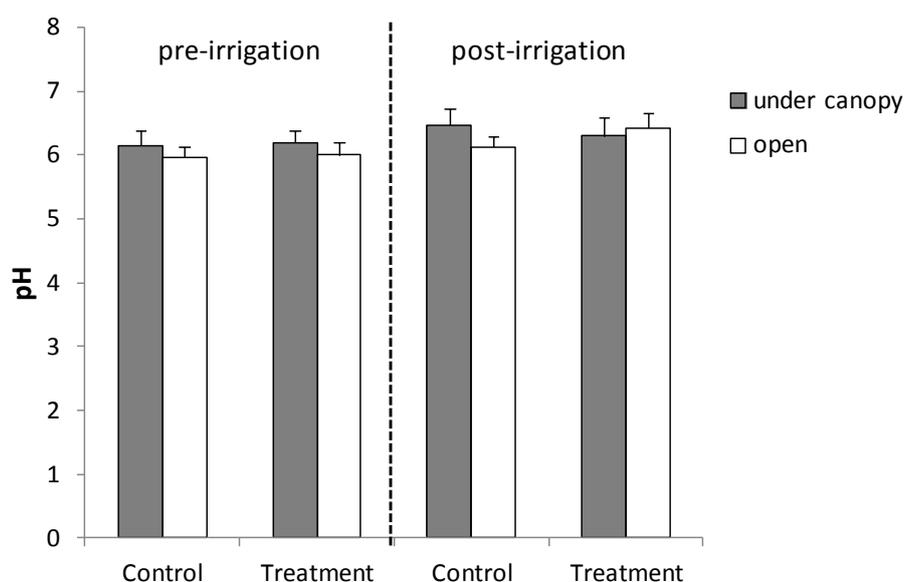
Figure 17: Comparison of soil pH under black box canopy (1 m) and in the open (5 m) for control and treatment plots during pre-irrigation (October 2012) and post-irrigation (January 2013); Markaranka field trial. Measurements are mean \pm S.E \times 1.96.

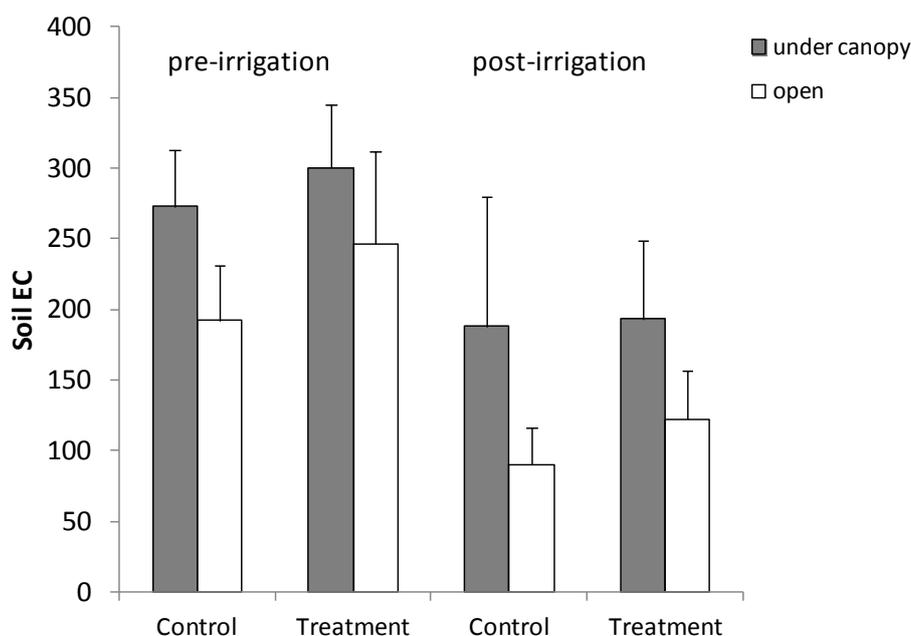
Figure 18: Comparison of soil surface EC under black box canopy (1 m) and in the open (5 m) for control and treatment plots during pre-irrigation (October 2012) and post-irrigation (January 2013); Markaranka field trial. Measurements are mean \pm S.E. \times 1.96.

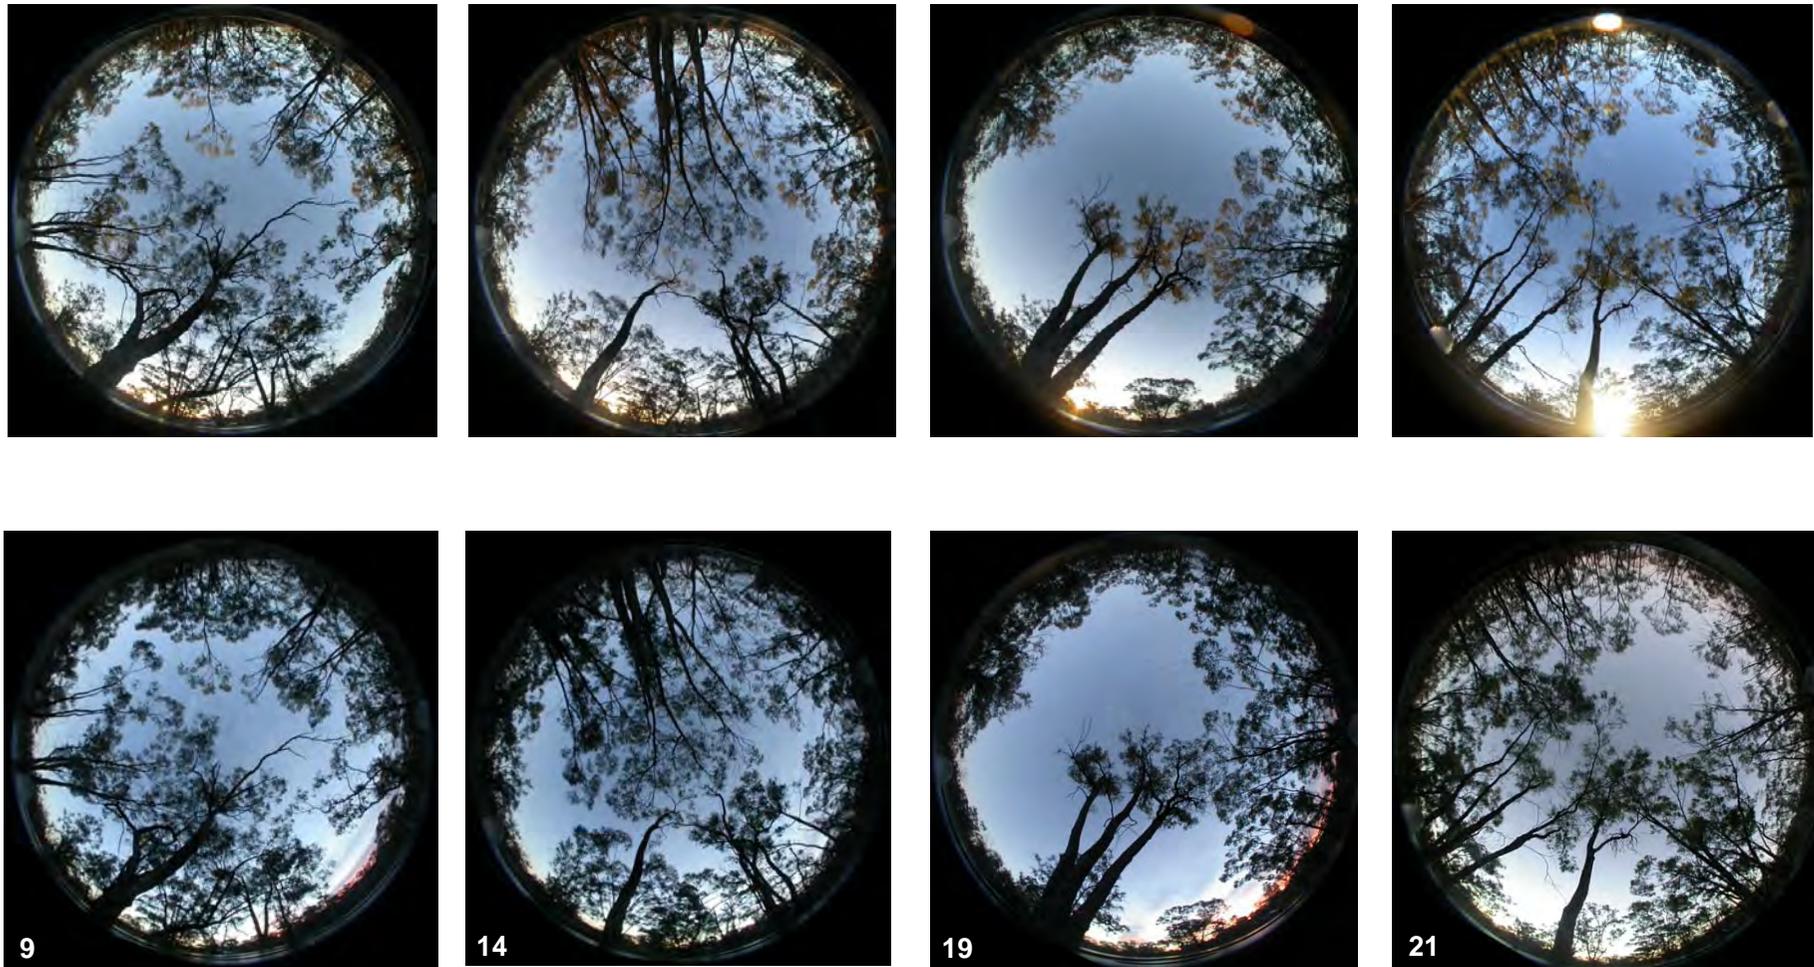
Appendix 5: Pre-irrigation (top row) and post-irrigation (bottom row) hemiview images of canopy for black box trees #9, 14, 19 and 21 in Treatment plot 1.

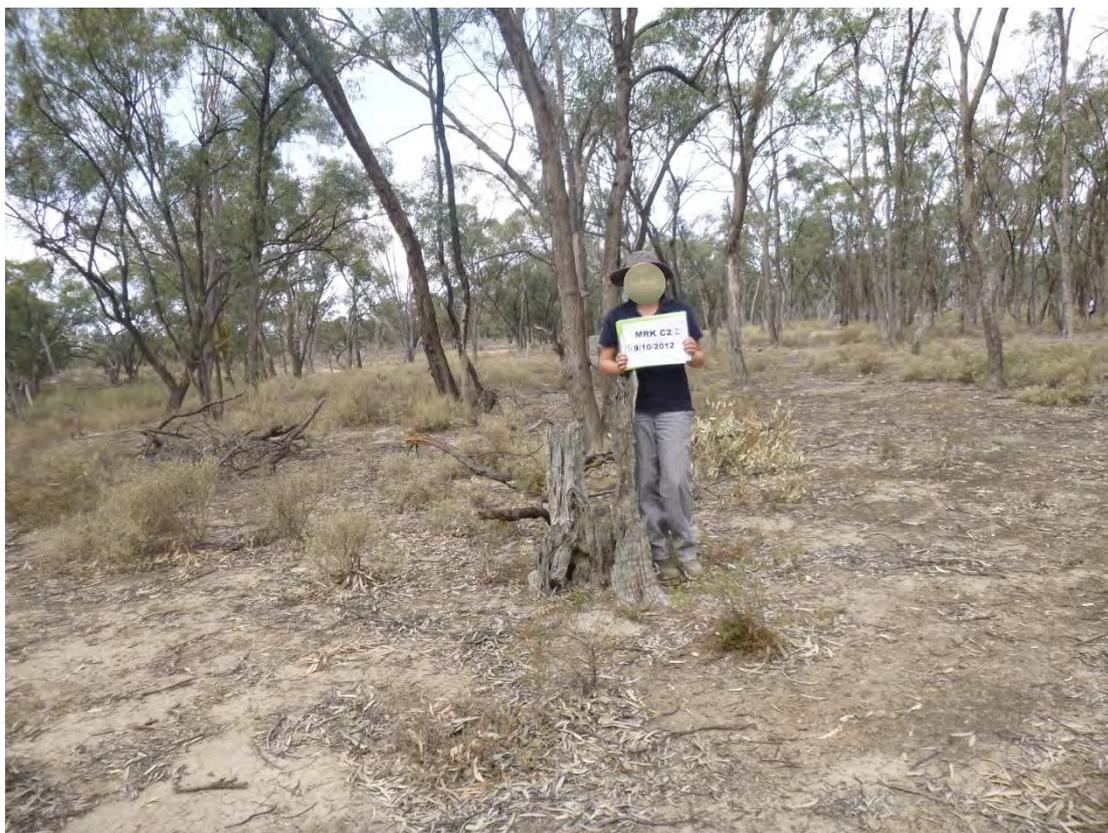
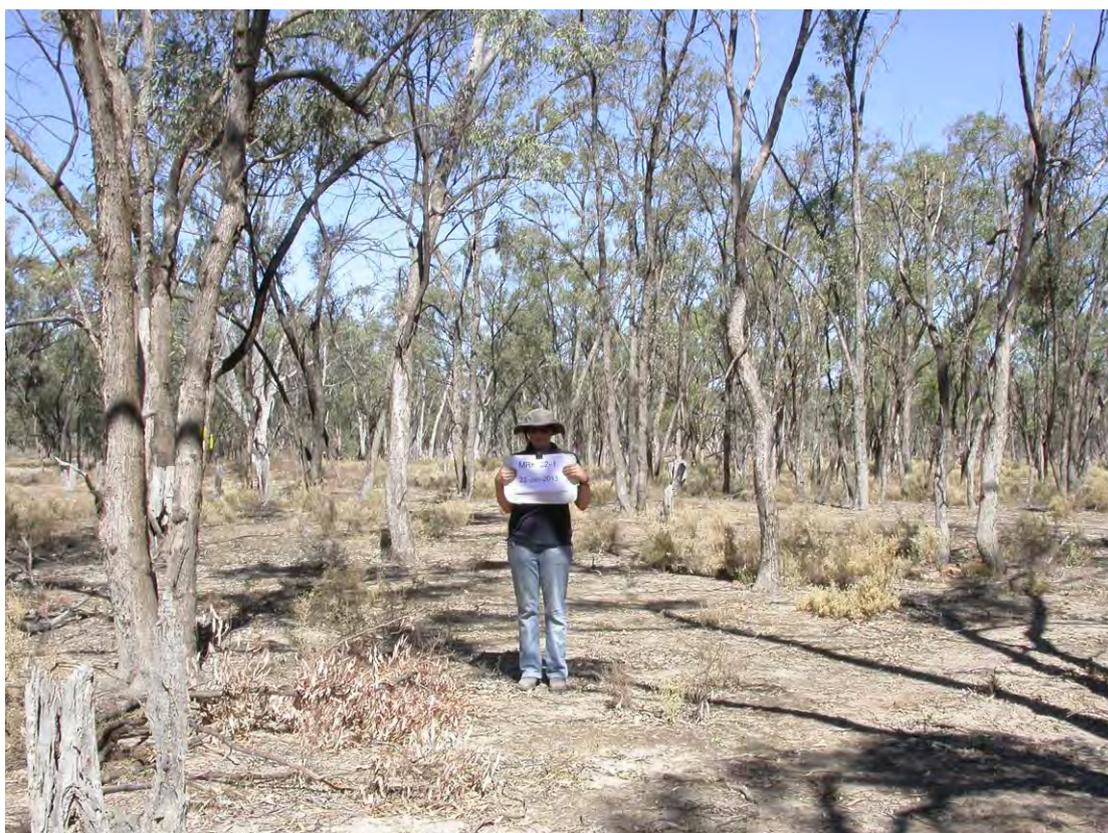
Appendix 9: Photopoint PI for control plot 2; pre-irrigation (above; 19/10/2012 and post-irrigation (below; 22/01/2013); Markaranka field irrigation trial.

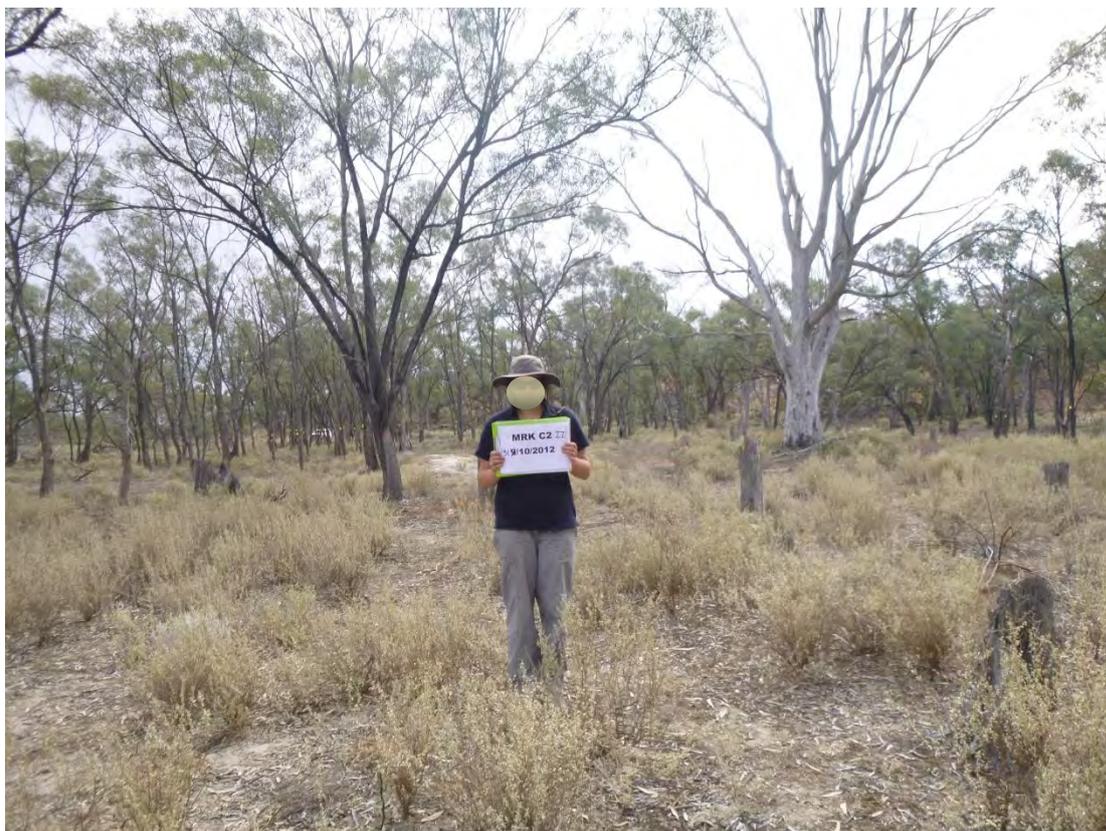
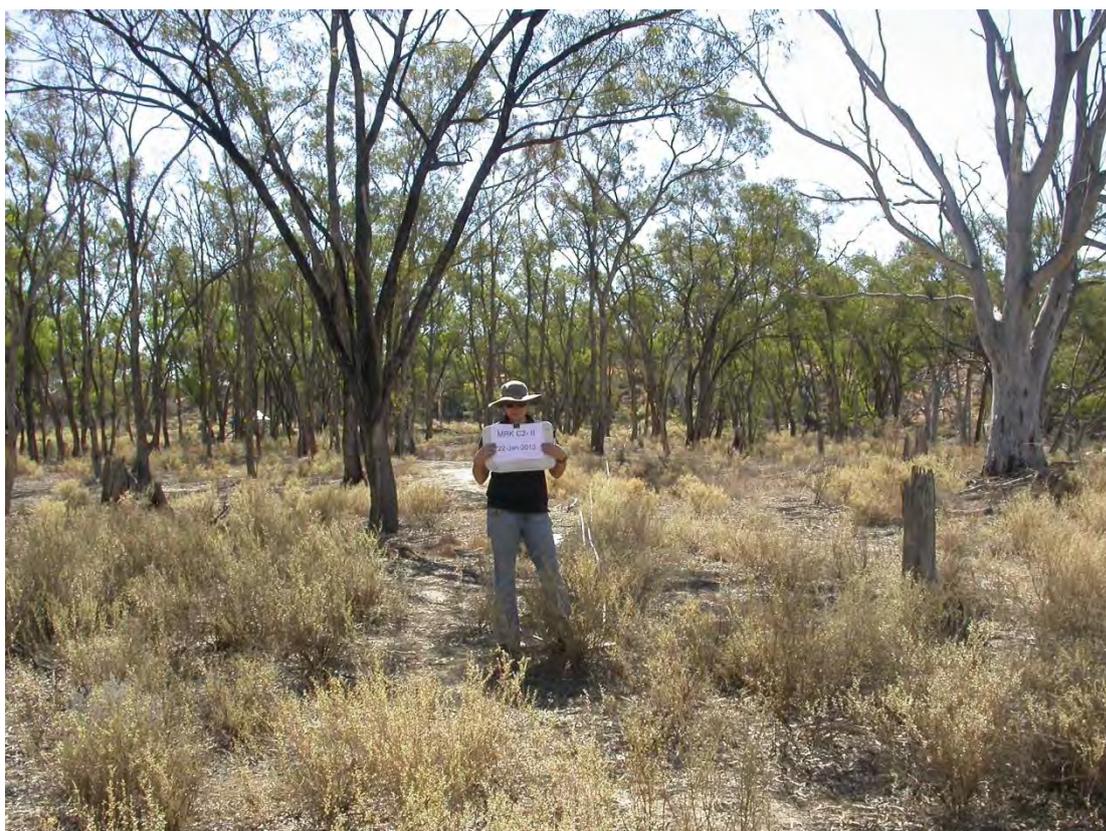
Appendix 10: Photopoint P11 for control plot 2; pre-irrigation (above; 19/10/2012 and post-irrigation (below; 22/01/2013); Markaranka field irrigation trial.

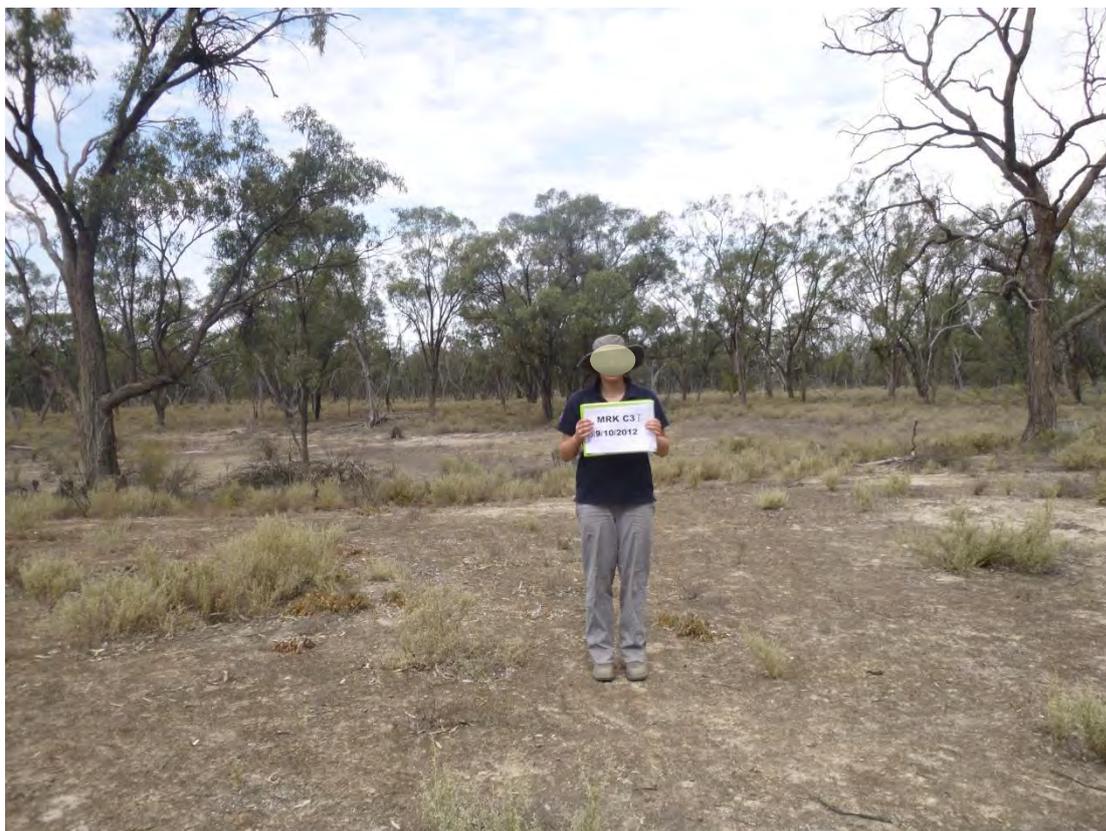
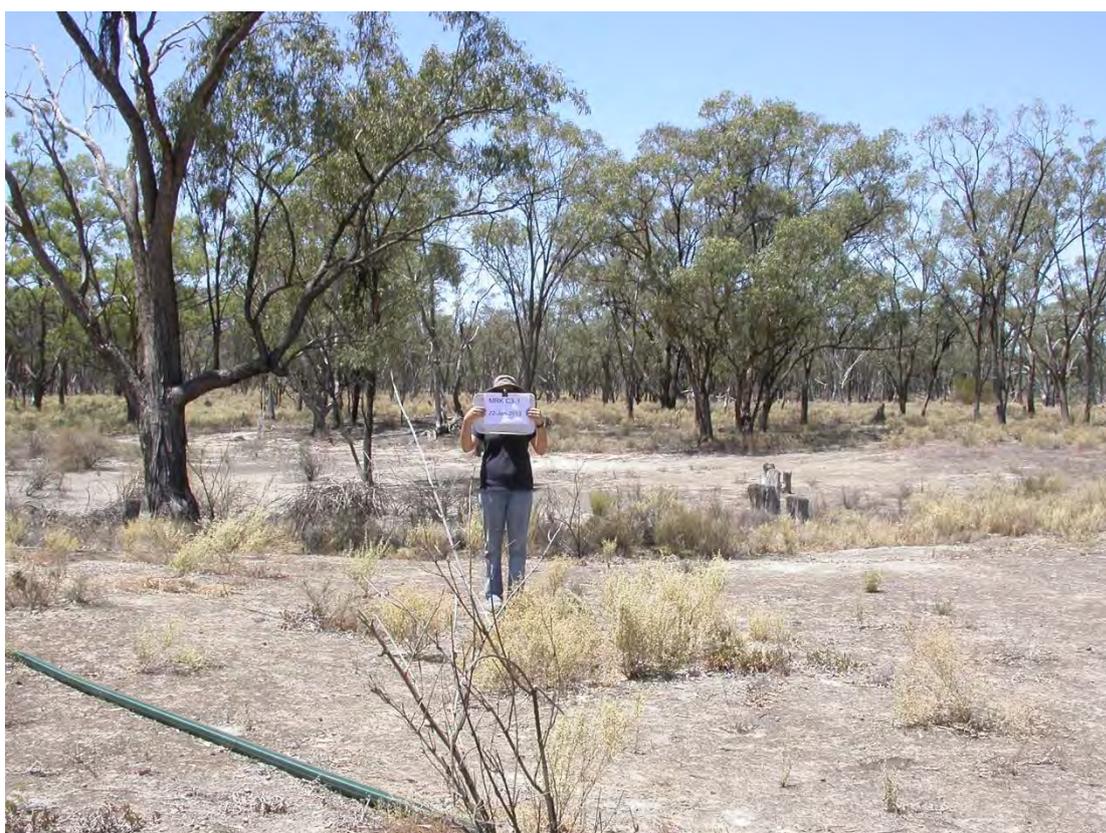
Appendix 11: Photopoint PI for control plot 3; pre-irrigation (above; 19/10/2012 and post-irrigation (below; 22/01/2013); Markaranka field irrigation trial.
