Field trial investigating use of drip irrigation to improve condition of black box (*Eucalyptus largiflorens*) woodlands Phase 1: Infrastructure Test Report

SARDI Publication No. F2013/000438-1
SARDI Research Report Series No. 706

August 2013

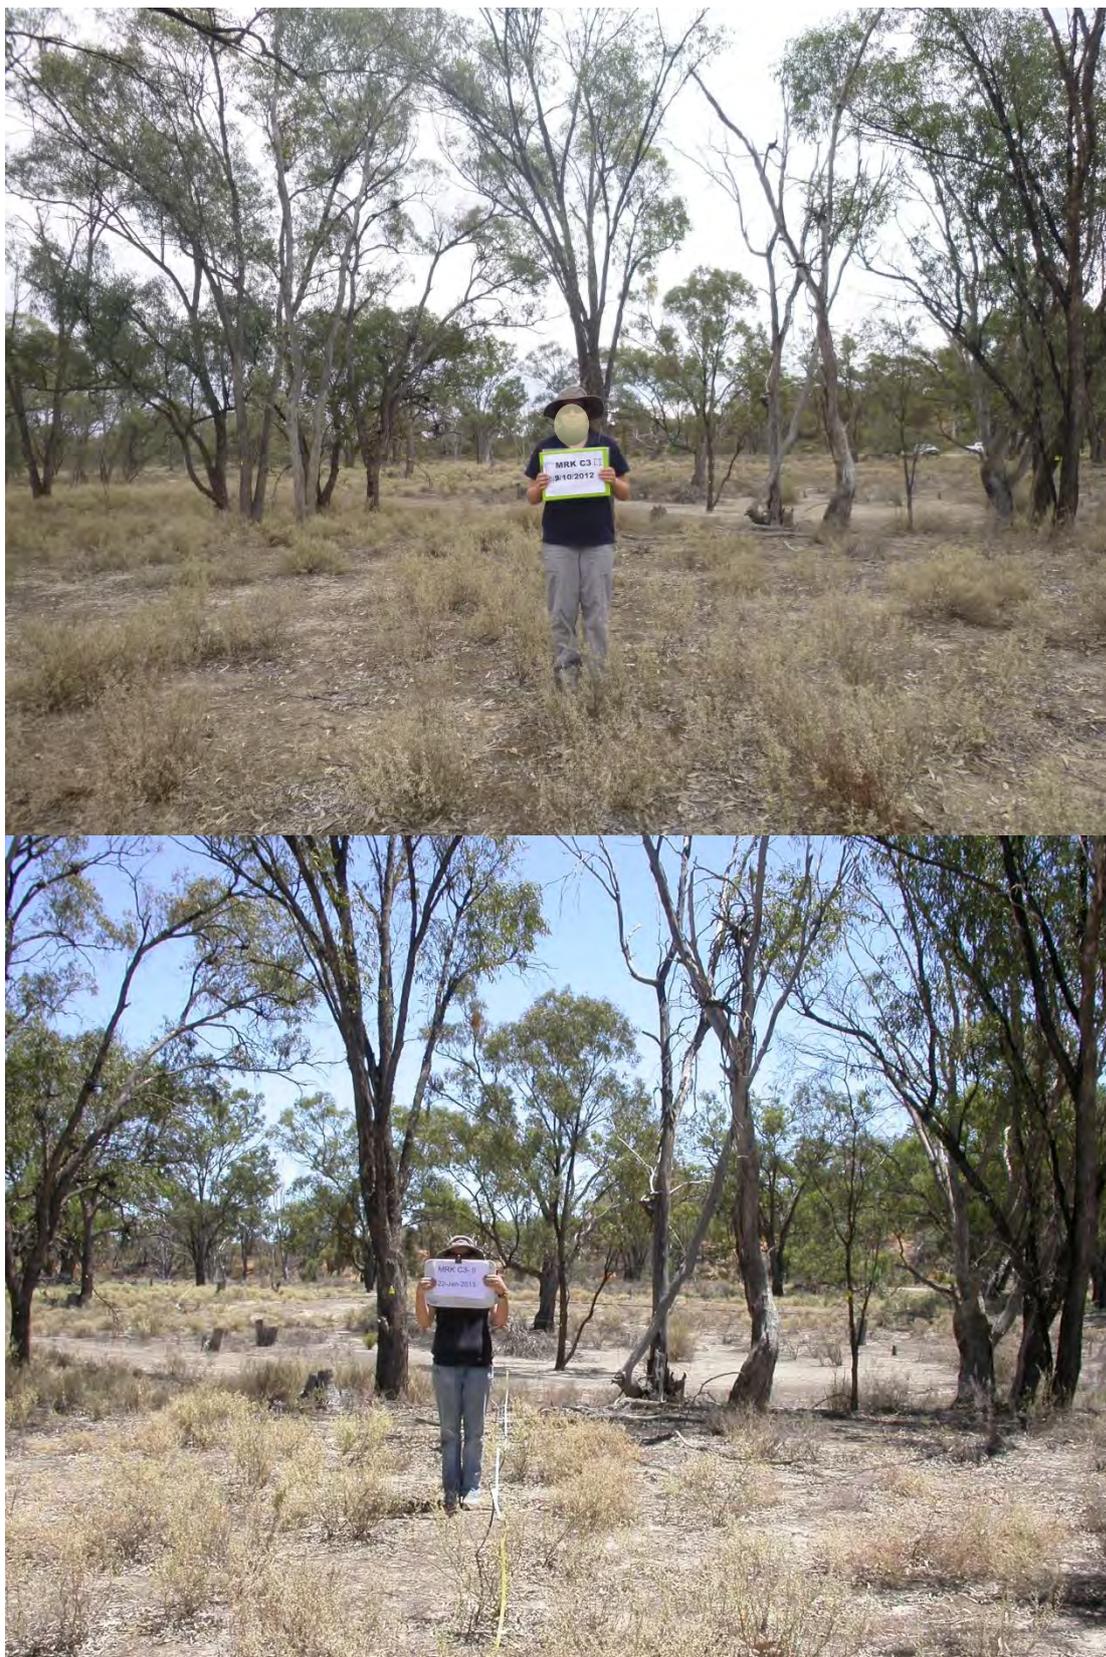
Appendix 12: Photopoint PII for control plot 3; pre-irrigation (above; 19/10/2012 and post-irrigation (below; 22/01/2013); Markaranka field irrigation trial.

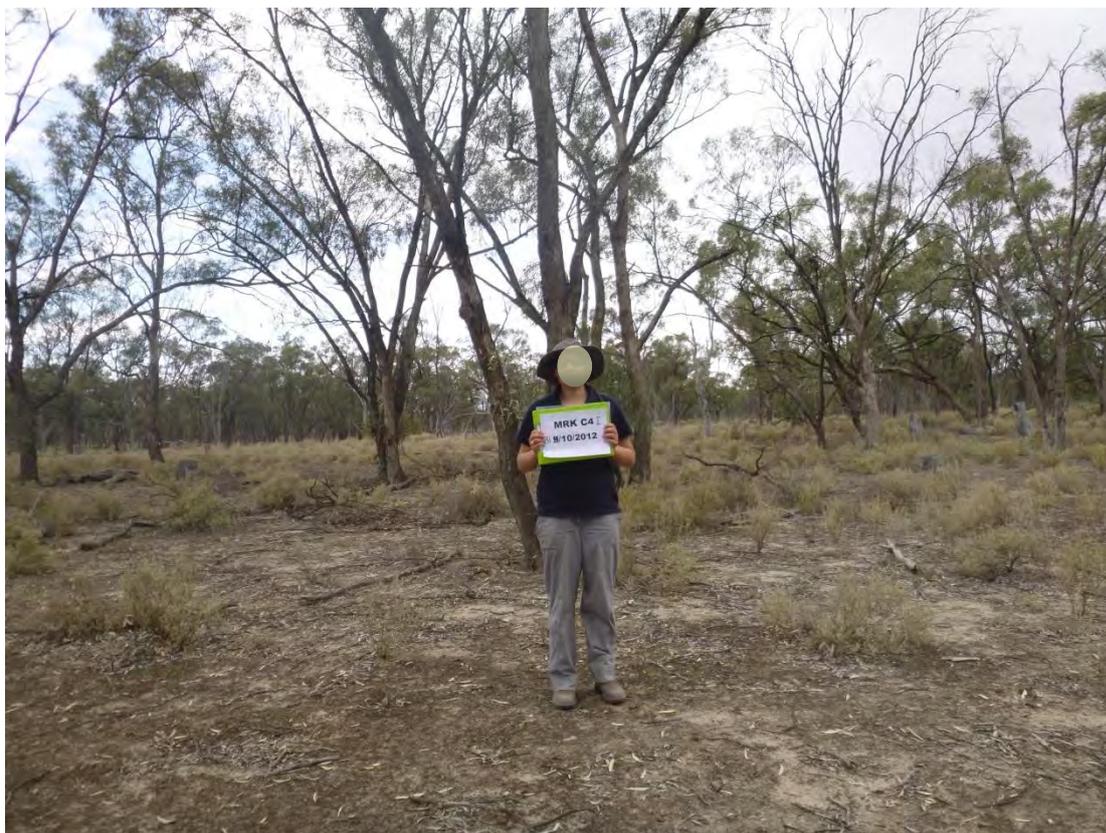
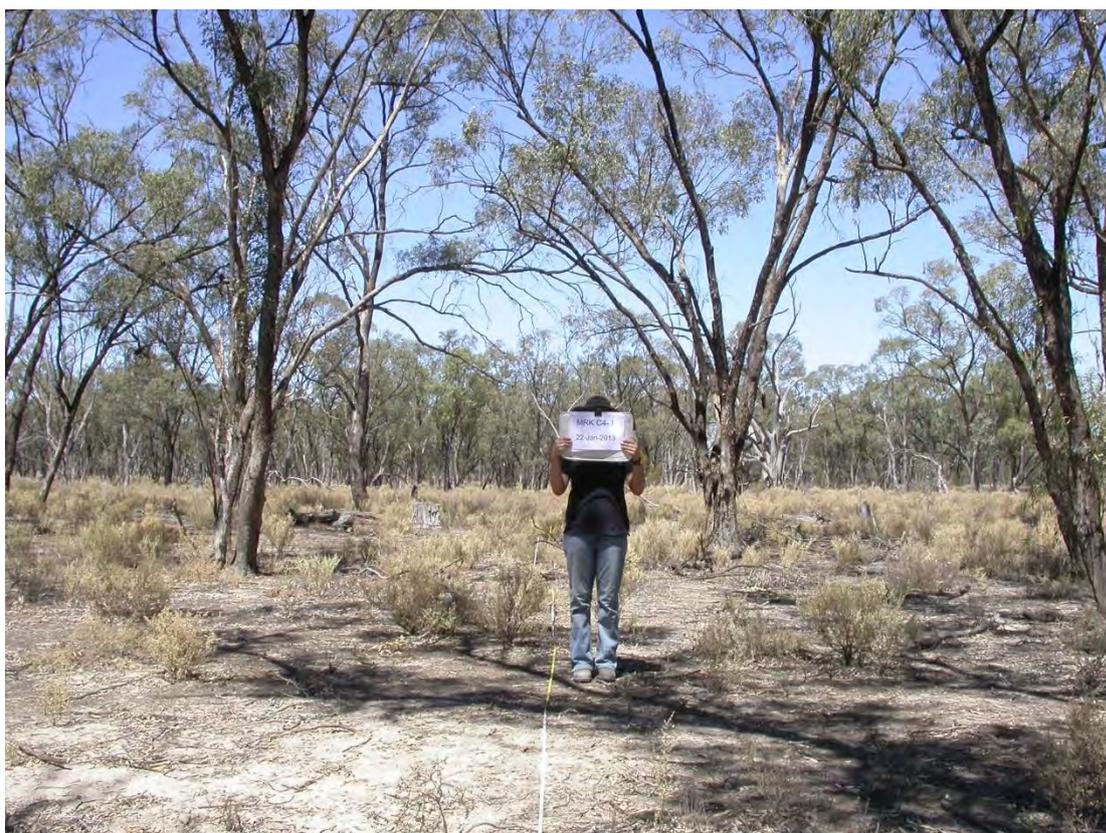
Appendix 13: Photopoint PI for control plot 4; pre-irrigation (above; 19/10/2012 and post-irrigation (below; 22/01/2013); Markaranka field irrigation trial.

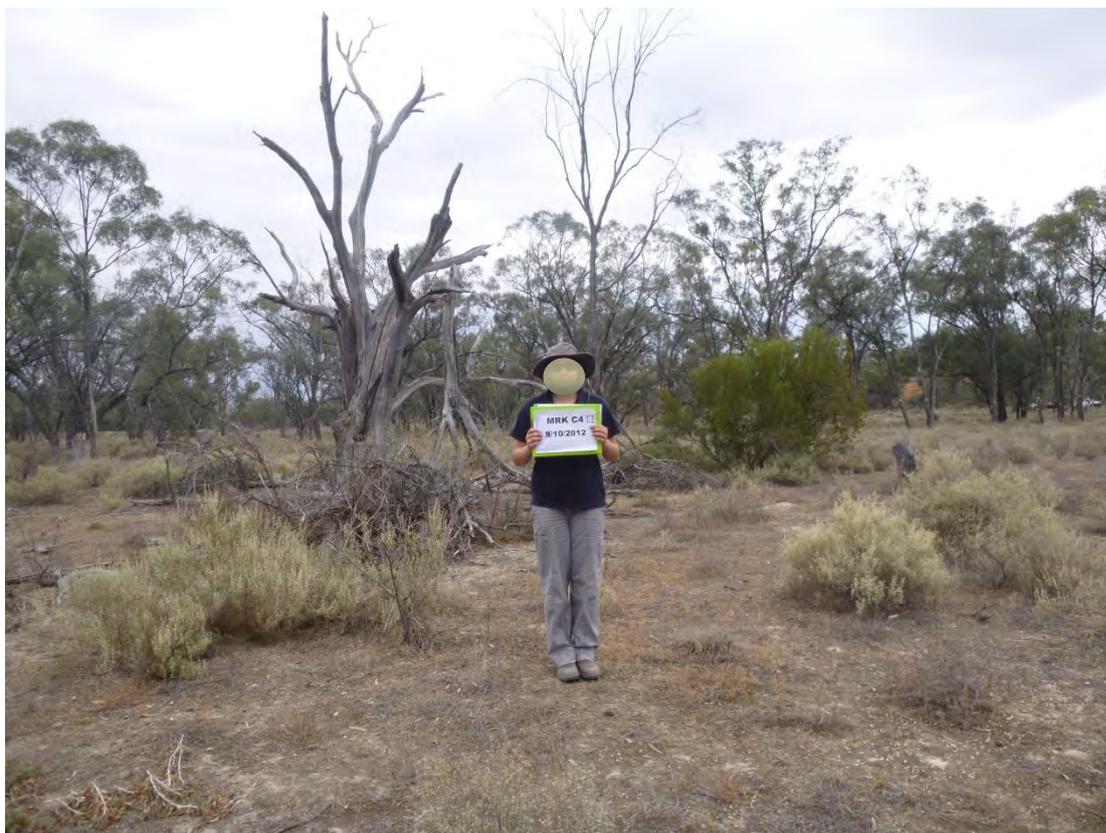
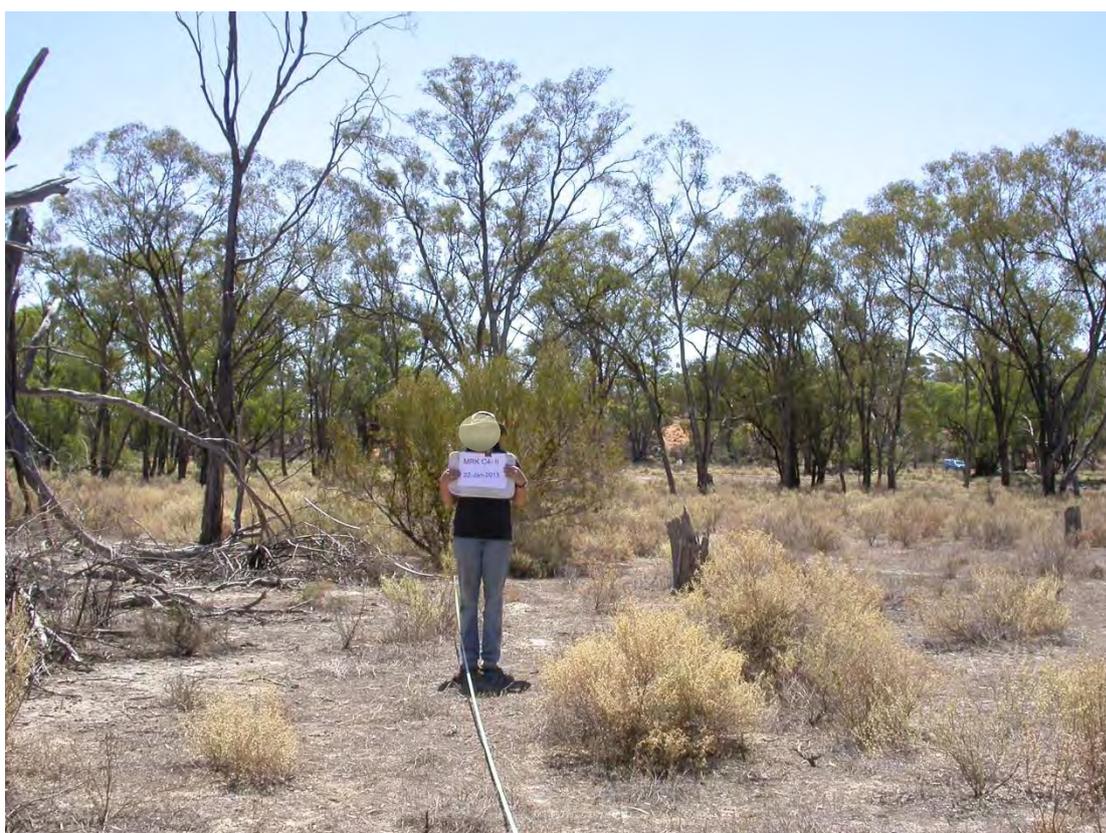
Appendix 14: Photopoint PII for control plot 4; pre-irrigation (above; 19/10/2012 and post-irrigation (below; 22/01/2013); Markaranka field irrigation trial.

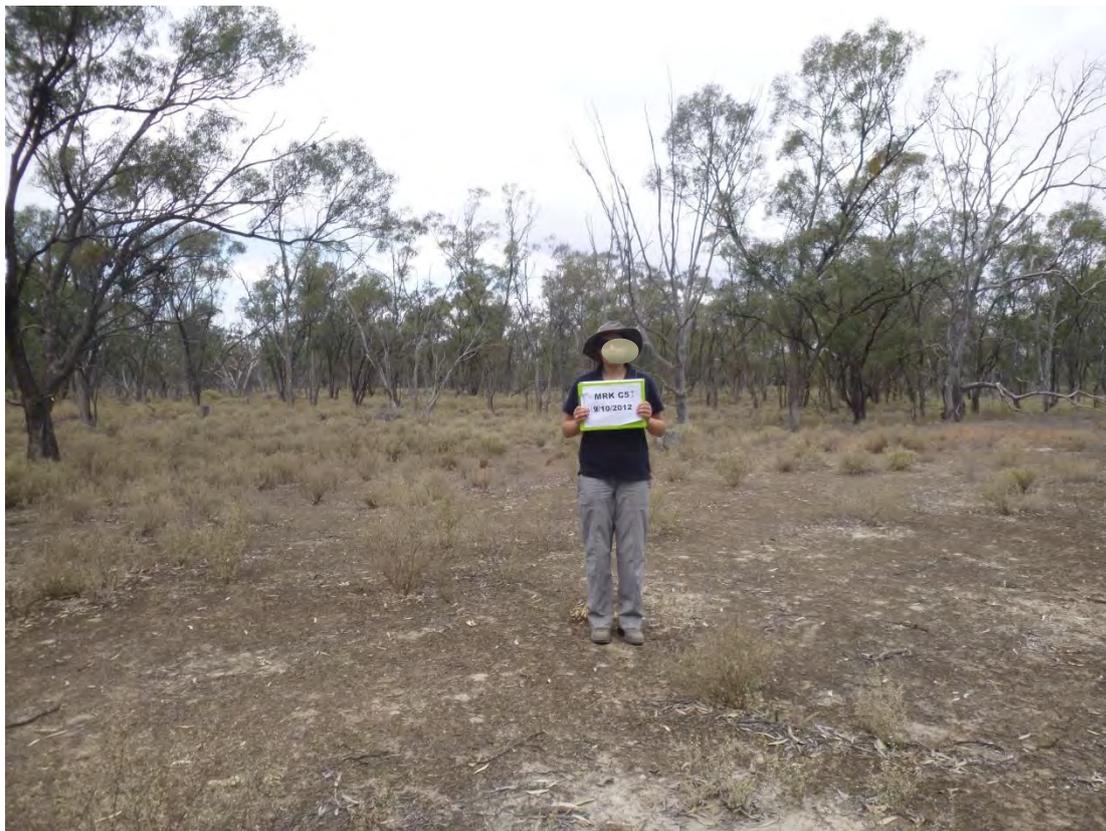
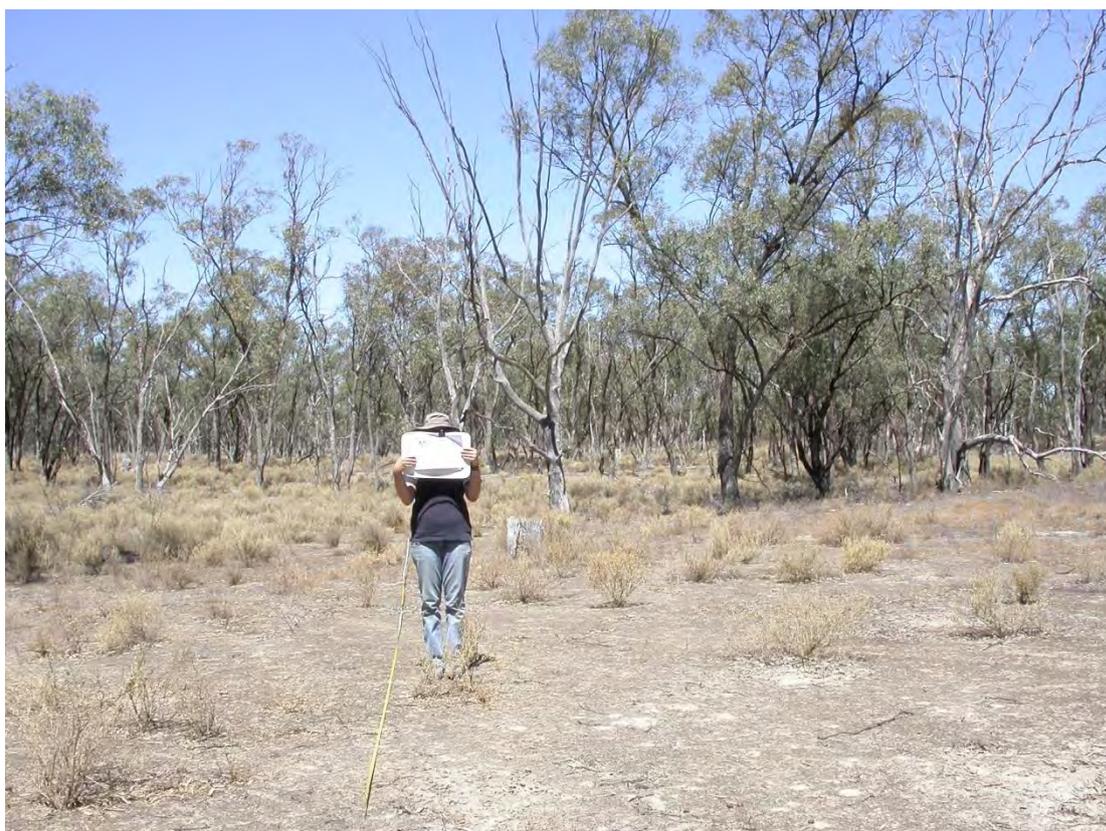
Appendix 15: Photopoint PI for control plot 5; pre-irrigation (above; 19/10/2012 and post-irrigation (below; 22/01/2013); Markaranka field irrigation trial.

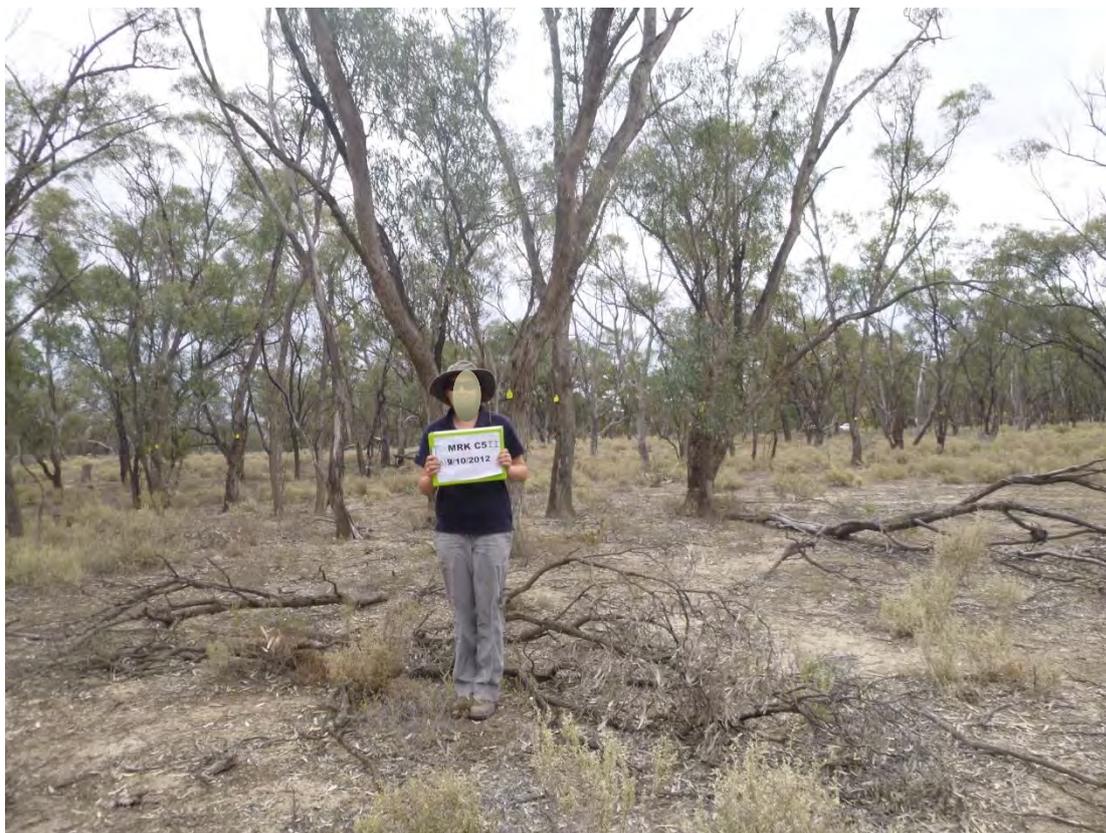
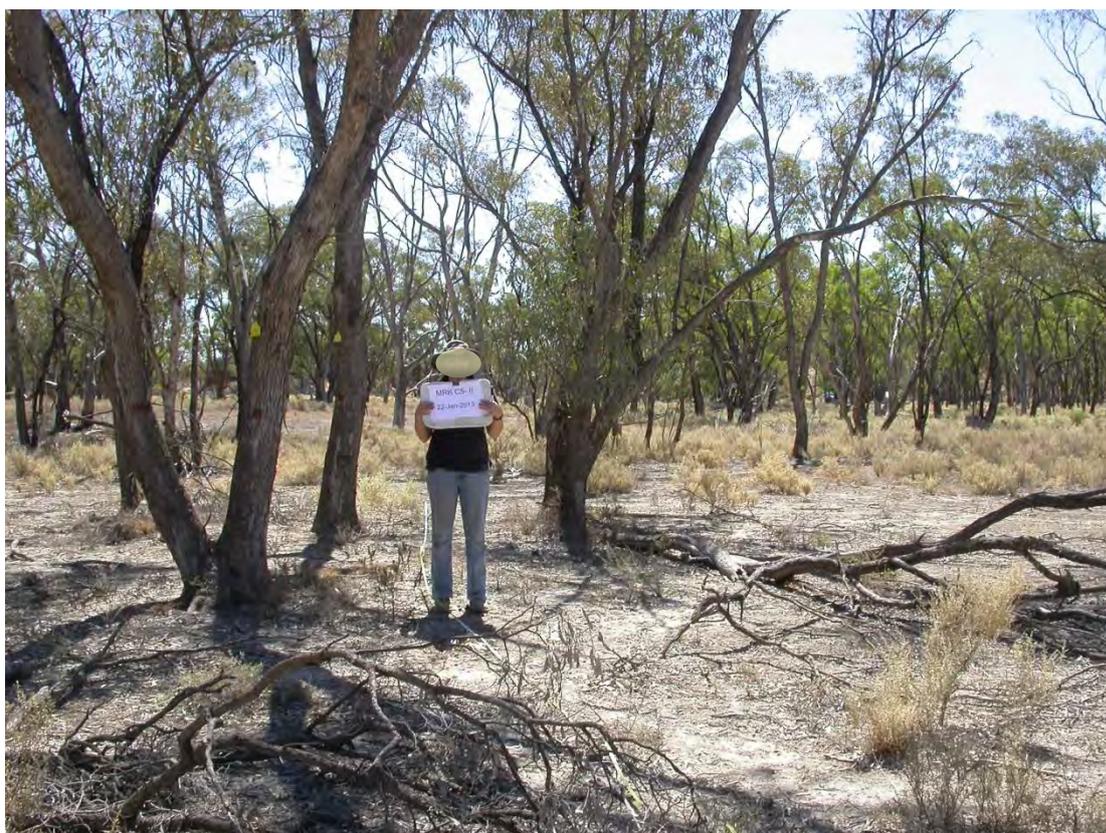
Appendix 16: Photopoint PII for control plot 5; pre-irrigation (above; 19/10/2012 and post-irrigation (below; 22/01/2013); Markaranka field irrigation trial.

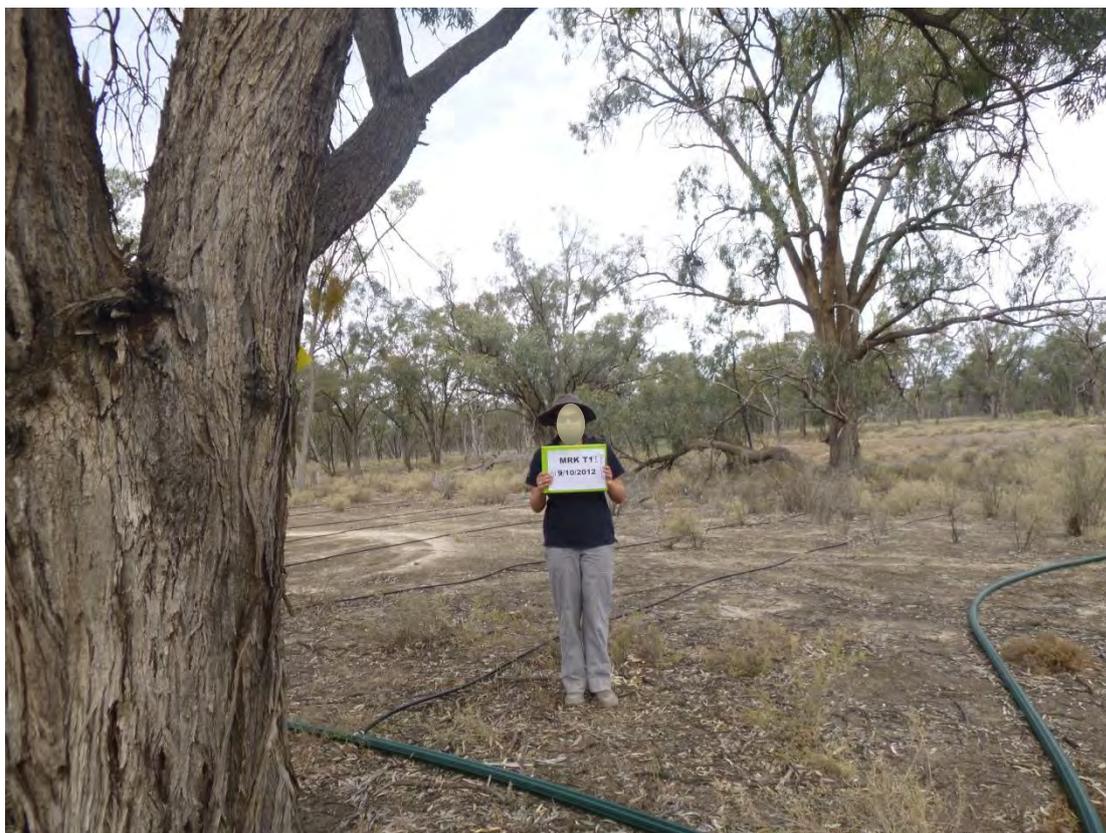
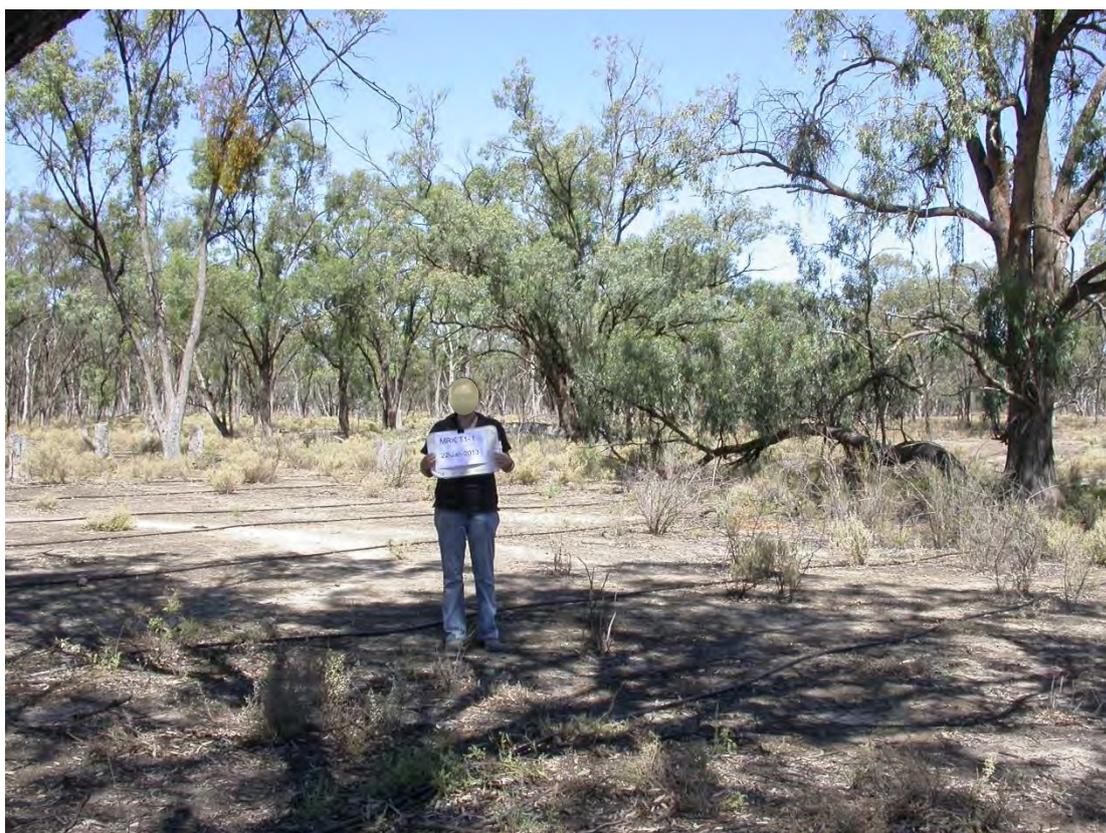
Appendix 17: Photopoint PI for treatment plot 1; pre-irrigation (above; 19/10/2012 and post-irrigation (below; 22/01/2013); Markaranka field irrigation trial.

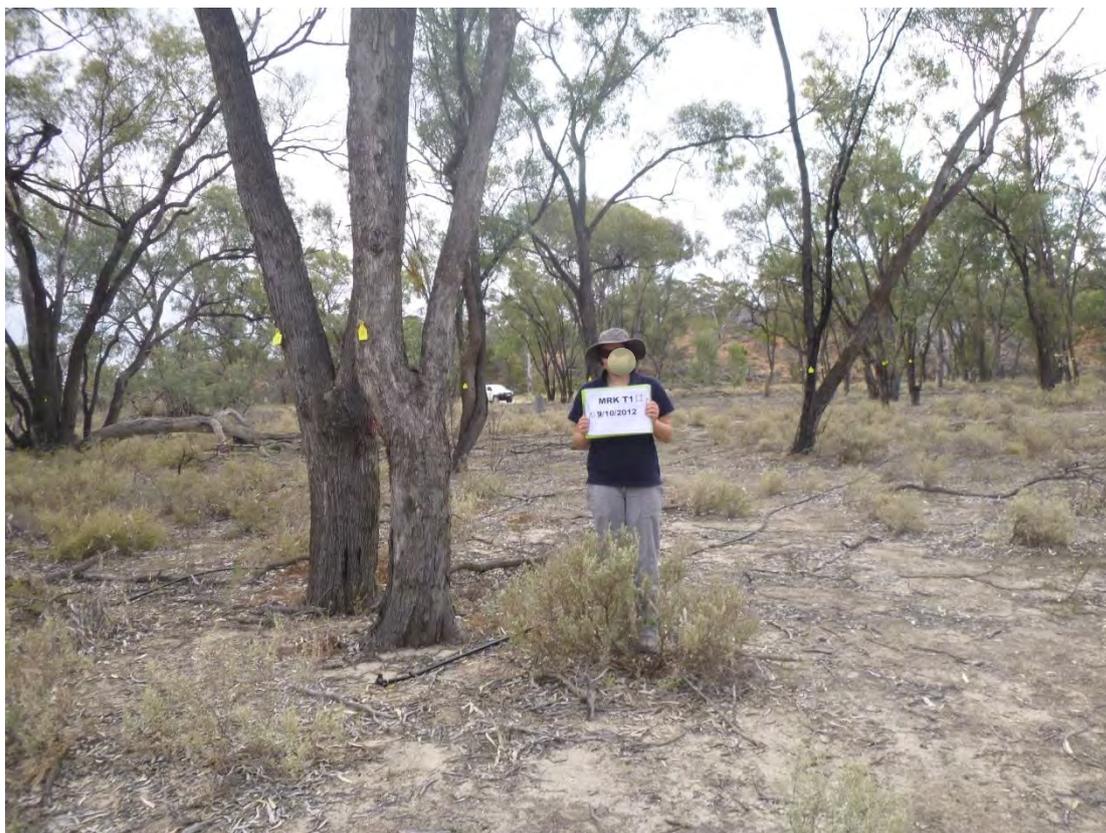
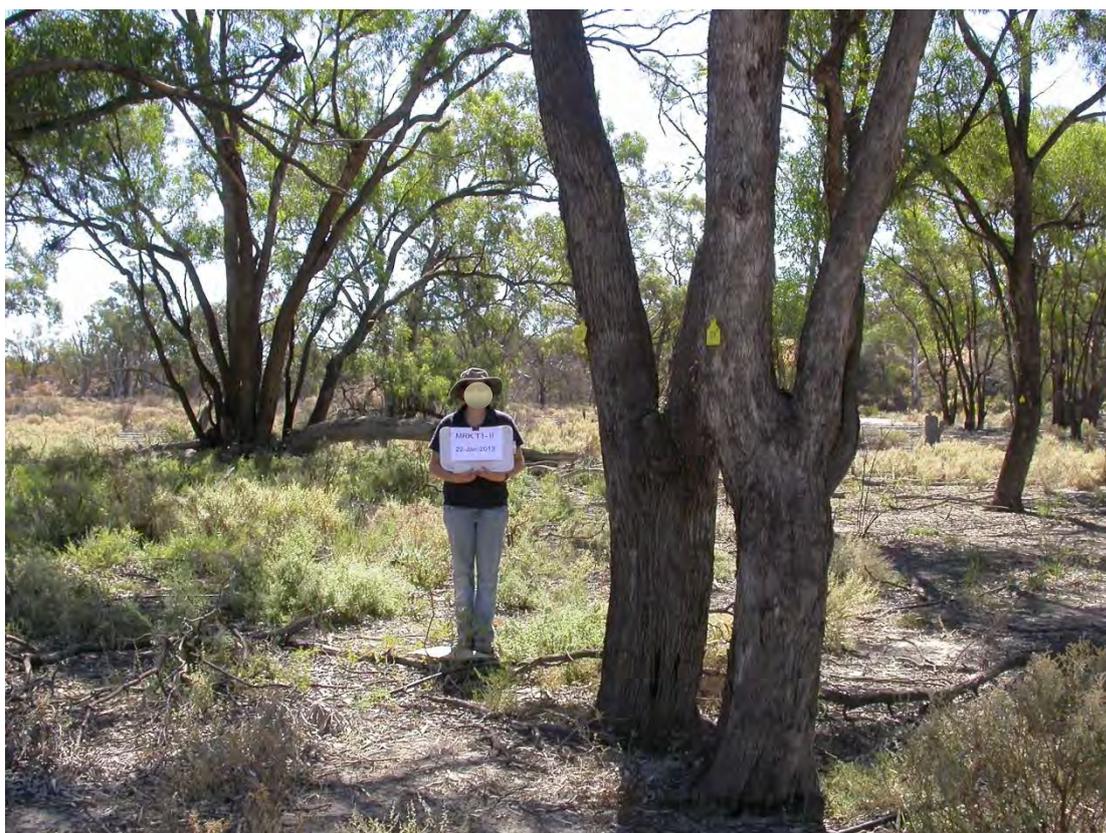
Appendix 18: Photopoint P11 for treatment plot 1 pre-irrigation (above; 19/10/2012 and post-irrigation (below; 22/01/2013); Markaranka field irrigation trial.

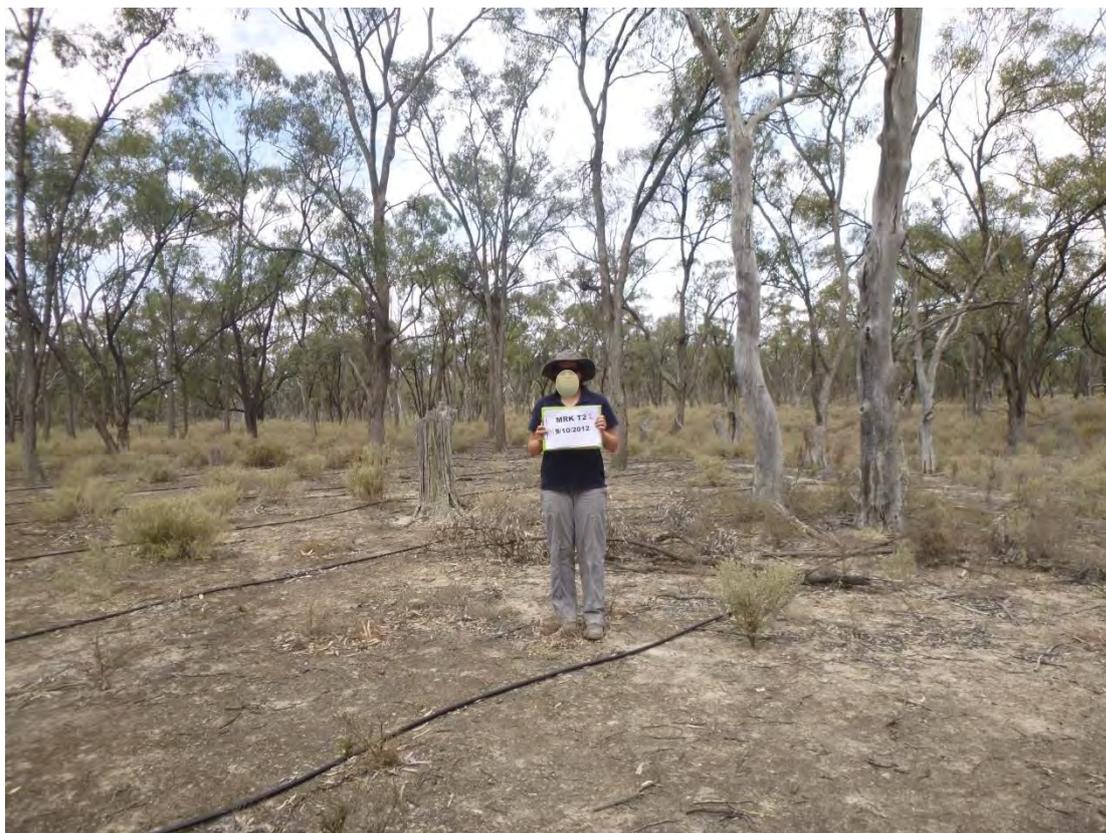
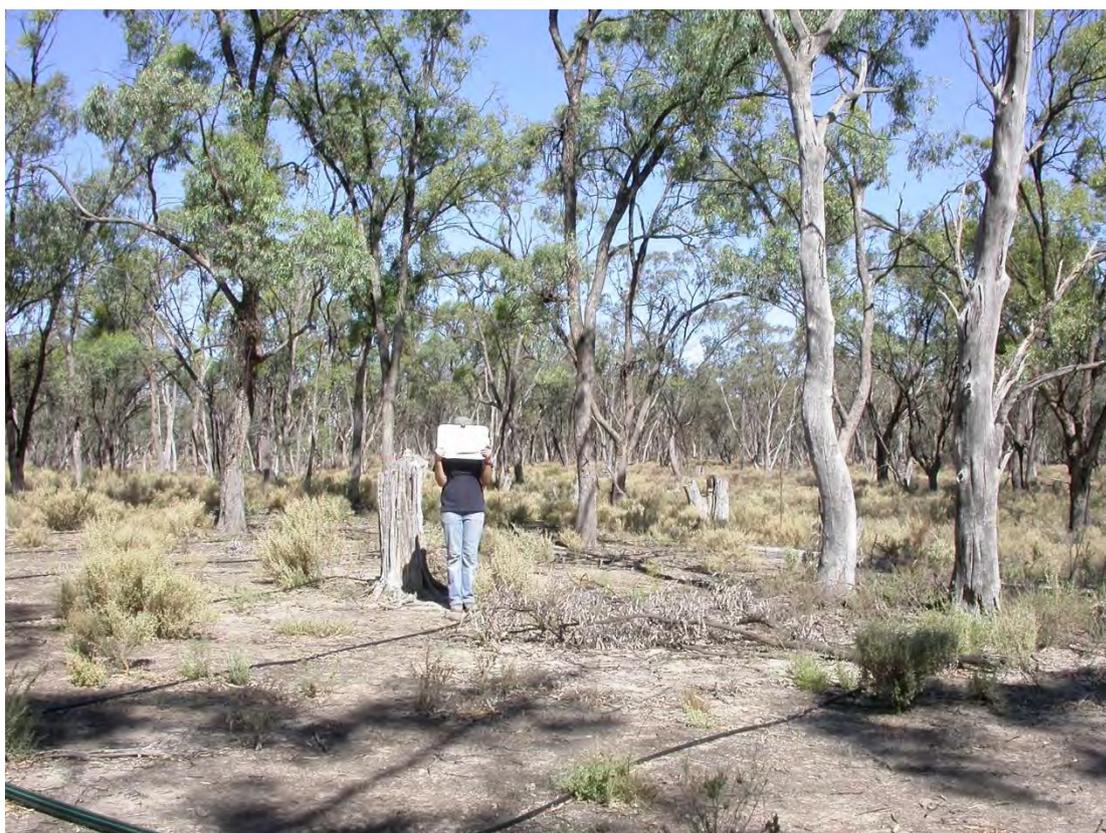
Appendix 19: Photopoint PI for treatment plot 2; pre-irrigation (above; 19/10/2012 and post-irrigation (below; 22/01/2013); Markaranka field irrigation trial.

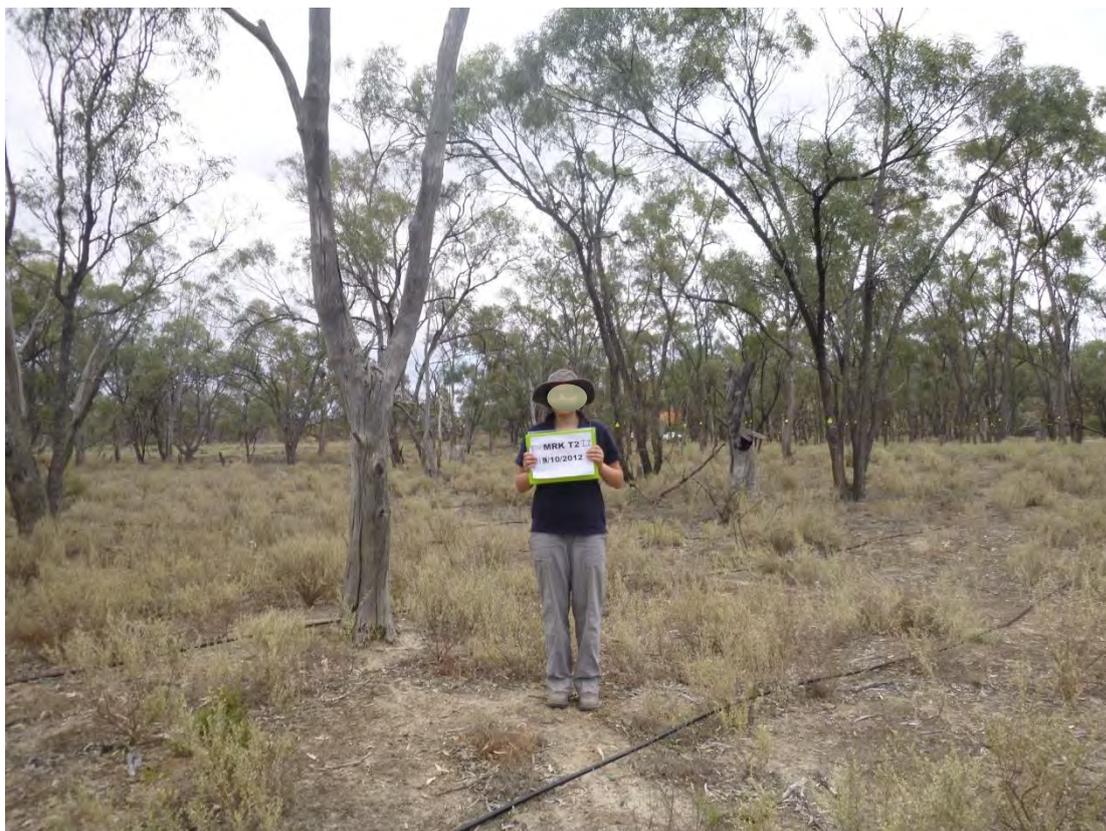
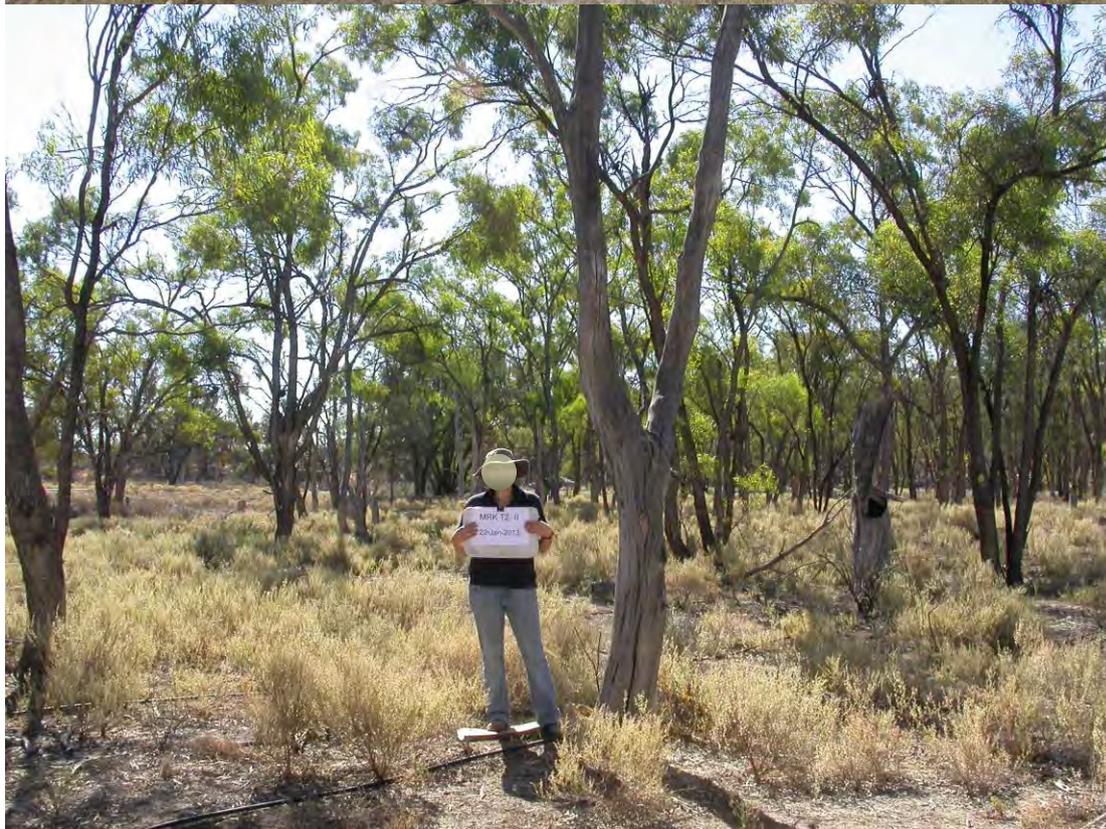
Appendix 20: Photopoint PII for treatment plot 2; pre-irrigation (above; 19/10/2012 and post-irrigation (below; 22/01/2013); Markaranka field irrigation trial

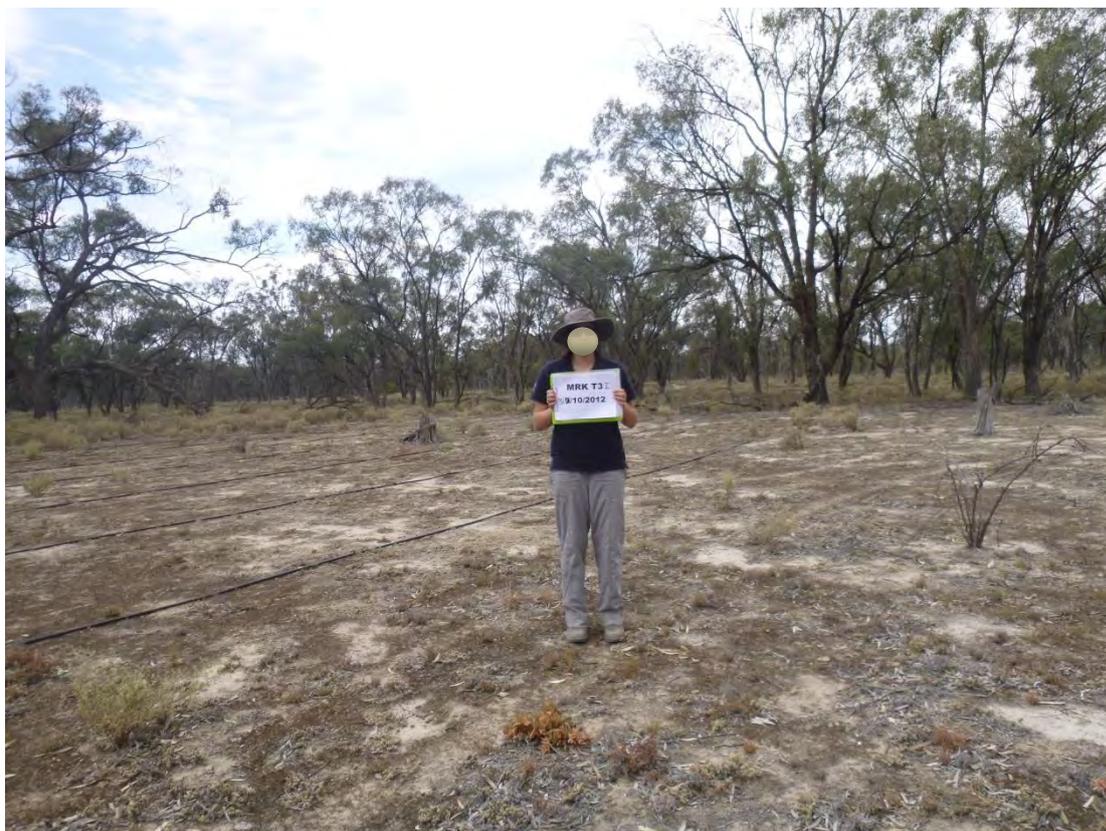
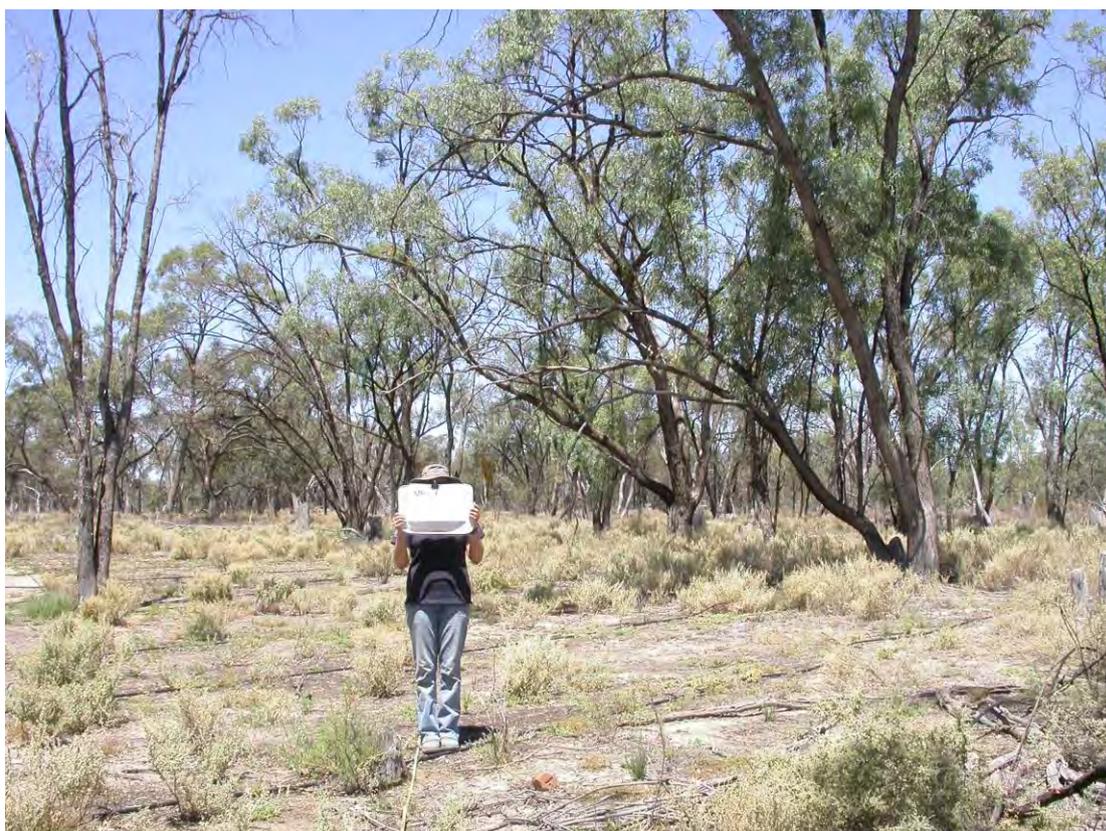
Appendix 21: Photopoint PI for treatment plot 3; pre-irrigation (above; 19/10/2012 and post-irrigation (below; 22/01/2013); Markaranka field irrigation trial

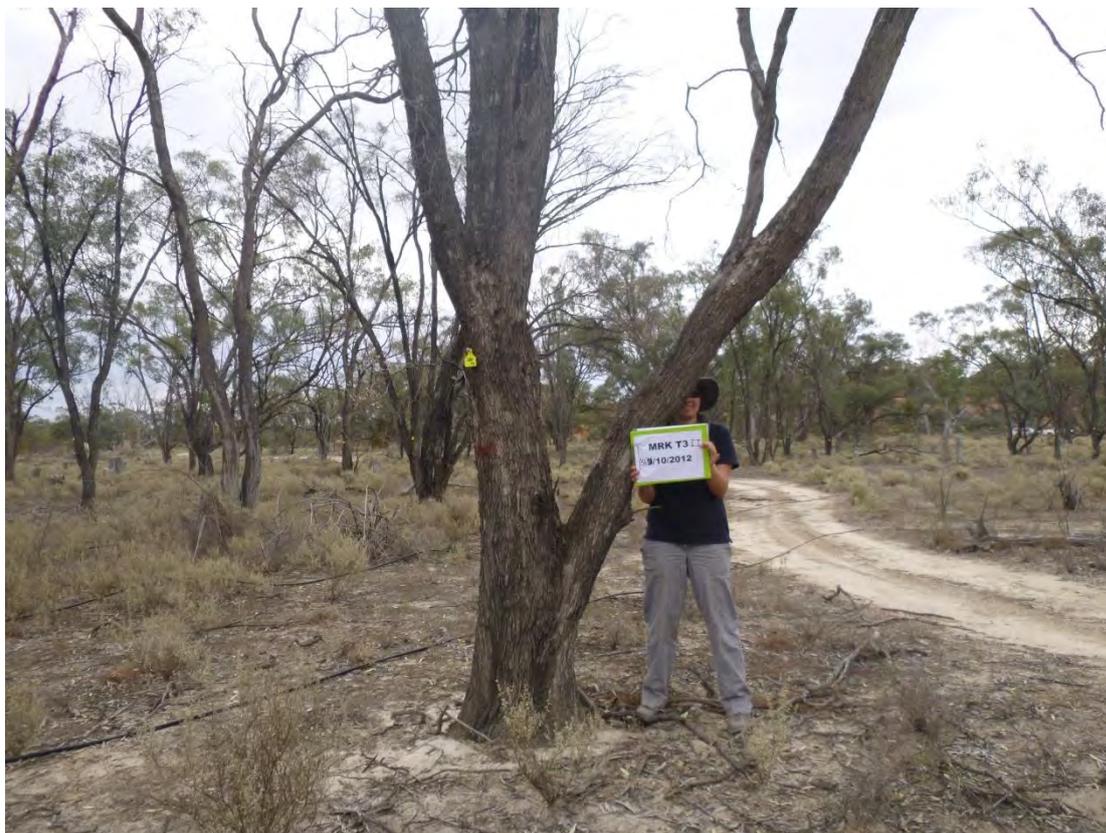
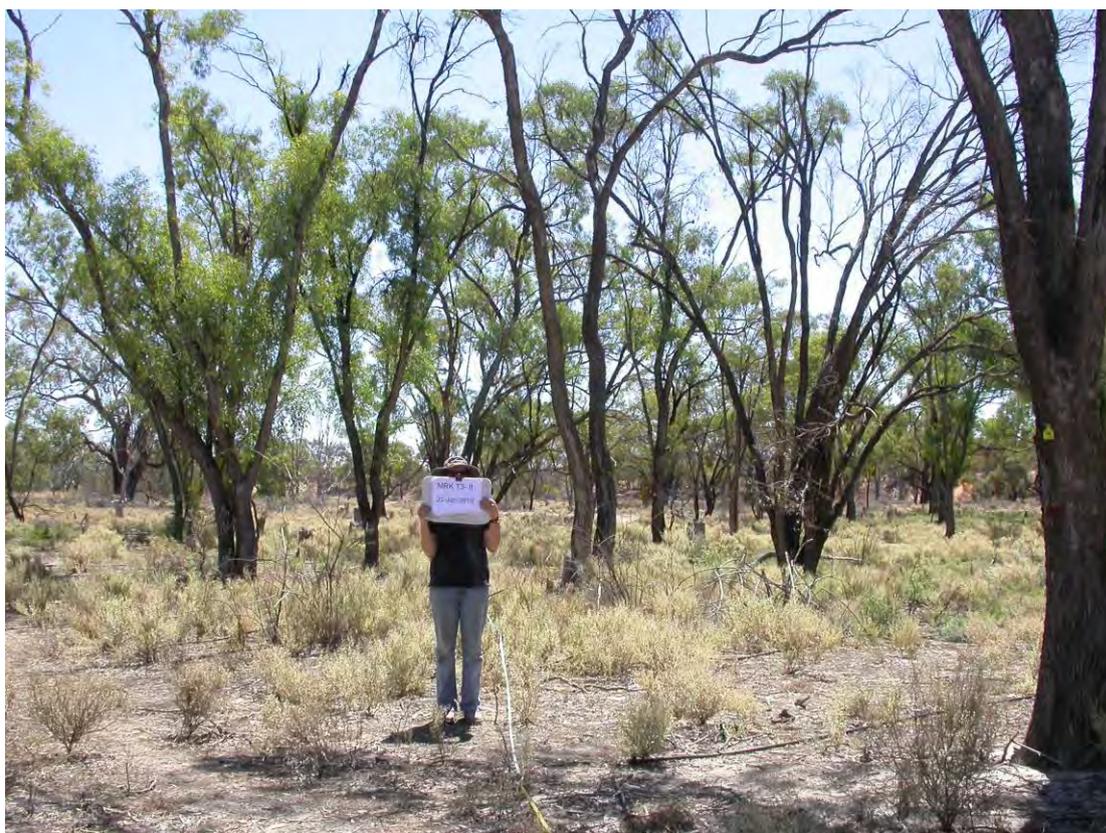
Appendix 22: Photopoint PII for treatment plot 3; pre-irrigation (above; 19/10/2012 and post-irrigation (below; 22/01/2013); Markaranka field irrigation trial

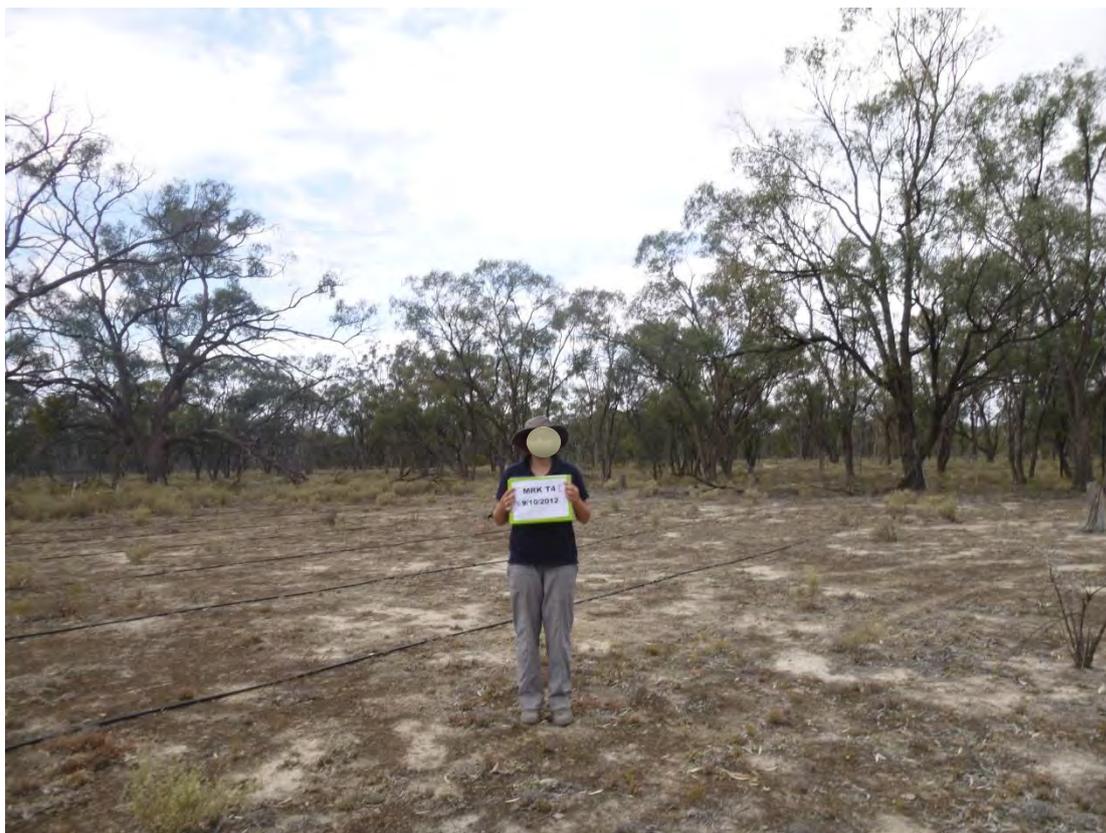
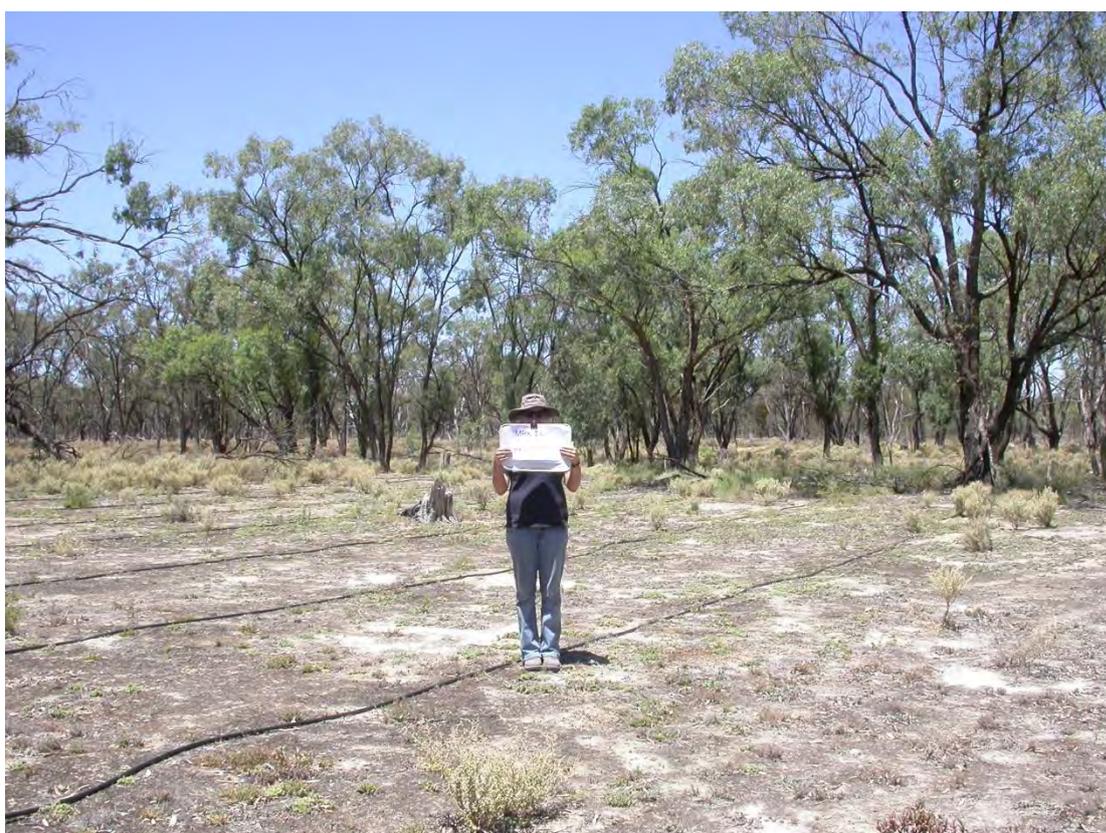
Appendix 23: Photopoint PI for treatment plot 4; pre-irrigation (above; 19/10/2012 and post-irrigation (below; 22/01/2013); Markaranka field irrigation trial
