Field trial investigating use of drip irrigation to improve condition of black box (*Eucalyptus largiflorens*) woodlands Phase 1: Infrastructure Test Report

SARDI Publication No. F2013/000438-1
SARDI Research Report Series No. 706

August 2013

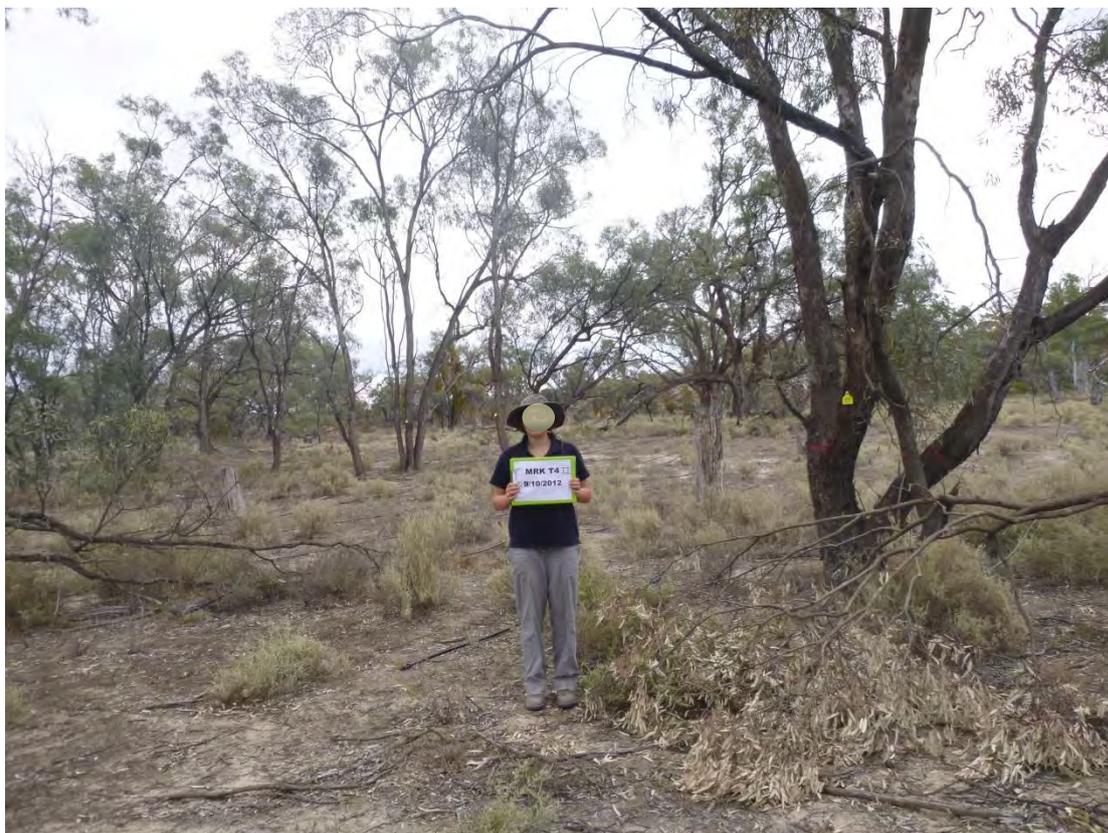
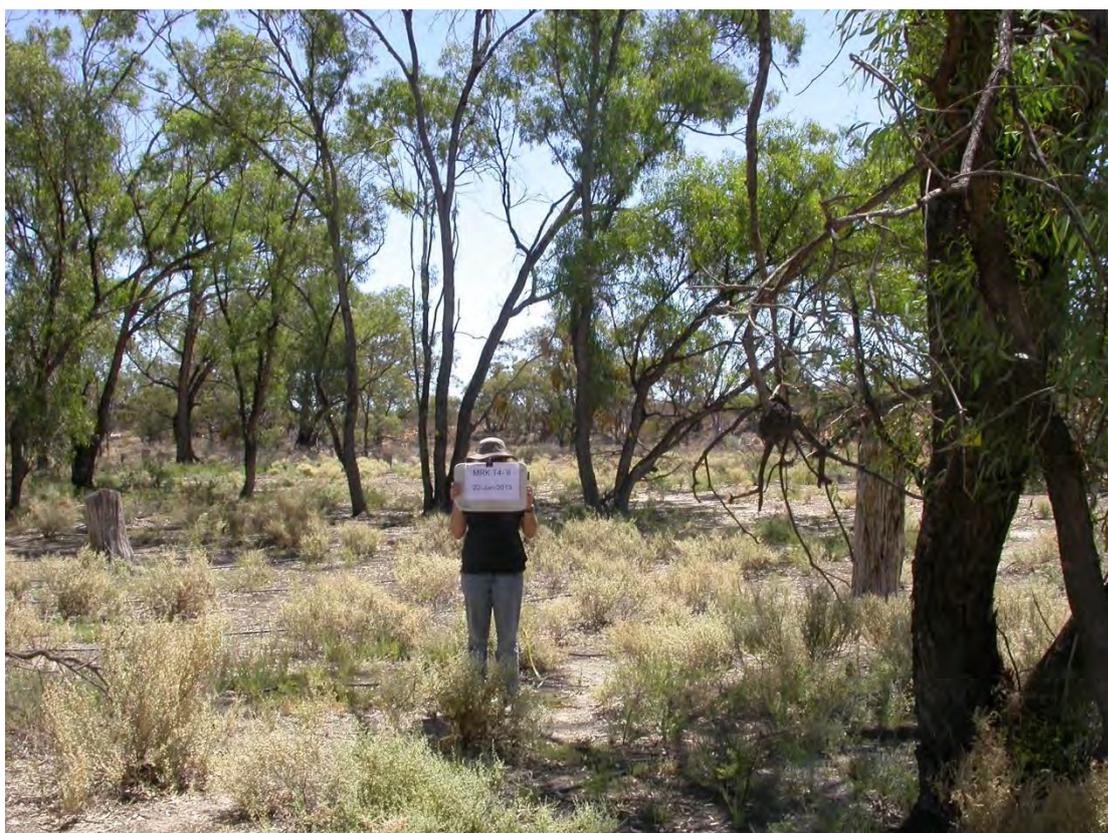
Appendix 24: Photopoint PII for treatment plot 4; pre-irrigation (above; 19/10/2012 and post-irrigation (below; 22/01/2013); Markaranka field irrigation trial
