# Dog Fence Board

## Activity, Inspection & Condition Report

28 August 2023 – 11 December 2023

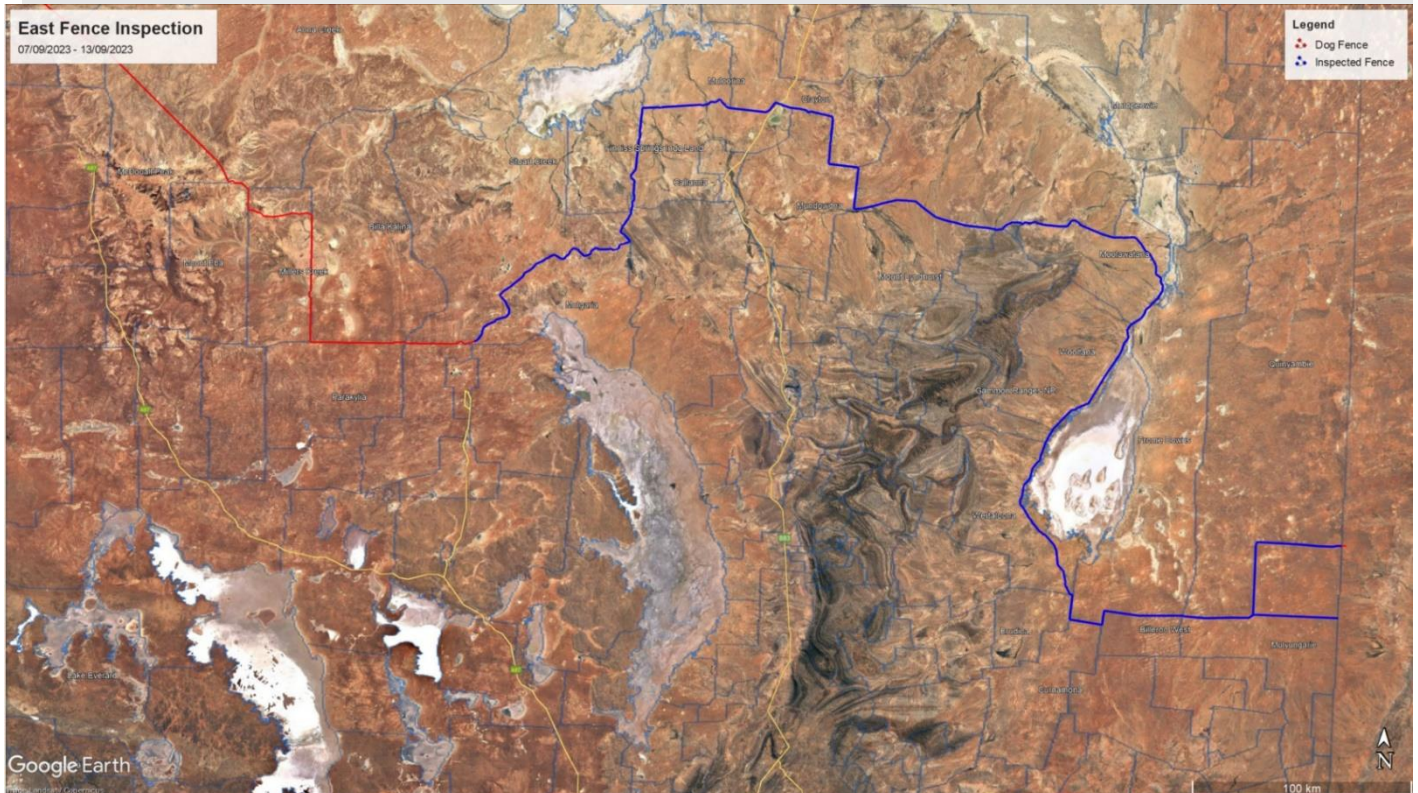
- Noted increased kangaroo pressure from the North.
- 1 grid alarm on Oodnadatta Track was vandalised, 1 alarm still operational. Replacement PIR sensor sent to Patrolman to install.
- Observed brumby/horse tracks – Mundowdna.
- Met with Contractor finishing floodgates and fence replacement on Mt Freeling section (Marree LDFB) and starting Stage 12 of rebuild (Moolawatana).
- Increased camel numbers around Moolawatana / Lake Callabonna.
- Met with Frome Patrolman.
- Surveyed Frome Fence for flood repairs.

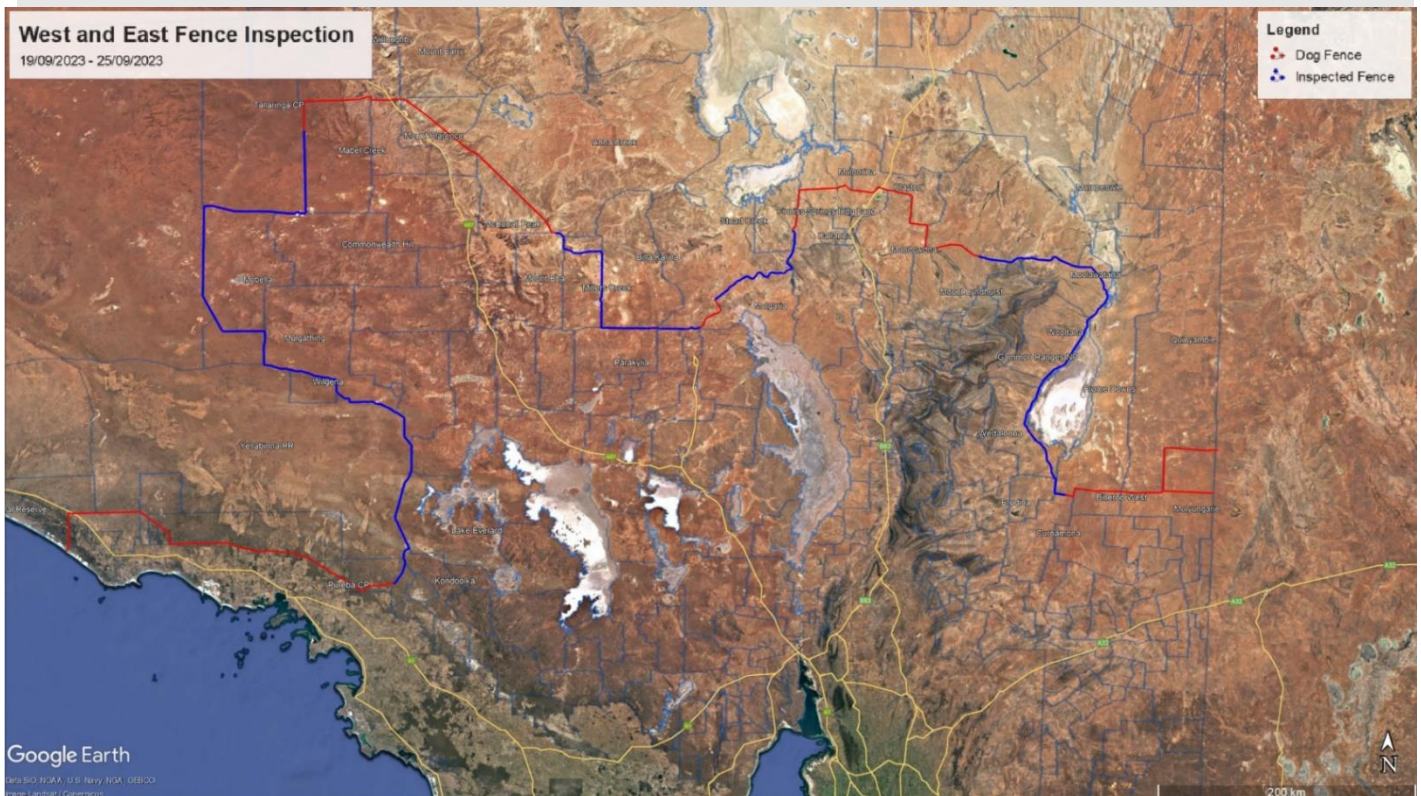
## West and East Fence Inspection 19/09/2023 – 25/09/2023

- Met with Penong Local Dog Fence Board and joined them on their Fence inspection trip.
- Met with Rebuild Contractors replacing the Lake Everard section.
- Noted stump regrowth occurring on Malbooma section of fence rebuilt ~2019 (NWP), property manager notified.
- Minor camel damage sustained to Mobella/Commonwealth Hill Fence (NWP), fixed.
- Visited Coober Pedy depot to take measurements for repair to wall lining and for storage racking.
- Met with Central LDFB Patrolman.
- Met with contractors working on the flood repairs (Frome).
- Inspected sections of fence are dog-proof unless stated otherwise; grid alarms operational.
