## Dog Fence Board Activity, Inspection & Condition Report

28 September to 20 December 2020

# Dog Fence Board - Activity, Inspection & Condition Report

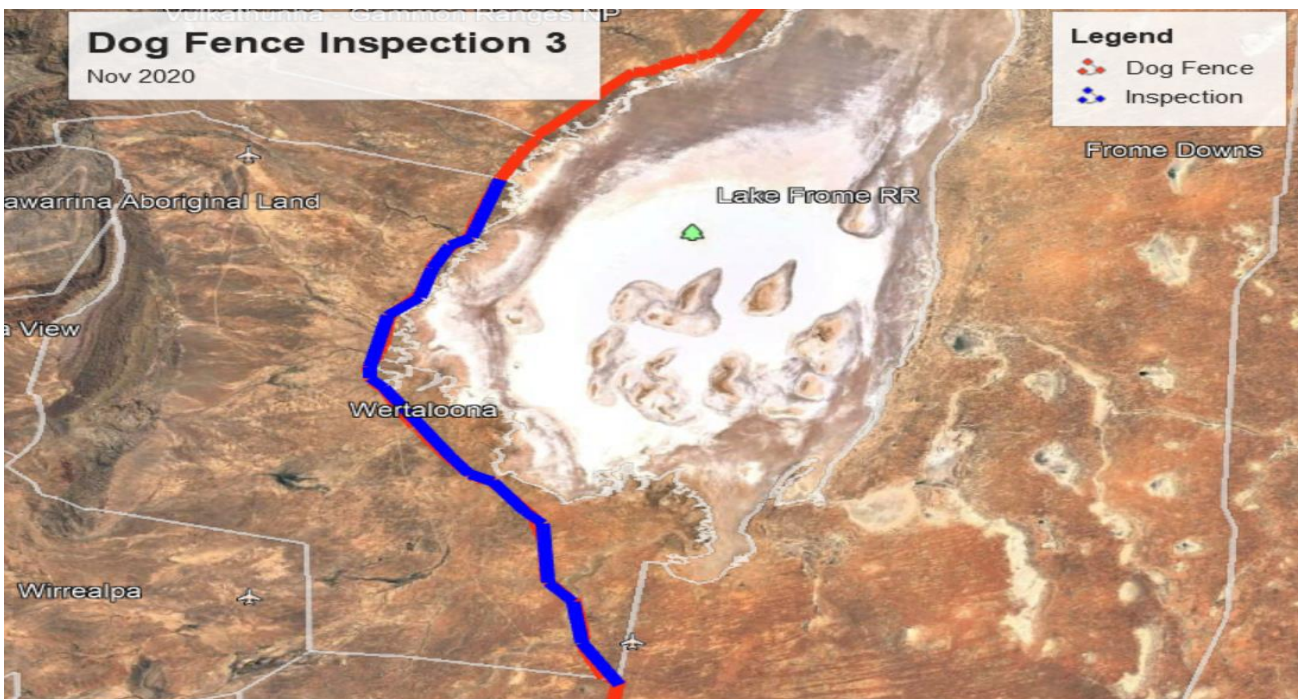
### Dog Fence Mapping Inspection 3

Date	Late Nov 2020
Section/s	Frome
Location description	Wertaloona
Inspected by	Dog Fence Rebuild Inspector,
Comments	<ul style="list-style-type: none"> <li>• Mapping and recording of all fence features for rebuild material requirements – fence type changes, direction changes, box frames, gates, wash outs and flood gates</li> <li>• Approximately 80 kms inspected</li> </ul>

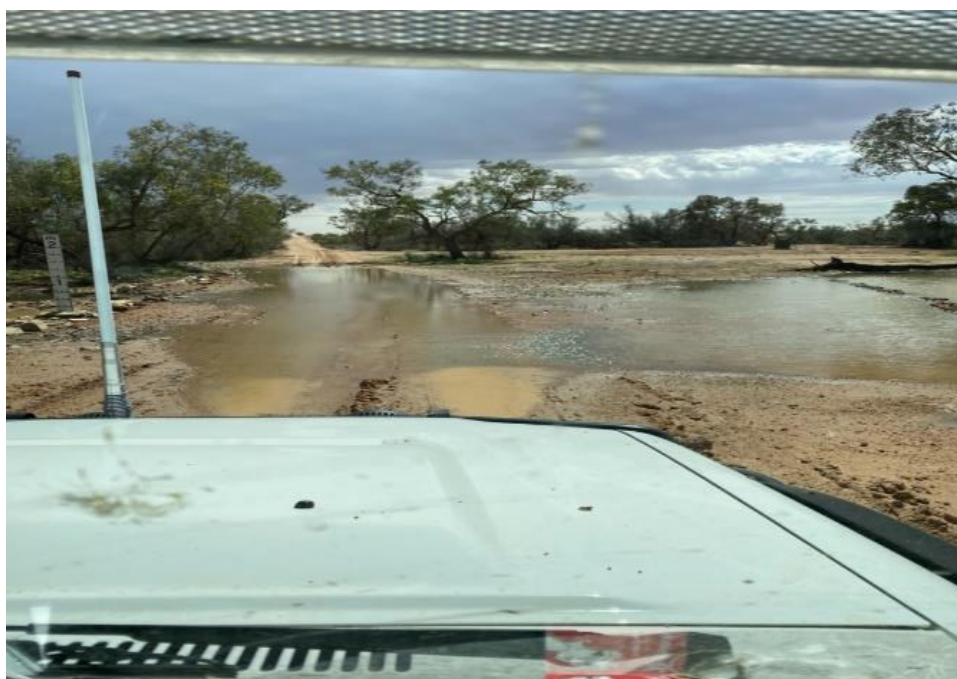
Flooding in the Marree LDFB section
