Dog Fence Board

Activity, Inspection & Condition Report

17 May 2023 – 28 August 2023

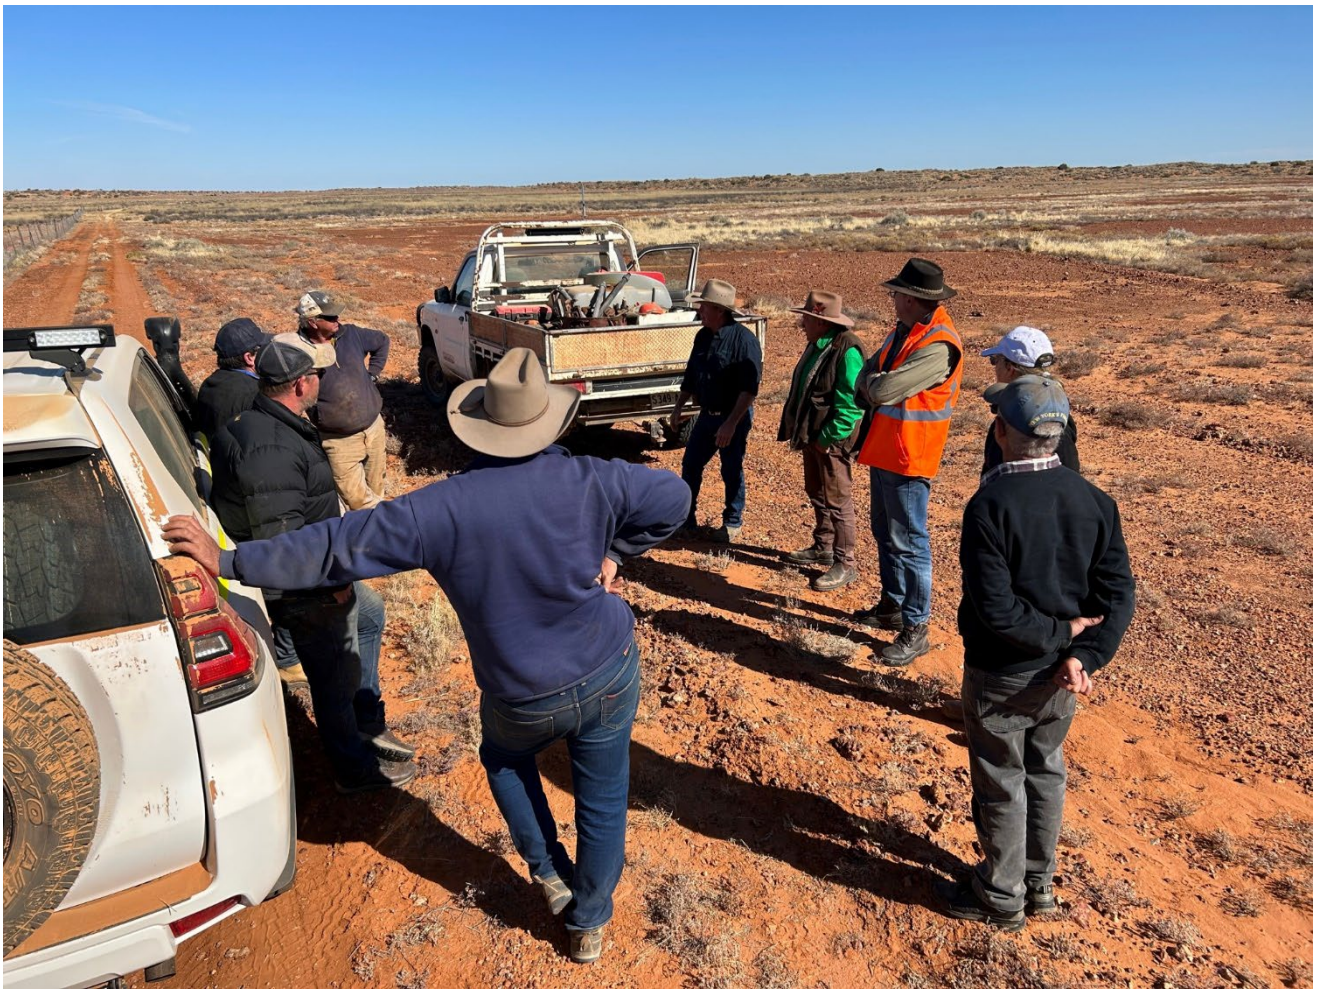
Dog Fence Board meeting with Fence Stakeholders – Mulgaria (Central)

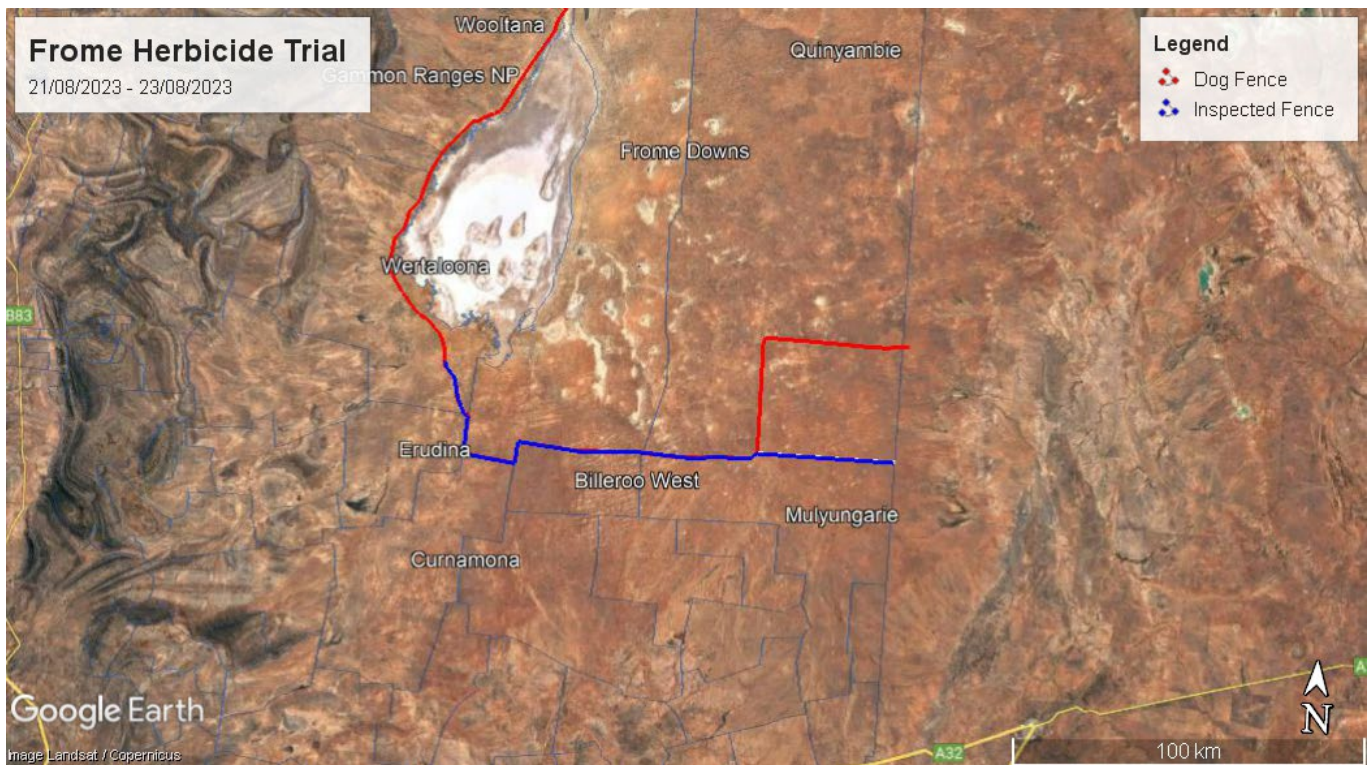
- Commenced testing of DFB's prototype herbicide applicator.
- Treated 156 km of fence.
- Tried different granulated herbicides split into 3 linear plots.
- Results and findings to influence future weed control.
- Grid on southern Tea Tree Road requires clearing – DIT notified.
- Dog and multiple camel tracks seen on Quinyambie and Frome Downs sections of fence.
- Inspected sections of fence are dog proof unless stated otherwise; grid alarms operational.

Tea Tree Road Grid – North side
