PIRSA

Dog Fence Board Activity, Inspection & Condition Report

2 September 2021 to 27 January 2022

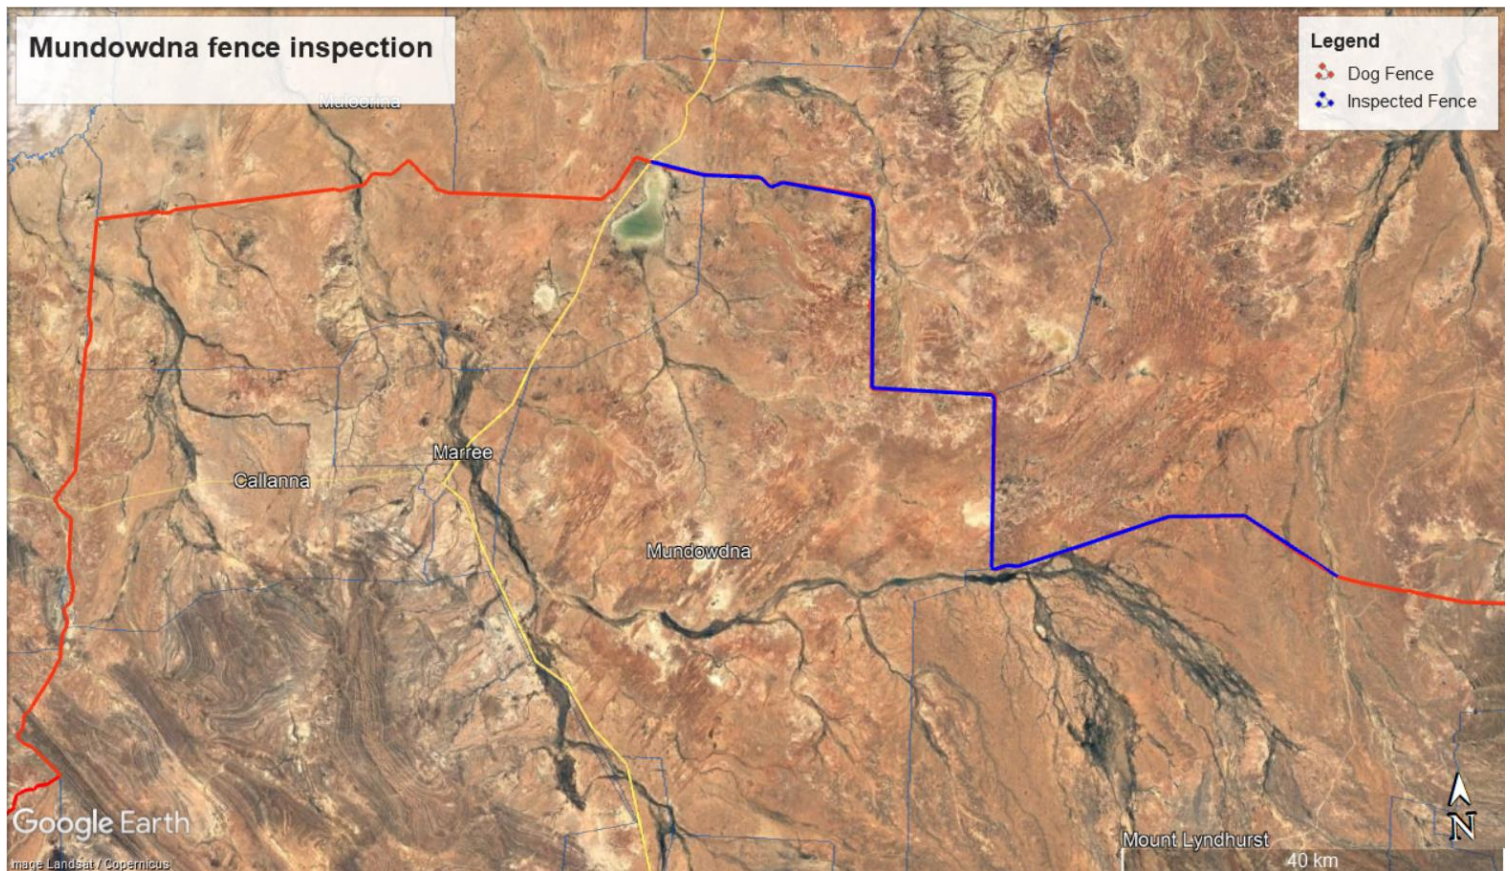
Mundowdna fence inspection – November 2021
1 November – 3 November 2021
Mundowdna, Mount Lyndhurst
Mundowdna to Mount Lyndhurst – 118km approx.
Dog Fence Inspector & Dog Fence Program Manager
<ul style="list-style-type: none">Inspected and undertook assessment of Dog Fence rebuild works at Mundowdna.Updated emergency procedures and signage at Lyndhurst depot.Birdsville and Strzelecki beepers operating correctly.

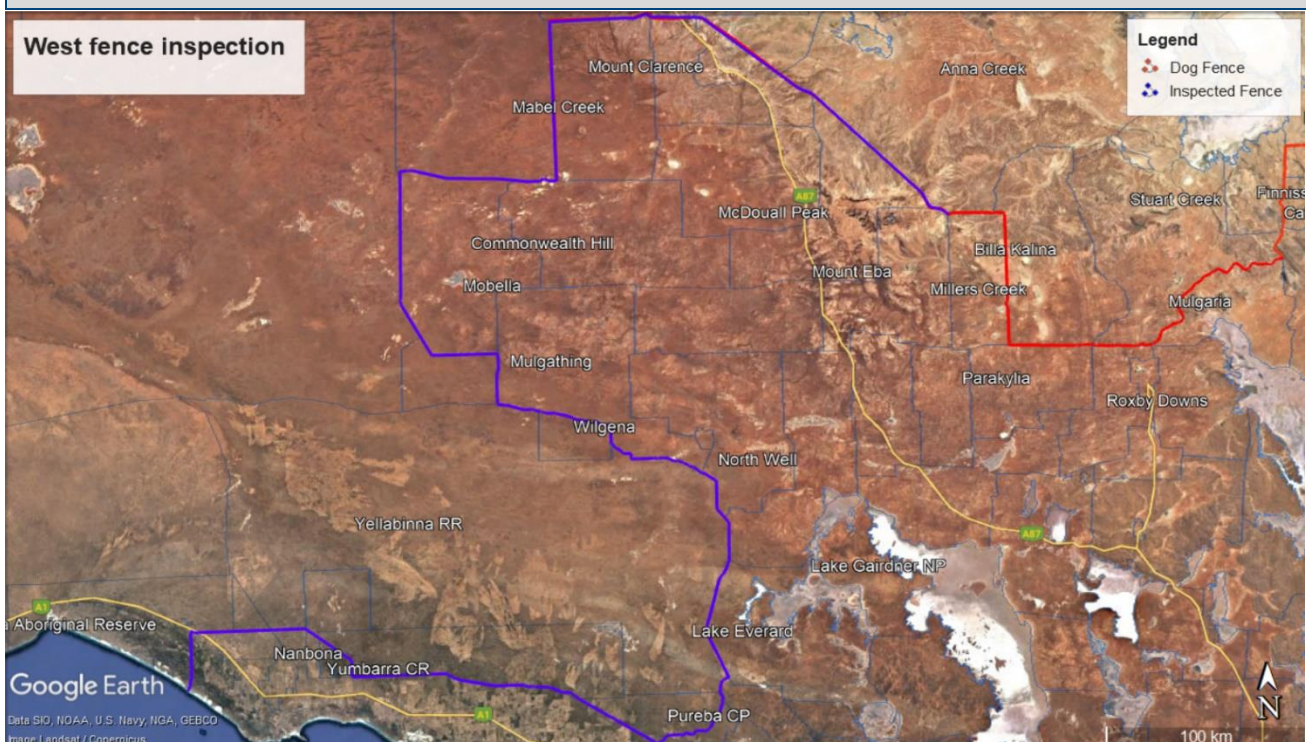
- Inspected Western half of Dog Fence.
- Observed replacement works of the Oodlea Road grid being carried out by Iluka Jacinth-Ambrosia mine. Iluka are replacing the grid to bring it in line with the Dog Fence Board's grid standard. Works were eventually put on hold due to damage being found on the already installed concrete abutments.

- North West Private Fence is in a dog-proof condition. Noted a grid in this section has wing damage and build up dirt and weeds. The NWP fence is under constant camel pressure, with camel activity noted along this fence section.

- Dog Fence Board annual half fence inspection (west).
- Collection of Dog Fence rates for the 2021/22 financial year.
- Investigate different application methods for granular herbicides including aerial. Do broad scale applications with a focus on newly rebuilt sections of fence.
- Explore different methods of recording maintenance reports for Patrolmen and Board.
- Tractor, wooden posts and pallet disposal (Lyndhurst depot).
- Installation of replacement grid for Balcanoona.
- Continuation of rebuild.
- Commencement of NSW border fence build.
- Distribution of containers along the fence for Patrolmen to store materials.
- Maintenance, repair or replacement of Jumbuck grid and wing.

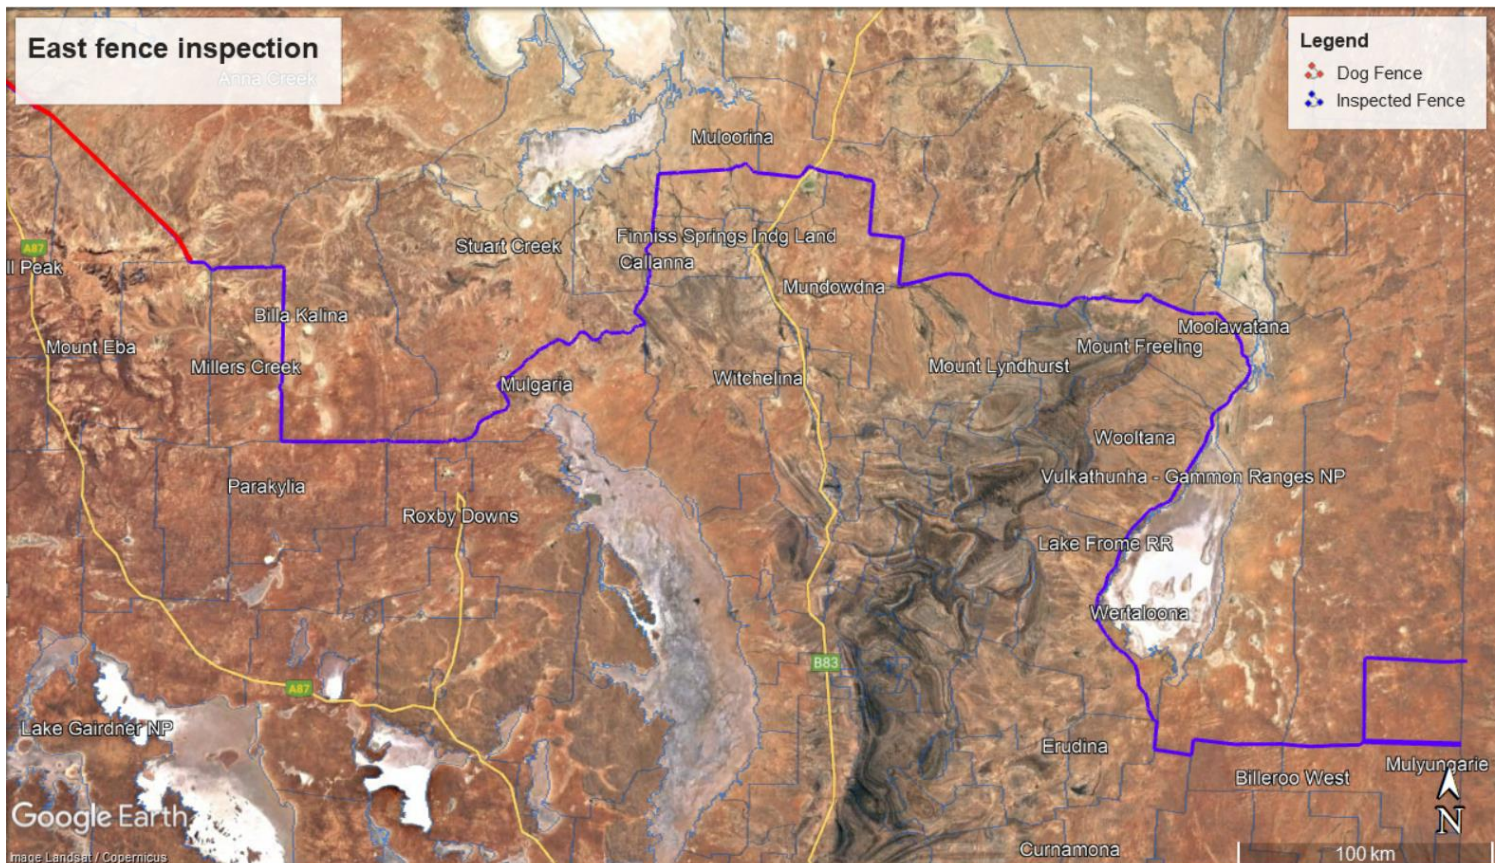
- Wertaloona, Balcanoona, Wooltana, Moolawatana, Mount Freeling, Mount Lyndhurst all in dog proof condition.
- Roo damage in top corner of Muloorina. Noted a few dead in the paddock.

- Inspected Callanna fence, several posts have been installed too high. Patrolman will undertake repairs.
- Witchelina, Roxby Downs, Parakylia, Millers Creek, Billa Kalina in good condition and dog proof.

- Noted a lot of old material and empty pallets along fence. Bent droppers and wires were left on the track in places, Fence inspector to remove on future fence trips.
