DOG FENCE B O A R D

Quarterly Report from the Dog Fence Board on the activities of the Inspector of Dog Fences

October 2019 – February 2020

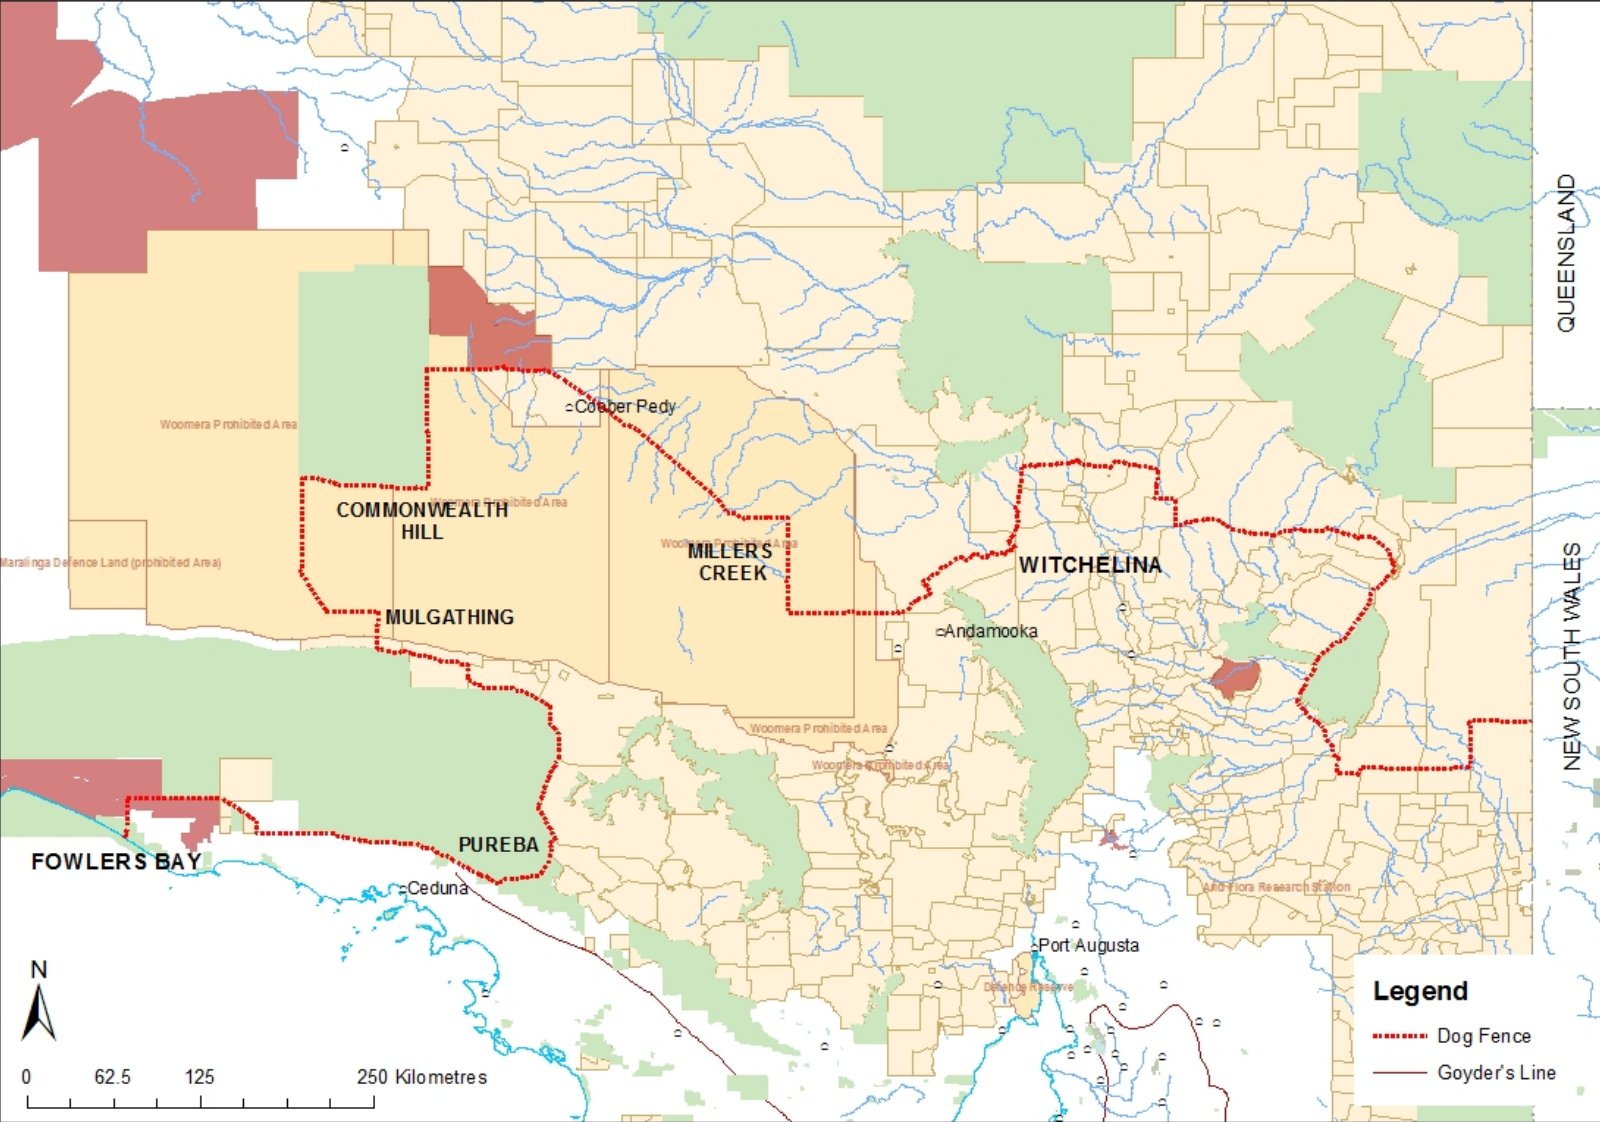
Figure 1: The Dog Fence between Coast and Witchelina was inspected in January 2020.

The fences that were inspected during this period were from the Coast near Fowlers Bay to New South Wales border.
